# A Failure Analysis and Remaining Life assessment of Boiler Water Wall tube

**Abstract—** This paper presents failure investigation on the SA210GrC water wall tube by visual Site inspection, tube wall thickness measurements, chemical composition test, Hardness test and microstructure analysis with proper evidence collected to identify the exact cause of the failure. The water wall tube was failed with blister, bulging and creep cracks on outer surface located near to the Soot Blower. On-site wall thickness measurements were performed on some of the water wall tubes located at the same level of the ruptured tube. The tubes have significant wall thinning and erosion from outside. Mild corrosion deposition also seen in the inner side. Microscopic examinations on the failed rupture region and some distance away of the as-received tubes are also conducted in order to determine the failure mechanism and root cause. Failure mechanisms are also discussed and relevant data from few months back to the failure gathered to identify the failure reason. The failure mechanism is identified as a result of the combination of the significant wall thinning of water wall tube due to long term overhe

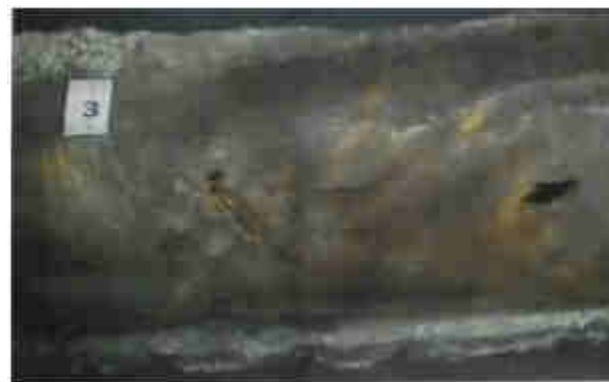
Fig.3.5: Mild corrosion deposit on ID surface in Blistered regions

In Fig 3.1 it is seen that the tube is in working condition (not failed) and the erosion due to abrasive property of the coal is damaging the surface. In fig 3.2 Bulging of the tube produced due to long term over heating creep damage or due to increasing temperature above the prescribed limit for long time. (1) External metal Wastage is due to corrosion or erosion. In fig 3.3 the Outer surface is covered with oil ash slag which is shining with coal ash layer and wall thinning with external damage is observed. (2) In fig 3.4 Thick-lip ruptures in steam-generator tubes occurred mainly by stress rupture as a result of prolonged overheating at a temperature slightly above the maximum safe working temperature. Thick-lip rupture may or may not be accompanied by sight swelling of the tube in the region adjacent to the rupture. In Fig 3.5 Mild corrosion deposit on ID side may be due to corrosion of protective layer of ferrous oxide. Due to the increasing temperature and bad water chemistry it is happened. (3) It is seen copper segregation at some point makes caustic corrosion.

So it was confirmed from that the failure was occurred after 7000h due to long term overheating and creep. The corrosion in the inner side of the tube was due to pitting/oxygen corrosion.

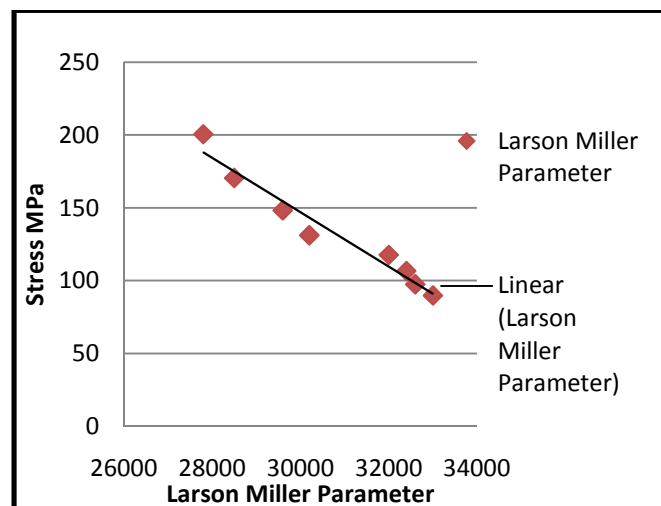
When the creep test for specific SA210 was carried out by many scientists the relation between stress and Larson Miller Parameter found that as the stress increases LMP is decreasing logarithmically. From LMP the remaining life and the cumulative creep damage is found. When the cumulative creep damage crosses the value 1.0 it is failed. In Fig 3.8 Stress vs.LMP for SA210 steel is drawn to obtain the LMP from the given stress and it is useful to find out the cumulative creep damage.

Fig.3.8: Stress vs. Larson Miller Parameter

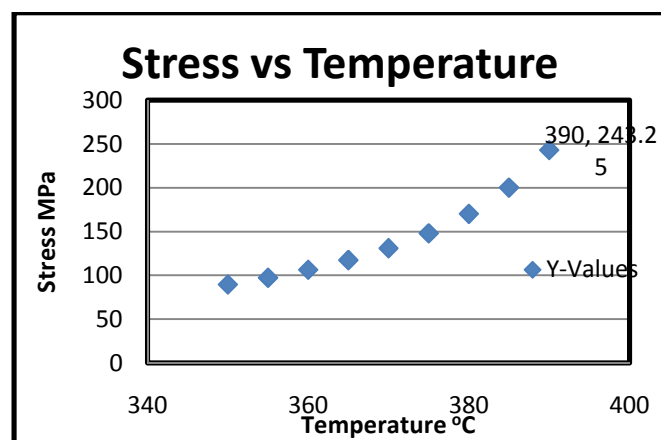
In Fig 3.9 Stress vs. Temperature for SA210 steel is drawn to show that the stress is badly affecting the remaining life with increase in temperature.

Fig.3.9: Stress vs. temperature
