Flexible Pavement Analysis - Study of a critical stretch on the AM highway - 010

Cited the problems, this article presents a case study of the AM-010, with photographic survey, the stretch is located between the state capital, Manaus, and the county Rio Preto da Eva, starting point at km 22 and end point at km 25.

The highway chosen to carry out this work, was the AM-010, Amazonas state highway, specifically the stretch between km 22 and km 25.

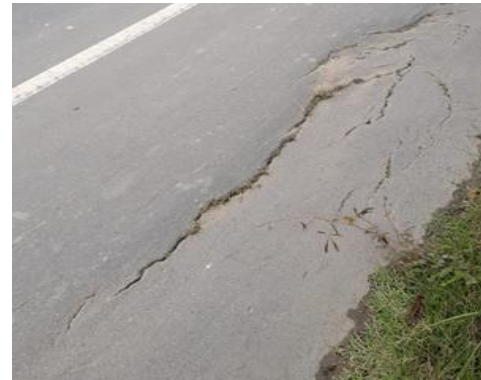
The cracks are common pathologies to arise, are linked to the life of the flexible pavement and are enhanced by environmental actions and the region's traffic. The following figures represent the most common types of cracks in the analyzed snippet.

Fig. 18: Longitudinal cracks (Copyright Images)

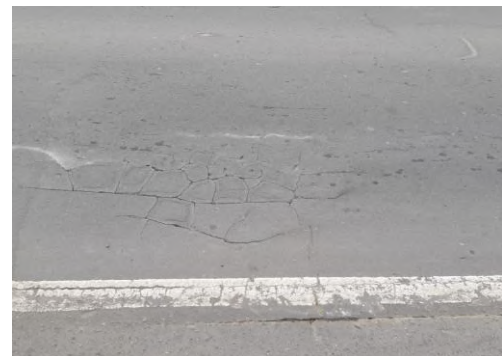
Fig. 19: Alligator cracks (Copyright Images)

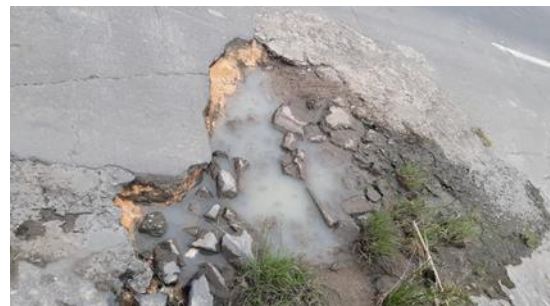
The pot hole is a cavity formed on the surface of the coating that can reach the base and originates from the evolution of cracks, snooses or wear (SILVA, 2011).

Fig. 20: Pot hole reaching the base, on the pathway
(Copyright Images)

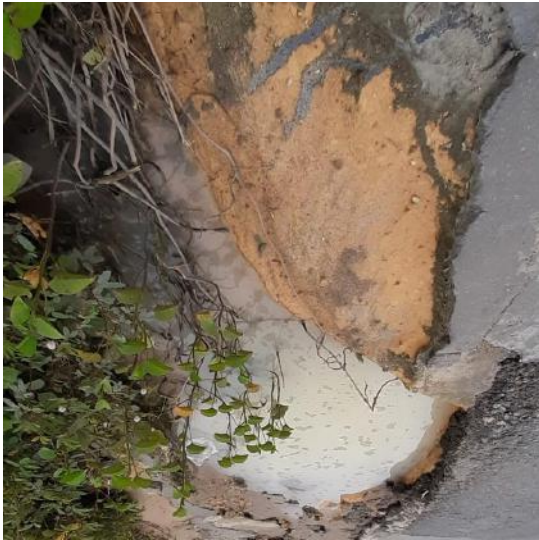
*Fig. 21: Pot hole reaching the base, on the sidewalk
(Copyright Images)*

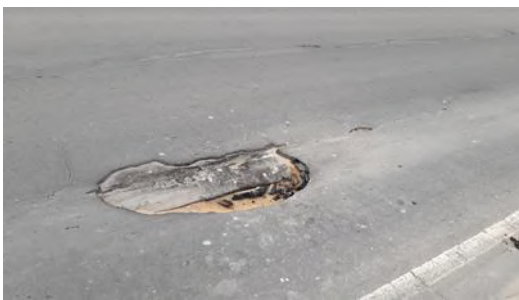
Next, it is possible to see that a patch was performed previously, the opening of the pot hole allows the view of the patch and the base.

*Fig. 22: Pot hole with old patch, reaching the base
(Copyright Images)*

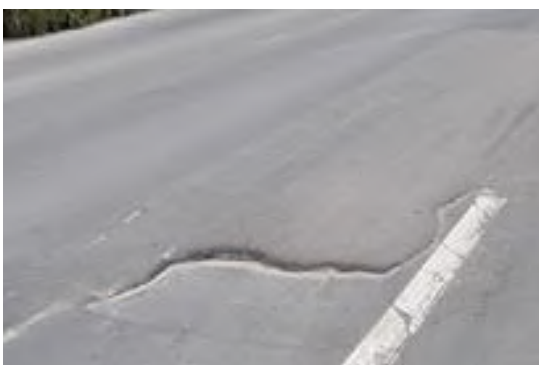
Next, the images show patches executed incorrectly, at levels higher than the pathway, some have already begun the process of deterioration in the margins of the clipping.

Fig. 23: Patch poorly executed (Copyright Images)

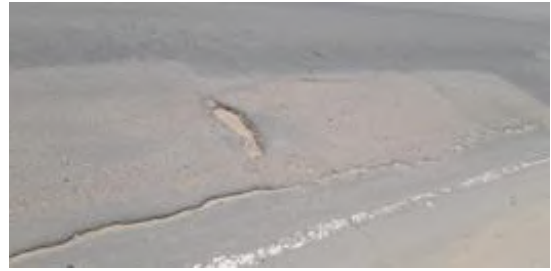
*Fig. 24: Pot hole between poorly executed patches
(Copyright Images)*

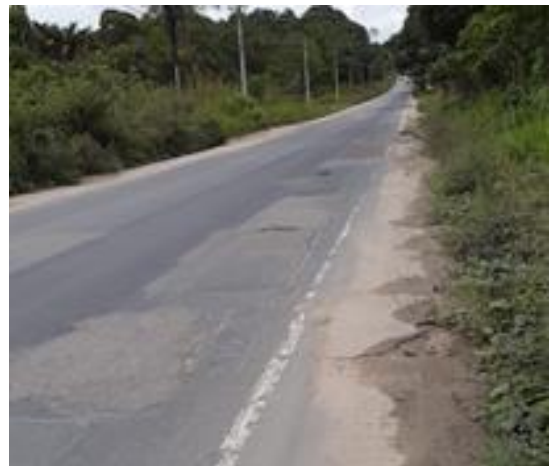
In the next image we have a follow-up of patches, by a large extent of the pathway. In this case it could be evaluated the possibility of performing the full recovery of this extension, the excess of patches, poorly executed, can aggravate the emergence of new pots and still make traffic in the region more turbulent and less safe.

*Fig. 25: Patch extension poorly executed
(Copyright Images)*

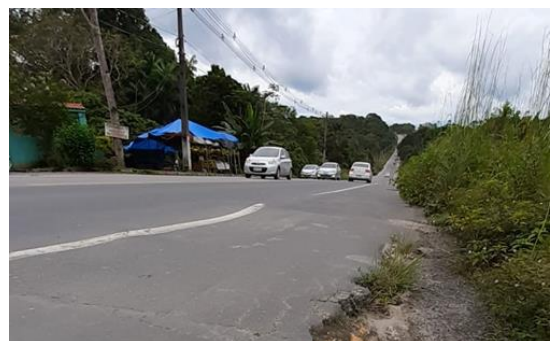
The sinking is considered a permanent deformation, the presence of a patch is visible, evidencing that there has already been an attempt to solve the problem, however, and this type of maintenance does not solve this defect.

Fig. 26: Sinking (Copyright Images)
