Elaboration of a damage map the facades of a public building in the city of Triunfo/PE

Abstract – This research seeks to identify and explore the main pathological manifestations found in the facades of Guarany Theater Cinema, in the city of Triunfo/PE, with the objective of elaborating a damage map. For the purposes of analysis, visits were made to the historic building to inspect the facades, as well as the capture of photographs that identify and guide pathological manifestations. Cracks and stains resulting from infiltration were found, but the existence of vegetation and places with deteriorated paint and plaster was still localized. This study enhances that analyses of a given constructions extremely important for the production of a damage map that assists, for example, in a possible project of restoration and preservation. In short, studying a construction with immeasurable historical, artistic, cultural value and of great relevance is necessary, not only for the Pernambuco Sertão, but also for the entire state of Pernambuco.

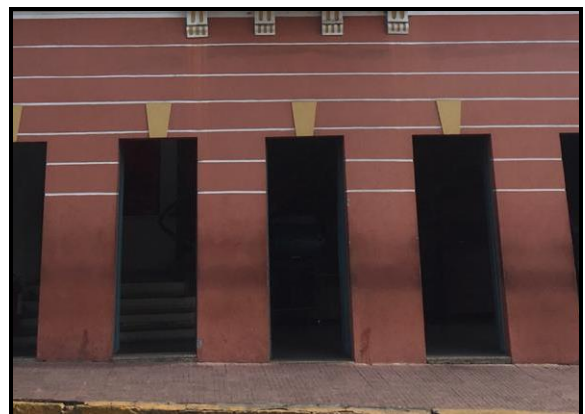
Surface stains are present on the two facades of the theater, all located at the same height. Such stains were caused by the constant passage of people through the sidewalks of the building, where they lay hands on the walls. The appearance of this type of pathological manifestation occurring over time, p and a repetitive and constant act. The result of the presence of this problem can be seen in Fig. 3.

Fig. 3: Surface stains on the facades of the building

This is a type of only aesthetic damage, which does not compromise in any way the functioning of the building, but it should be in addition to the fact of the visual

importance that the Theater has, in this way, simple maintenance, as paintings performed on a regular basis could solve this problem. Another suggestion for this problem is the use of super washable anti-stain paints, which can be applied both indoors and outdoors and that use special additives that allow the elimination of dirt without changing the paint.

The additive used in stain paints is a hydro repellent additive that prevents stains and dirt from attaching under paint, repelling them from the surface when it is washed with a damp cloth and neutral soap.

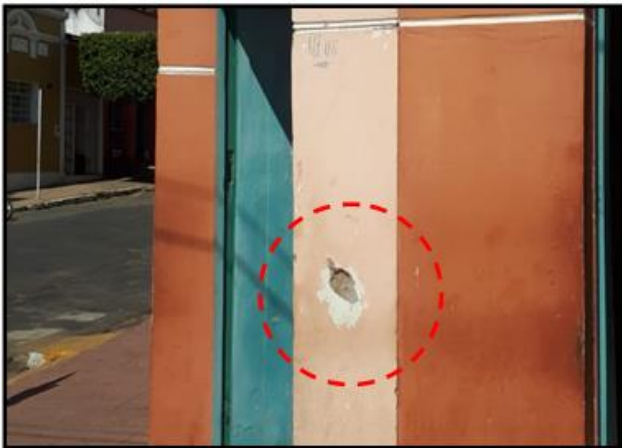
Some small areas with plaster detachment were identified Fig. 4, this pathological manifestation also called deplanement consists of the rupture of a part of the coating in relation to the whole, that is, a stretch of the mortar is parted from the surface (floor, ceiling, internal and external masonry), leaving exposed the area of occurrence of this pathological manifestation.

Fig. 4: Plaster detachment

Detachment can be caused due to sudden and continuous temperature changes, poorly executed labor, execution of very thin or very thick layers of plaster, among other factors. In the case of the external analysis of Guarany Theater Cinema, and observing that the plastering displacements are of low occurrence and in sizes considered small, one should first request the correct diagnosis with a professional in the area, to ensure that the "neighboring" regions are not compromised.

From this diagnosis, a new coating with mortar can be made at the site of pathological manifestation, and later apply a new painting, thus preventing these damages from spreading and causing major disorders. On the other hand, in the case of surfaces with a lot of occurrence of detachments, the most recommended is the complete

removal of the damaged mortar and the application of a new one.

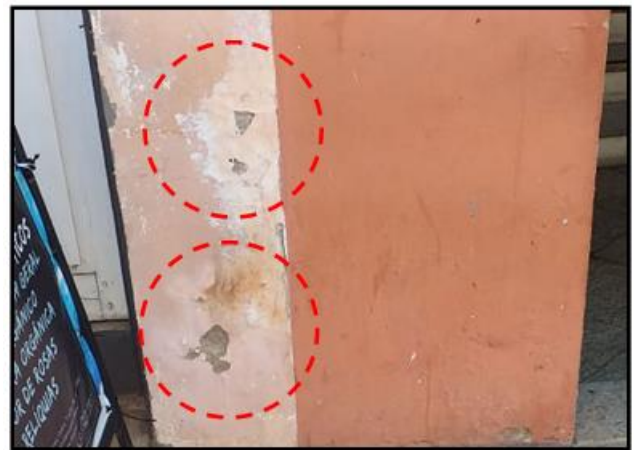
At the western end of the front façade at the bottom, there is the presence of peeling of the painting Fig. 5, in this particular case due to the absorption of water by a phenomenon known as capillarity – it is the ability that some substances have to climb or descend through capillary tubes or move through short spaces present in porous materials. This mechanism allows fluids to move against gravitational force.

Fig. 5: Detachment of the painting

The peeling of the painting presents on the façade occurred, therefore, due to the porosity of the material that composes the pillar where this pathological manifestation was identified, which allowed the transport of water by capillarity. As a solution to this problem, it is recommended to scrape and sand the surface and then apply a layer of waterproofing.

It is necessary to eliminate the contact between the surface and moisture, to ensure that the problem does not appear again over time. According to Demetrius da Rocha Ramos, Civil Engineer and technical advisor at Weber Saint-Gobain, there are waterproofing mortars available in the market that can solve this problem. He states that it is important to perform all the removal of the wall cladding and then apply the product, both on the inner and outer side.

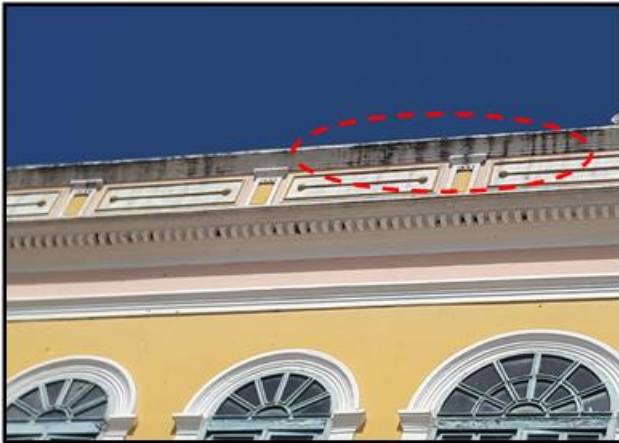
Moisture stains were noted on both theater facades, between the cornice components and especially in the upper regions of the building, as shown in Fig. 6. With the moisture present in the wall, it can trigger mold and the action of microorganisms. Moisture spots can appear in various situations and climates, such as in coastal regions and in cities such as Triunfo – with rainy winter and low temperatures.

Fig. 6: Surface spots characterized by moisture

The presence of moisture can affect the paint, flooring, ceramic coatings and even the structure of buildings. In the case of Guarany Theater Cinema, it is believed that the climate and frequency of precipitation (especially between May and July) have contributed to the emergence of this type of pathological manifestation. Unlike the peeling of the paint due to the absorption of water by capillarity, these types of moisture stains found on the facades, are derived from the contact that the surfaces have with the fluids, which are damaged by not having a correct waterproofing.

Even though the Guarany Theater was built with the use of whale oil, both as a binder and as a waterproofing agent, the age of the building may have made the oil's waterproofing capacity lost.

To treat this pathological manifestation, the procedures are to clean the region of occurrence to eliminate and prevent mold, perform proper waterproofing and then remake the finishes on the walls or any surfaces.

Expanded Polystyrene (EPS), for example, is being increasingly applied, mainly in external coatings, due to its thermal insulation capacity, prevention against molds and moisture, low water absorption, in addition to sustainability, economy, and the property of preventing the proliferation of microorganisms, among other factors.

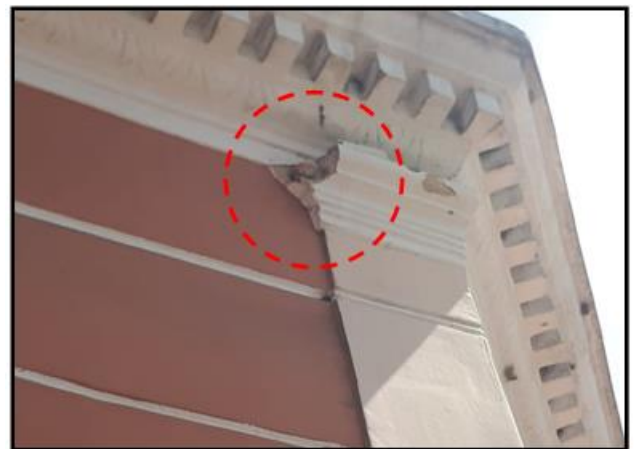
It was located on the front façade, a broken capital as shown in Fig. 7. In architecture, capital refers to the top of the column, located above the steel. In the case of the damaged capital at Guarany Theater Cinema, the cause of the damage is unknown, but it is believed to have been caused simply by the use of a weak mass or the presence of fissures in the region of the collapse, which over time occurred the detachment of part of the structure.

Fig. 7: Areas with loss of concrete

As in the construction of the theater, no cement was used, this may also have contributed to this architectural component breaking down. For correction, the reconstruction of the workpiece must be performed, maintaining its characteristics.

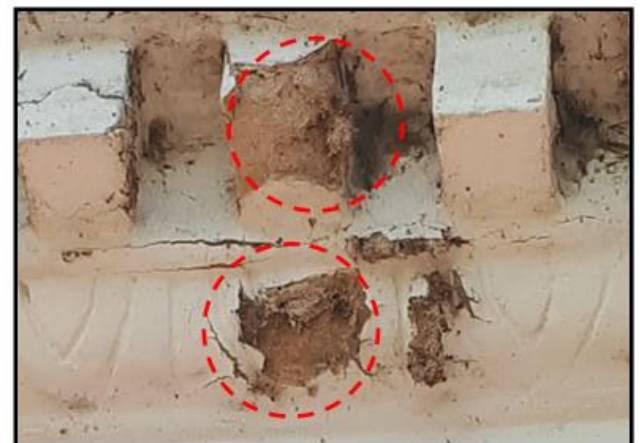
Another component found broken was a piece of the cornice, located on the side façade seen in Fig. 8. In the same way as the capital, cracks may have caused the damage in the cornice region and consequently its detachment, therefore to reconstitution of the same, it must be carried out the reconstruction and reform of the piece.

Fig. 8: Areas with loss of concrete

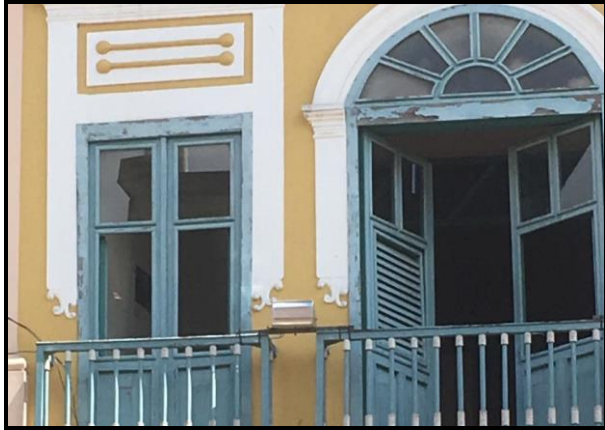
In this context it can also be mentioned the wear of the frames that is related to the peeling of the painting, having been identified in almost all doors and windows, in addition to the wear noticed in the bodyguards, which are also wooden as seen in Fig. 9. To solve this problem, just sand the frames in order to remove the damaged paint and make a new one, which is proper for external environments, that is, with waterproofing properties.

Fig. 9: Wear of the frames

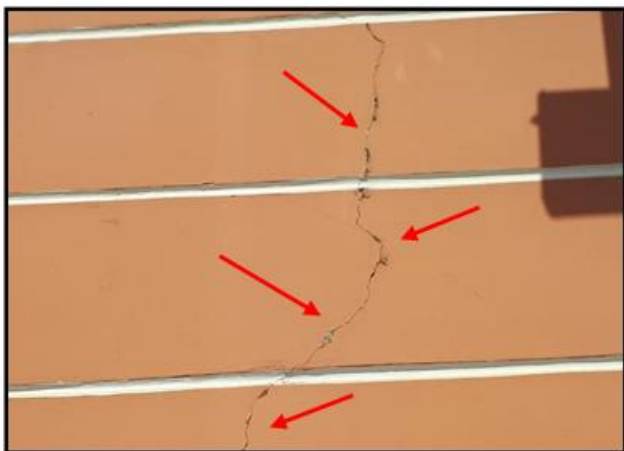
The fissures were identified in the lateral façade as shown in Fig. 10. According to their physical characteristics, they were possibly caused by the vibration of cars that travel daily in the streets in front of the two façades, another possibility that should be taken into account is the vibration that was caused in the building when these highways were paved at the time of the use of compactor rollers, which are heavy machinery used to compact the asphalt mixture. Another point that may have generated the cracks is the temperature oscillation, which causes the materials to dilate and contract.

Fig. 10: Occurrence of fissures

Fissures are pathological manifestations that generally deserve special attention, because they are directly linked to the physical functioning of the building, and may worsen and become larger in larger cracks – cracks, which alert to structural problems.

A professional in the area needs to make the correct diagnosis about the fissures in order to point out what is the best method of treatment. For small cracks, you can retouch the plaster using acrylic mass or mortar, but they can reappear over time. Another option is to pass pure elastomeric paint at the crack site and then apply two or three coats of paint.

Another alternative to repair, is to open the crack using an equipment called "crack open", in addition to taking the paint present in the side bands, then you should remove the dust and clean the surface using a brush and a damp cloth, the next step is to fill the crack with dough, after full need to cover with a thin mesh canvas and cover the screen with the dough used previously, finally, sand and paint the surface that has been restored.

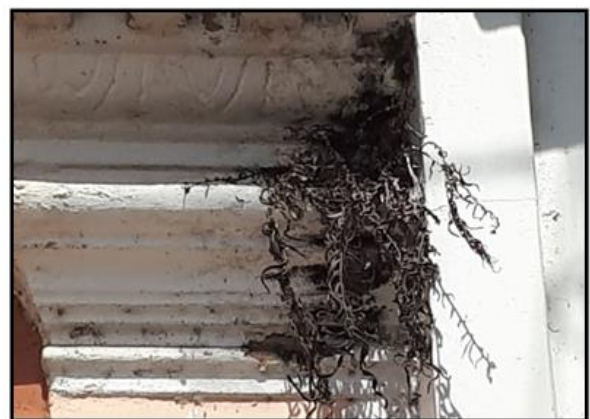
It was also noted the presence of vegetation at the eastern end of the side façade, at the limit where the Guarany Theater Cinema ends and begins the masonry of the neighboring building, possibly indicating a joint between the two buildings, which allowed the development of such pathological manifestation. The presence of this vegetation still exposes the lack of maintenance of the external area of the theater. This pathological manifestation can be seen as shown in Fig. 11.

Fig. 11: Presence of vegetation
