The Fatigue Failure Analysis of Steel Structure and Review of Collapse Accidents

In this paper, exemplified by a certain factory building of Shanxi bolt-ball rack collapse as the research background, we will study the area of collapse network frame through the methods of field observation, deformation measurement, fracture analysis and sampling test, and analyze the failure process of the network frame, find out the accident reason finally. Main job:

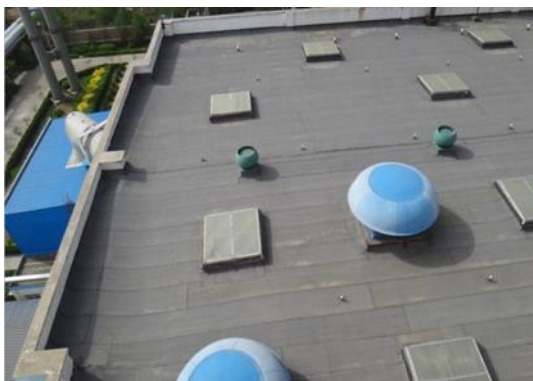
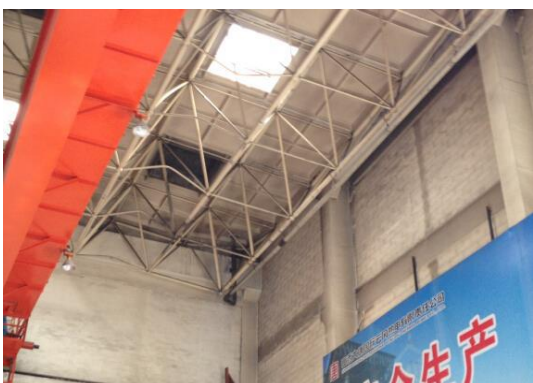
On May 17, 2015, local collapse occurred in the southwest corner of the bolt ball grid roof of the plant, and the lower chord of some grid frames was bent greatly, See "Fig.3-2 "-"Fig.3-3 ". At night of May 20, the whole collapse occurred in three sections of a span on the west side of the bolt ball grid. See "Fig.3-4 "~"Fig.3-7 ". Some large equipment was damaged and no casualties were caused due to unmanned operation at night.

Fig. 3-2: Partial collapse.

Fig. 3-3: Lower chord bending

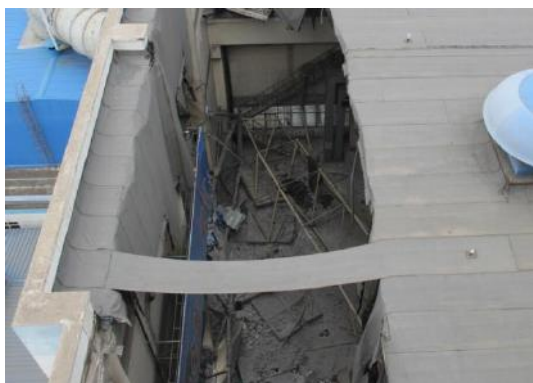
Fig. 3-4: The overall collapse

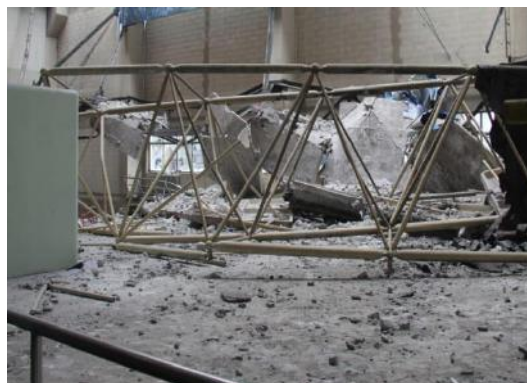
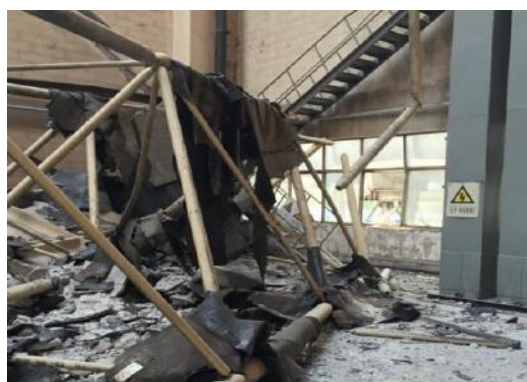
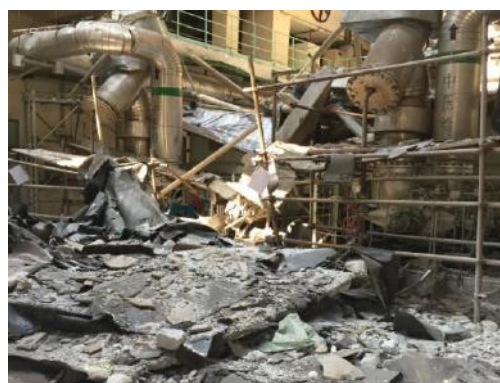
Fig. 3-5: The collapse of the scene

Fig. 3-6: The collapse of the scene

Fig. 3-7: The collapse of the scene

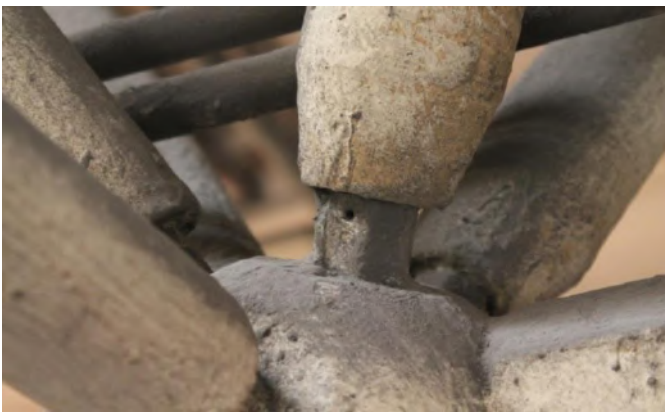
Through the observation of the bolt sphere grid structure in the area without collapse, it is found that some high-strength bolts connecting the web members are missing sleeve pins, but the outer skin is complete, as shown in Figure "Fig.3-8 ". It can be seen from the field photos that the pin is missing before painting. If the pin is missing before installation and the sleeve does not have the snap action of the pin, the high-strength bolt will not rotate and tighten with the sleeve during installation, it is likely that the high-strength bolt will not screw into the bolt ball or the screw in length is not enough, but it cannot be checked from the appearance, resulting in huge safety All hidden dangers. See "Fig.3-8"

Fig. 3-8: Bolt sleeve pin is missing

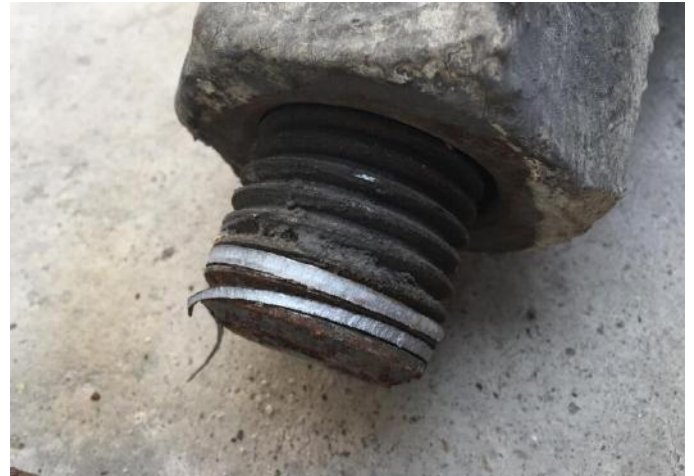
The M42 high-strength bolt connected to the diagonal web rod at the southwest corner of the grid frame has two rounds of ball thread. See "Fig.3-9 " the high-strength bolt out of the thread. This is caused by the slippage of the M42 high-strength bolt and the lower chord ball. The bolt ball grid has the problem of false bolts during the installation and construction, and the construction quality is not high, and the bolt ball grid is used by thousands of high-strength bolts. It is not excluded that other bolts also have the same problem, and the hidden danger is huge.

Fig. 3-9 M42 high-strength bolt out of the thread

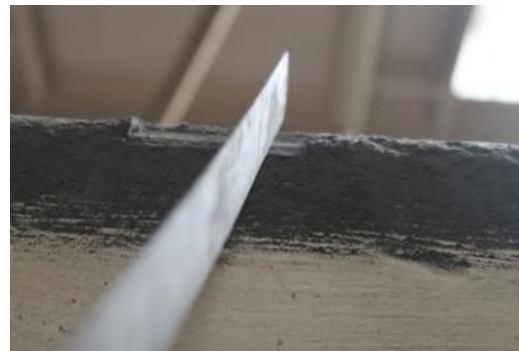
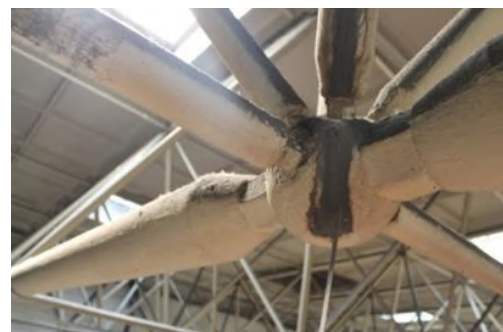
The ash on the side of the bar and bolt ball is 1-3MM, with an average thickness of about 2MM. See "Fig.3-10" - "Fig.3-11" . This shows that the maintenance problem of the bolt ball grid in the daily use process has not attracted the attention of the user, and there is a management problem of long-term maintenance and troubleshooting, which makes the bolt ball grid unable to meet the durability of its original design, and it cannot be timely in case of structural problems It is found that there is a large potential safety hazard.

Fig. 3-10: Bar of formation

Fig. 3-11: Bolt ball formation

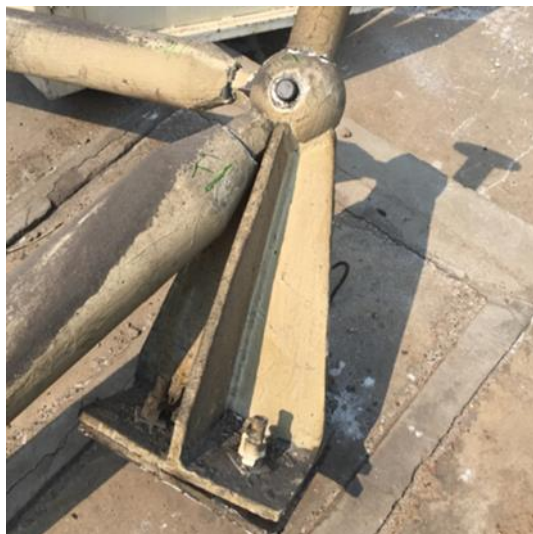
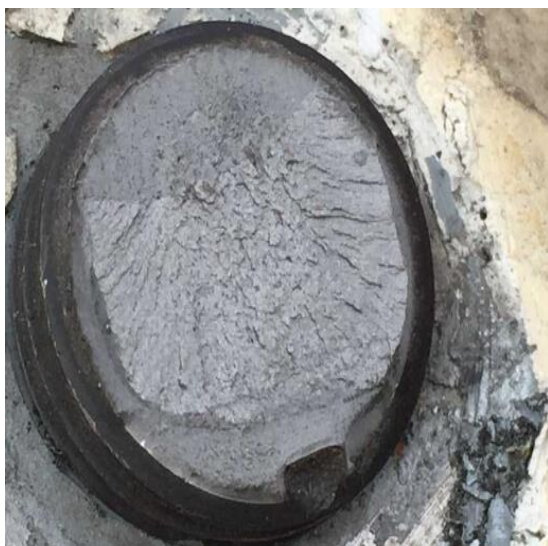
Through the observation of the accident site, it is found that the fracture surface of M33 high-strength bolt connecting the upper chord at the long axis of the southwest corner support of the grid structure shows a clear fatigue fracture morphology. See "Fig.3-12" - "Fig.3-13" which indicates that the bolt ball grid structure has fatigue problems, and the fatigue fracture belongs to brittle fracture, which can be the failure source of the grid structure collapse, so it needs to be paid attention to

Fig. 3-12: The bearing

Fig. 3-13: M33 high strength bolts fracture

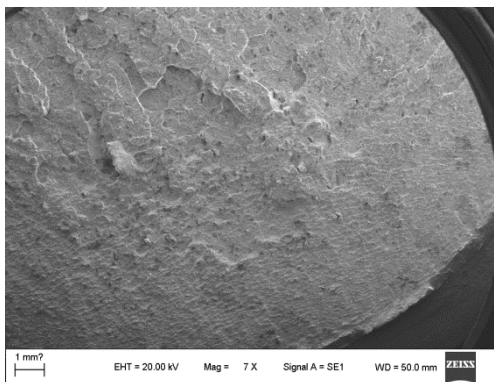
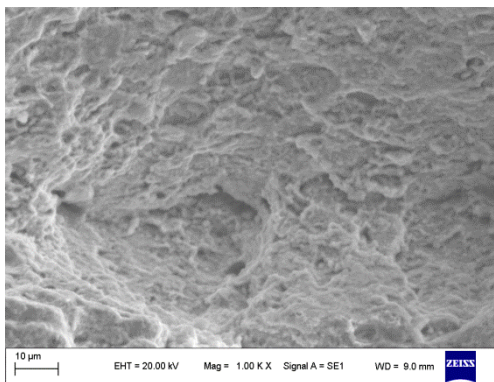
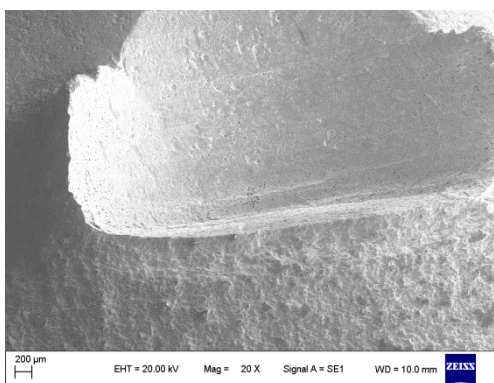
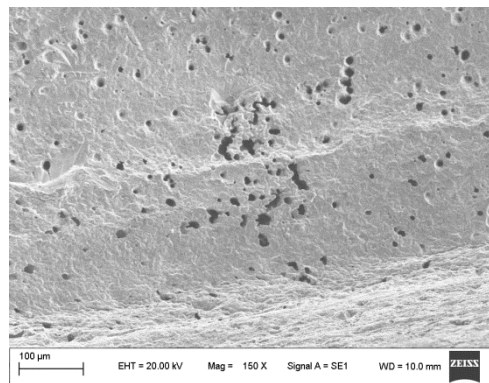
Fig. 4-9 The fracture morphology (7 times)

Fig. 4-10 Fatigue striations (1000 times)

Fig. 4-11 Pin hole crack source (20 times)

Fig.4-12 Pin hole inner surface pitting corrosion pit (150 times)

The results show that the fracture morphology presents typical characteristics of fatigue source region, propagation region and instantaneous fracture zone. There are two fatigue source regions in the fracture. One is that the crack starts at the root of the thread, showing fracture dimple morphology and radiation striation morphology; the other is that the crack starts at the pin hole, and there are many corrosion pits on the inner surface of the pin hole;

there are secondary cracks in the propagation area of the fracture; the instantaneous fracture area of the fracture is a mixed fracture morphology. The fracture morphology is low cycle fatigue.

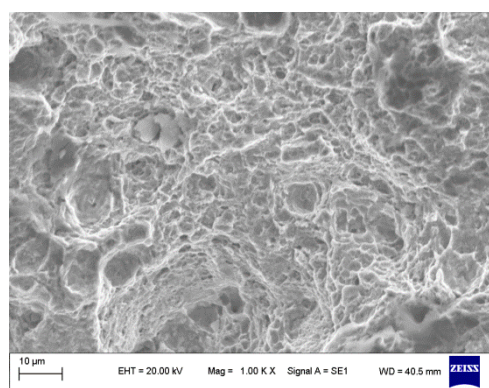
Fig. 4-13 Extension area morphology (1000 times)

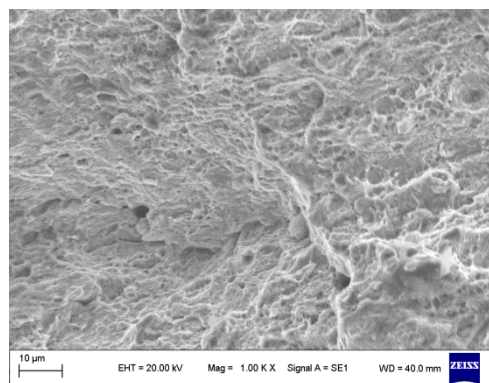
Fig.4-14 Transient breaking area morphology (1000 times)
