# Geotechnical Investigation of Fracture Patterns in a Rock Mass during Excavation by Blasting

**Abstract**— *Overcharging in rocks (wall faces) during blasting and excavation usually causes damage to rock mass in most mining and quarry industries. This creates blast-induced fractures which can relate with pre-existing fracture pattern thereby increasing sliding and rockfall from the crest and body of an excavated wall. The spacing and orientation of pre-existing fractures are predominant at a small-scale mining (galamsey) site at 'Atta ne Atta', a town near Beposo, in the Western Region of Ghana. Geotechnical field studies were carried out to investigate the possibility of any instability within the area to eradicate the occurrence of an unexpected future wall failure (rockfall). The geotechnical mapping conducted was focused on fracture distribution and spacing. Mean spacing ( $S_m$ ) of existing fractures was calculated and corrections were made to obtain calculated spacing ( $S_c$ ). The scanlines of wall face 001 and wall face 002 intersect with their corresponding strike and dip at  $78^\circ$  and  $80^\circ$  respectively creating a slightly favourable fracture pattern and

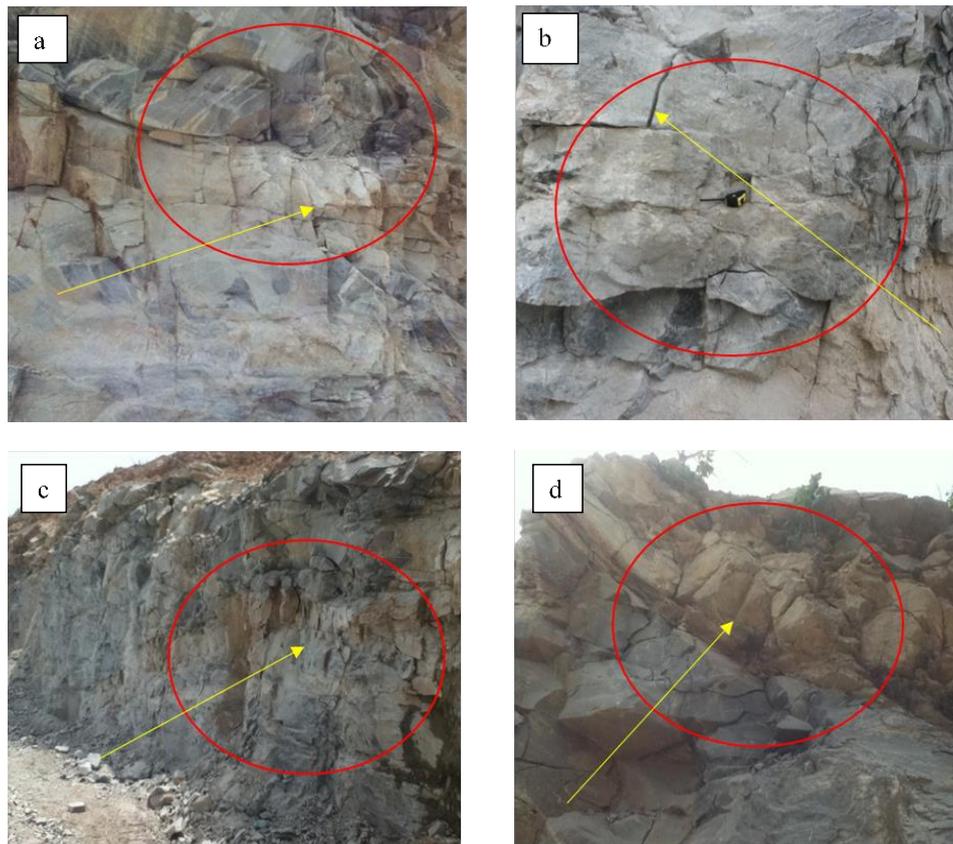
Face 002, Wall Face 003 and Wall Face 004. Fig. 2 below shows the fracture pattern at the various walls.

Fig. 2: (a) Fracture pattern at Wall Face 001 (b) Fracture pattern at Wall Face 002 (c) Fracture pattern at Wall Face 003 (d) Fracture pattern at Wall Face 004

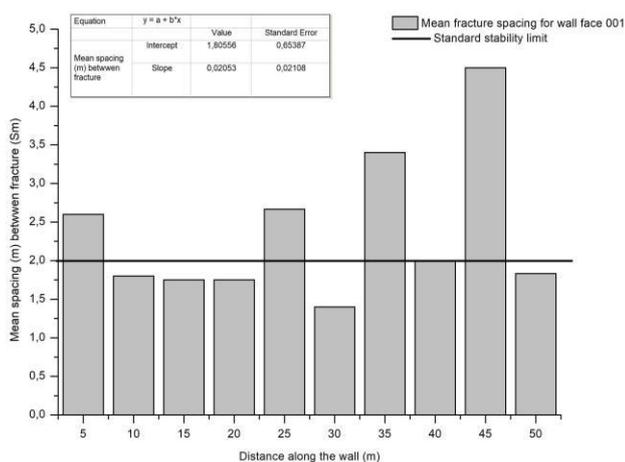
From Fig. 4 the scanlines strike  $75^\circ$  with their corresponding strike and dip creating a favourable fracture pattern. The fracture set at a distance of 5 m, 25 m, 35 m, 40 m and 45 m along the wall are above the 2 m spacing of fracture which represents the stability of the wall around these places. The fracture set at a distance of 10 m, 15 m, 20 m 30 m are all below 2 m spacing of fracture were observed to be unstable (below 2 m).

Fig. 4: A Graph of Mean spacing of Fracture at Wall Face 001

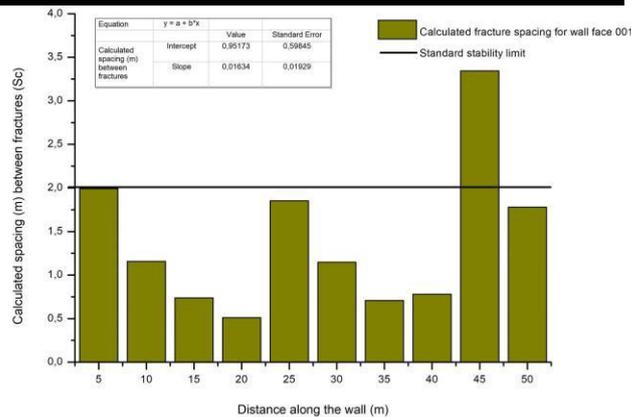
Considering the calculated spacing of the fracture sets, corrections were made for clear estimation of wall stability. The calculated spacing  $S_c$  was used in concluding the results because errors were corrected. As illustrated in Fig. 5, about 90 % of the fracture sets were below 2 m of mean spacing between fractures indicating marginal instability within the Wall face 001. Though only one i.e. the fracture pattern at the distance of 45 m as shown in Fig. 5 exceeded the 2 m spacing of fracture, other sets of fractures were closely below the standard stability limit making it marginally stable. The reason for the marginal stability of these walls by observation is as a result of mineral infillings (quartz veins) in the fractures and which prevents water encroachment between fractures. In addition, by physical observation on the walls, the blast holes were charged with small number of explosives hence small fracture zones were created.

Fig. 5: A Graph of Calculated Spacing of Fracture at Wall Face 001

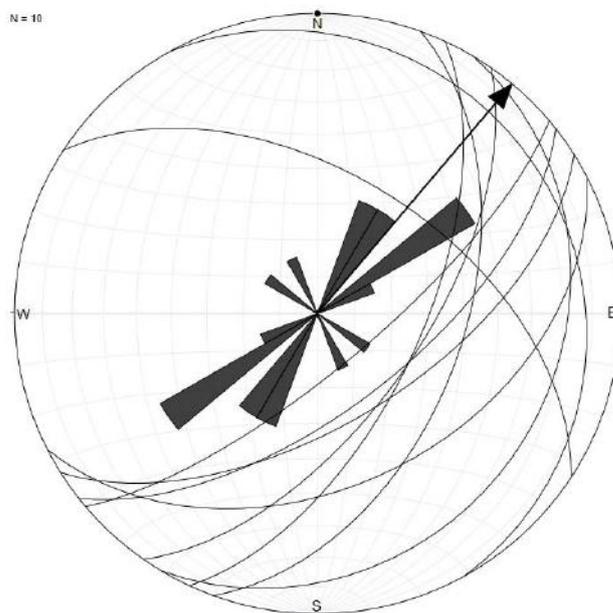
The stereographic projection of the dip and strike of fracture spacing within Wall Face 001 shows a general strike of NNE-SSW (Fig. 6). Observations made from the Rose plot also shows a maximum of 30 % strike between  $051^\circ$  and  $060^\circ$ .

Fig. 6: Stereographic projection and Rose plot for Fracture Spacing at Wall Face 001

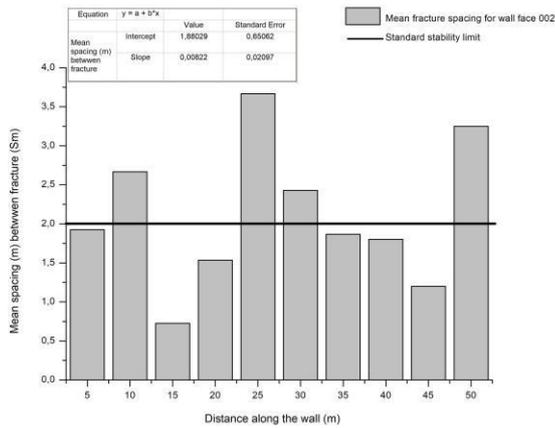
From Fig. 7 the scanlines strike  $80^\circ$  with their corresponding strike and dip creating a favourable fracture pattern. The fracture set at a distance of 10 m, 25 m, 30 m and 50 m along the wall are above the 2 m spacing of fracture which represents the stability of the wall around these places, however, other fracture sets were below the 2 m spacing of fracture which indicate unstable condition.

Fig. 7: A Graph of Mean Spacing of Fracture at Wall Face 002

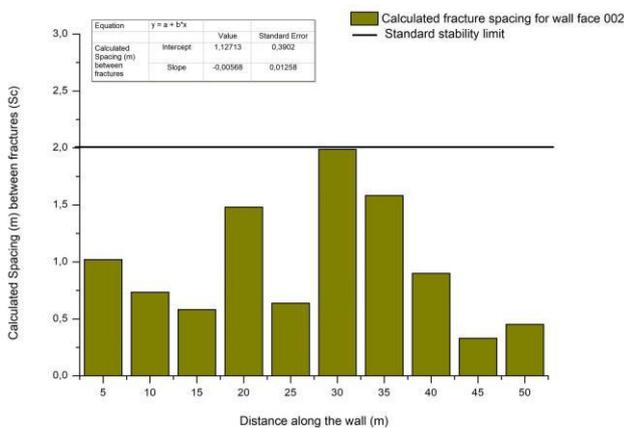
Again, the calculated spacing  $S_c$  was used in concluding the results because errors were corrected. As illustrated in Fig. 8, all the fracture sets were below 2 m of mean spacing between fractures indicating high instability condition within the Wall face 002. Stereographic projection of the dip and strike of fracture spacing within Wall Face 002 also shows a general strike of ENE-WSW. Observations made from the Rose plot also shows a maximum of 20 % strike between  $061^\circ$  and  $070^\circ$  (Fig. 9).

Fig. 8: A Graph of Calculated Spacing of Fracture at Wall Face 002

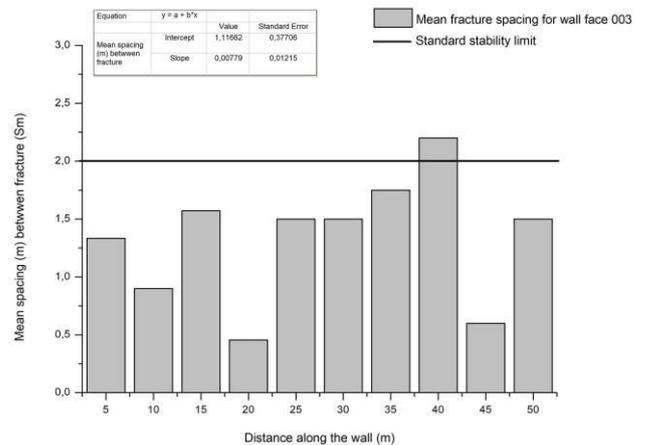
As illustrated in Fig. 10 the fracture set along the walls Face (003) at 40 m is are above 2 m spacing of fracture whereas the remaining 9 fracture sets were below the standard stability limit making them walls unstable and vulnerable to failure.

Fig. 10: A Graph of Mean Spacing of Fracture at Wall Face 003

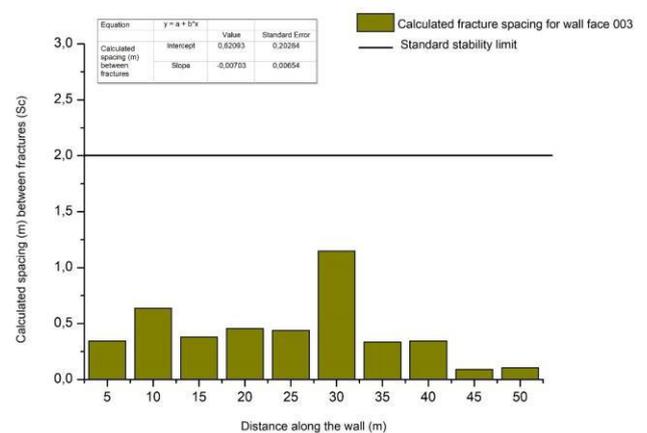
Wall Face 003 recorded the most harmful zones of fracture after estimation using the calculated spacing of fracture sets. Consequently, from Fig 11 all the fractures with their spacing of 0.00-1.24 m and their corresponding strikes created differential unstable parts of the walls which is very unfavourable in response to rock fall and rock slide. Blast induced fractures were observed to be widen as a result of weathering.

Fig. 11: A Graph of Calculated Spacing of Fracture at Wall Face 003

- Overcharging of blast holes should be avoided.
- The spacing of drill holes at regions of low stability should be wider.
- Drilling at regions of low stability should be done with extreme care.
- Investigation on the walls should be repeated after every episode of blasting.

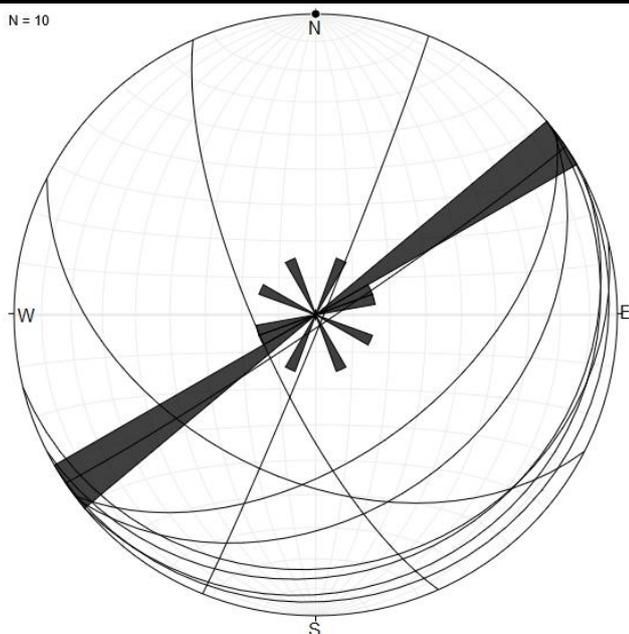
Results obtained from the Stereographic projection of the dip and strike of fracture spacing within Wall Face 002 also shows a general strike of NE-SW. Observations made from the Rose plot also shows a maximum of 50 % strike between 051° and 060° (Fig. 12).

Fig. 12: Stereographic projection and Rose plot for Fracture Spacing at Wall Face 003

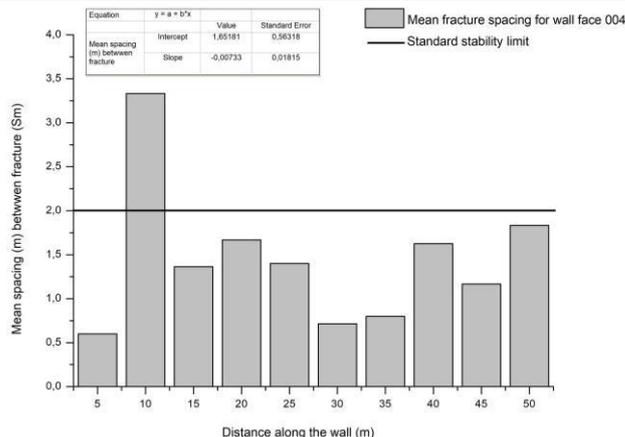
Observations made from Fig. 13 show the scanlines strike  $73^\circ$  with their corresponding strike and dip creating an unfavourable fracture pattern. The fracture set at a distance of 10 m along the wall is above the 2 m spacing of fracture which represents the stability of the wall around these places. However, the remaining fracture set were all below 2 m spacing of fracture which indicates high instability within this Wall Face (004).

Fig. 13: A Graph of Mean Spacing of Fracture at Wall Face 004

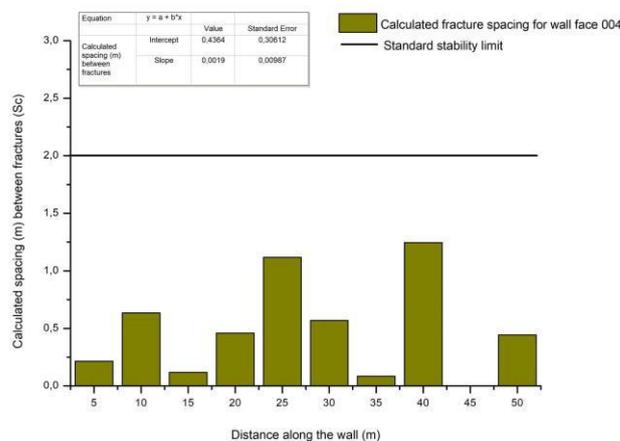
Again, considering the calculated spacing of the fracture sets, corrections were made for clear estimation of wall stability. The calculated spacing  $S_c$  was used in concluding the results because errors were corrected. As illustrated in Fig. 14, all the fracture sets were below 2 m of mean spacing between fractures indicating high instability within the Wall face 004. The reason for the high stability of these walls by observation is as a result of absence of mineral infillings (quartz veins) in the fractures thereby enhancing weathering of the rock surfaces due to water encroachment between fractures. In addition, by physical observation on the walls, the blast holes were charged with high number of explosives due to the presence of mineralized zones within these areas resulting in the creation of high fracture zones.

Fig. 14 A Graph of Calculated Spacing of Fracture at Wall Face 004

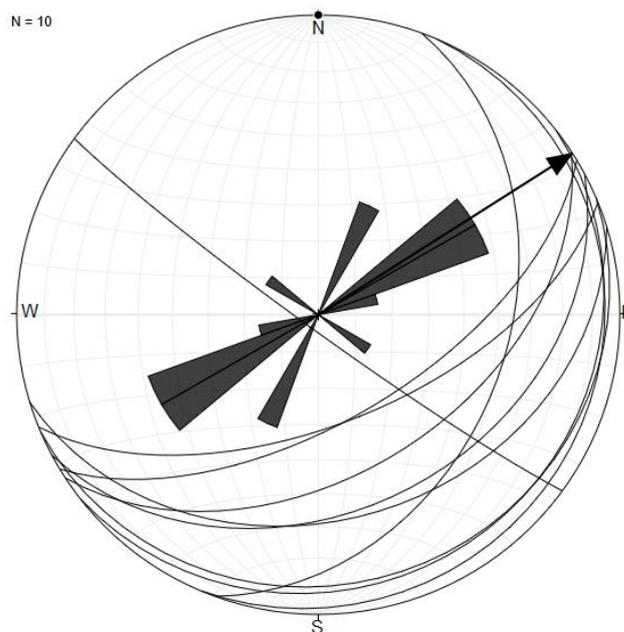
The stereographic projection of the dip and strike of fracture spacing within Wall Face 004 shows a general strike of NE-SW (Fig. 15). Observations made from the Rose plot also shows a maximum of 30 % strike between  $051^\circ$  and  $060^\circ$  similar to the strike recorded in Wall Face 001.

Fig. 15: Stereographic projection and Rose plot for Fracture Spacing at Wall Face 004
