Coastal Heritage Conservation Methods, a Visual-Based Pathological Assessment for Historic Masonry; A case study of Fort Williams

Keywords— Architectural heritage conservation, coastal masonry deterioration, Fort Williams, ICOMOS standards, visual-based assessment, Ghanaian forts.

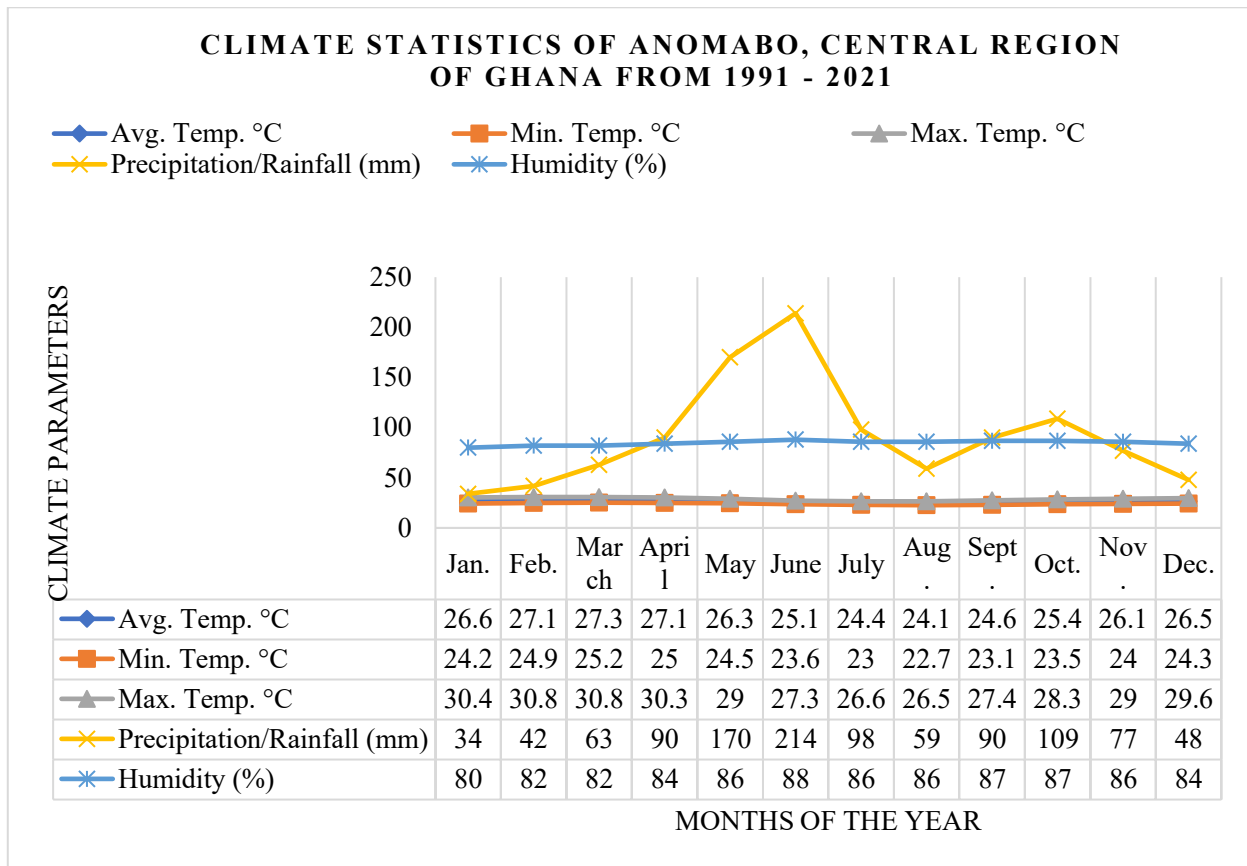
Anomabo has a humid tropical coastal climate with a mean annual temperature of 24.1–27.3 °C. and relative

humidity of 80–88%. A bimodal rainfall from May–June and September–October with a persistent marine aerosols

Fig.6. Climate Statistics of Anomabo, Central Region of Ghana from 1991 – 2021.

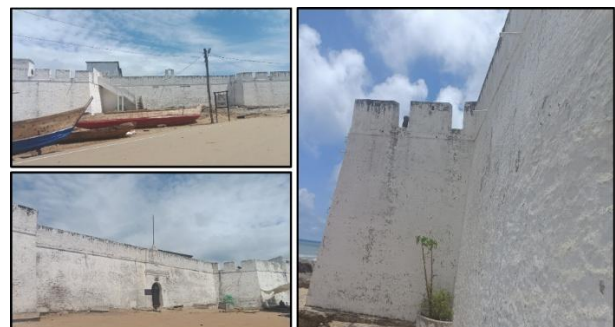
Externally, the fort’s walls have been freshly painted, giving a superficial impression of good condition. However, the interior courtyard reveals extensive deterioration (Figures 7–8). Roofs show local failures, biological growth is widespread, and mortar joints are eroded. Despite this, the overall geometry and spatial hierarchy remain intact.

Fig.7. Exterior Walls of Fort Williams Source: Site investigation by author, 2025.

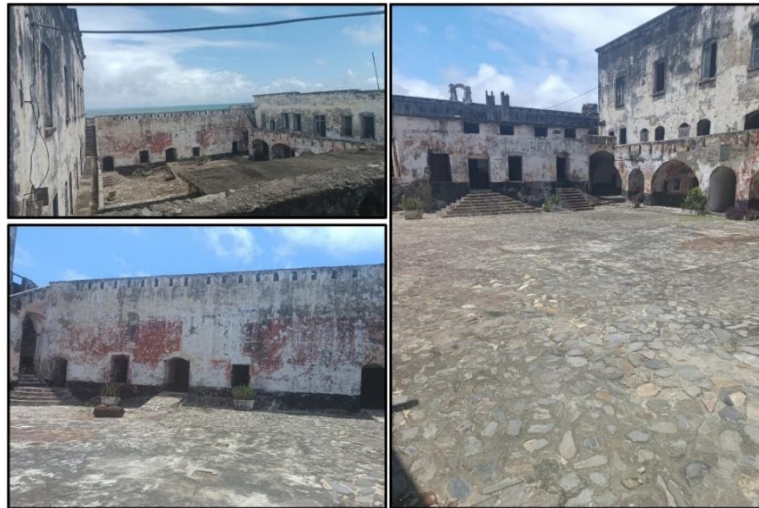
Fig.8. Courtyard within Fort Williams Source: Site investigation by author, 2025.

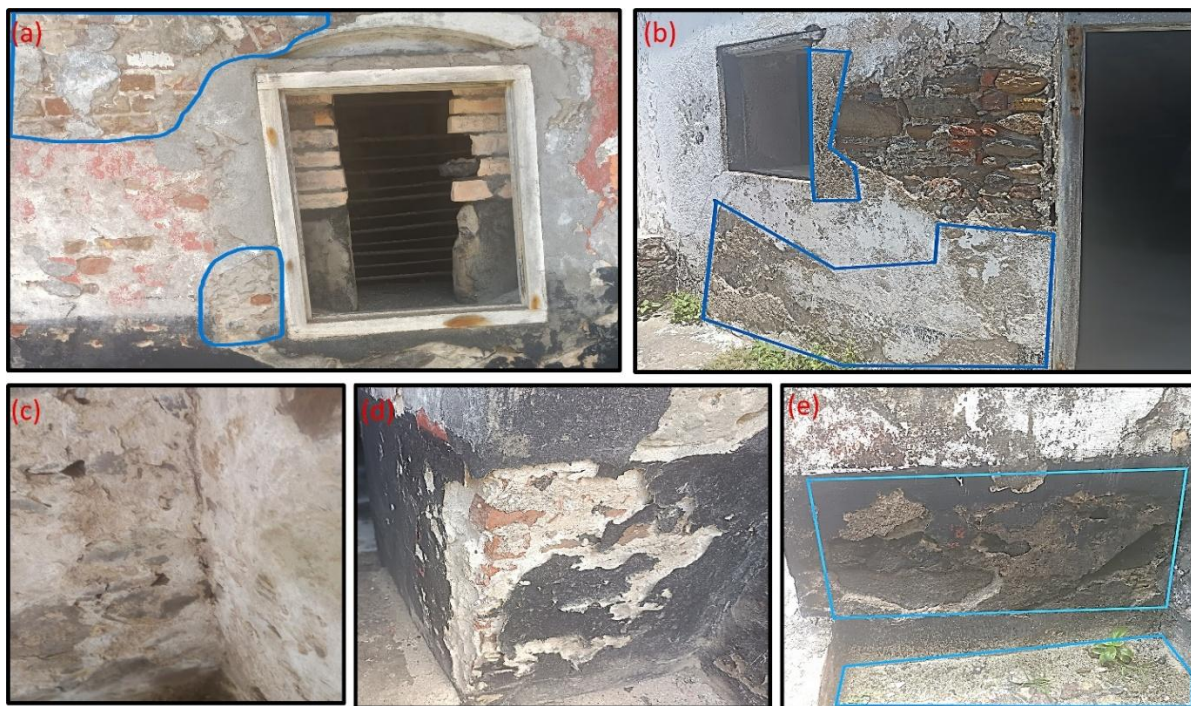
At Fort Williams, white powdery efflorescence is common on surfaces in the courtyard, terrace and most of the interiors. These deposits form where salt-laden moisture rising by capillary action evaporates at the masonry surface, leaving dissolved salts behind. More damaging is sub-florescence (crypto-florescence), where salts crystallize beneath the surface within the pore structure. This generates crystallization pressure that exceeds the tensile strength of

historic bricks and mortars, causing plaster delamination, spalling, and brick scaling (Figure 9 a–e). Severe deterioration is concentrated at wall bases, matching the classic rising-damp salt zonation model. Plaster detachment and paint failure occur at material interfaces where impervious layers trap crystallizing salts. The most advanced damage shows complete loss of plaster and surface disintegration of brick, particularly in areas with chronic moisture exposure and no historic damp-proof course.

Fig.9a–e: Salt efflorescence, plaster failure and brick disintegration. Source: Site investigation by author, 2025.

The concentration of severe damage at wall bases matches Charola's synthesis of Arnold's four-zone model of salt-affected walls (Charola, 2000). The lowest zone, closest to the ground, retains more soluble salts in solution and shows less damage. The most deteriorated zone occurs immediately above, where less soluble salts such as sodium sulphate precipitate, generating the expansive forces responsible for spalling, delamination, and material loss (Charola, 2000). This vertical zonation is clearly visible at Fort Williams (Figure 9 c–e).

deterioration patterns different from single-salt systems (Manohar et al., 2023). The observed progression from plaster staining (c) to render failure (b) to complete material loss (e) represents the temporal evolution of salt damage (Franzoni et al., 2014). Critically, delamination and paint failure at material boundaries occur when impervious layers trap crystallizing salts (Woolfitt, 2019; Charola, 2000). This explains why surface treatments applied to salt-laden masonry inevitably fail, because salts continue migrating toward drying surfaces and accumulate beneath any impermeable coating. Therefore, any sustainable conservation strategy must prioritize moisture source control before attempting desalination or re-plastering.

1. **Source control** (drainage, roof repair, damp-proof course) must precede any aesthetic or surface treatment.
2. **Desalination** (poulticing) is essential before re-plastering; otherwise, salts will migrate into new plaster.
3. **Sacrificial lime plasters** (more porous than the original brick) are recommended to allow salts to concentrate in the plaster, which can later be replaced.
4. **Biocides** should be used sparingly and only after moisture reduction, with preference for low-toxicity products (e.g., benzalkonium chloride).

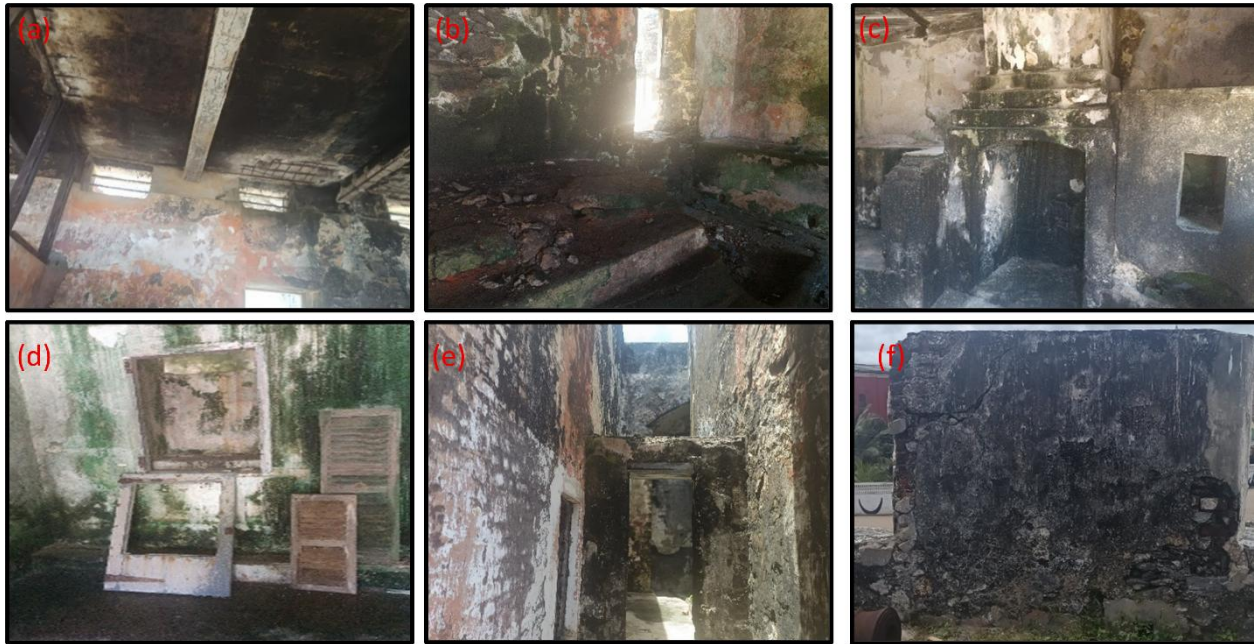
The results again show persistent dampness is widespread at Fort Williams, originating from rising capillary groundwater, wind-driven rain, sea spray, and roof leaks. This sustained moisture supports extensive biological colonization. Green-black algal biofilms cover interior walls and ceilings (Figure 10 a–d), while cyanobacteria and

fungus growth appear on both interior and exterior surfaces. Moss colonization is visible on damp exterior walls and roof areas (Figure 10 e–f). Biological growth is most intense at wall bases, where capillary rise maintains continuous wetness, and in poorly ventilated spaces such as dungeons and storage rooms. The biofilms retain moisture, prolonging evaporation and creates favorable conditions for further

Fig.10a-f: biological colonization. Source: Site investigation by author, 2025.

The porous nature of brick masonry, with its inherent roughness and capillary structure, enables water retention within the material fabric, creating microenvironments where moisture remains available for extended periods even when surface conditions appear dry (Gregorini, 2020). Algae and cyanobacteria function as pioneering colonizers in the biodeterioration sequence, establishing the initial biological foothold on damp masonry surfaces. These microorganisms maintain metabolic activity only when appropriate combinations of dampness, warmth, and light coincide, yet they demonstrate remarkable tolerance to climatic variations, surviving dry periods through dormancy and resuming growth rapidly when moisture returns (Jan, 2020). This adaptive capacity explains the persistent green-black staining on interior walls (Figure 10 a–d), which reappears even after dry spells.

at Fort Williams both indicates and accelerates underlying material decay. While surface colonization alone may appear primarily aesthetic, the sustained presence of moisture-retaining biofilms prolongs surface wetness, creating self-perpetuating conditions that favor continued biological activity and progressively more severe material deterioration (Stewart et al., 2019). Therefore, as earlier emphasized; effective intervention must first eliminate the moisture sources that sustain biological communities; biocide treatment alone, without moisture control, will only provide temporary relief.

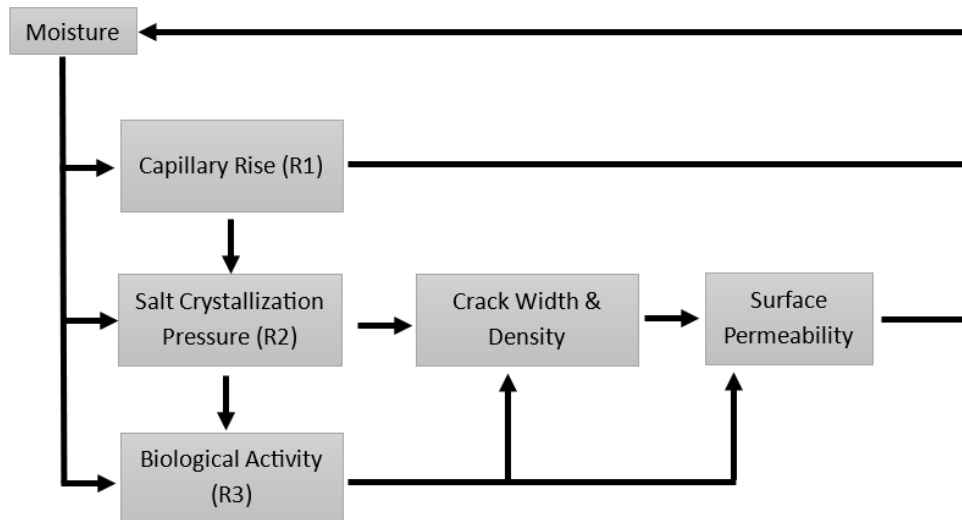
At Fort Williams, dampness caused by rising capillary moisture, rain penetration, and marine aerosols supplies the water that dissolves soluble salts within the masonry. As moisture moves toward evaporation surfaces, salt crystallization occurs initially as harmless surface efflorescence, then progresses into a destructive sub-florescence within the masonry pores. The crystallization pressure fractures mortar and brick, creating micro-cracks.

These cracks pave way for more moisture which transports additional salts, intensifying the cycle. Persistent dampness or moisture also sustains biological growth (algae, fungi) that retains more moisture, prolonging evaporation and salt activity. The combined effect is accelerated plaster delamination, spalling, material loss, and rising damp-driven vertical zonation of decay. Interrupting moisture sources is therefore the only way to break this self-reinforcing loop as shown in figure 11 below.

Fig.11: Causal loop diagram: Moisture-Driven Deterioration Cycles. (Source: Designed by author, 2025)
