Water Quality Considerations in Rainwater Harvesting Case Study of Heavy Metal Contamination in Kampala City

Abstract— Past studies have established a link between industrialization and heavy metal contamination of rainwater. However, no such study has been done in Kampala, or elsewhere in Uganda. In view of industrialization and the proliferation of iron roofs, this study aimed at addressing the suitability of rainwater harvesting and its quality as an alternative source of drinking water supply. The specific objectives were; to identify the predominant roof-covering materials in use in Kampala; to determine the level of heavy metal contamination obtained from each of these roof materials; and to compare the quality of water obtained, with various accepted standards for drinking water. The roof coverings considered were clay tiles, plain Galvanized Corrugated Iron (GCI) sheets and painted GCI sheets. In each of these types, they were further classified as relatively new, medium age and the relatively older. Samples were collected from each of the five divisions, including a control sample that was intercepted directly from open space. In the laboratory, heavy metal tests were per

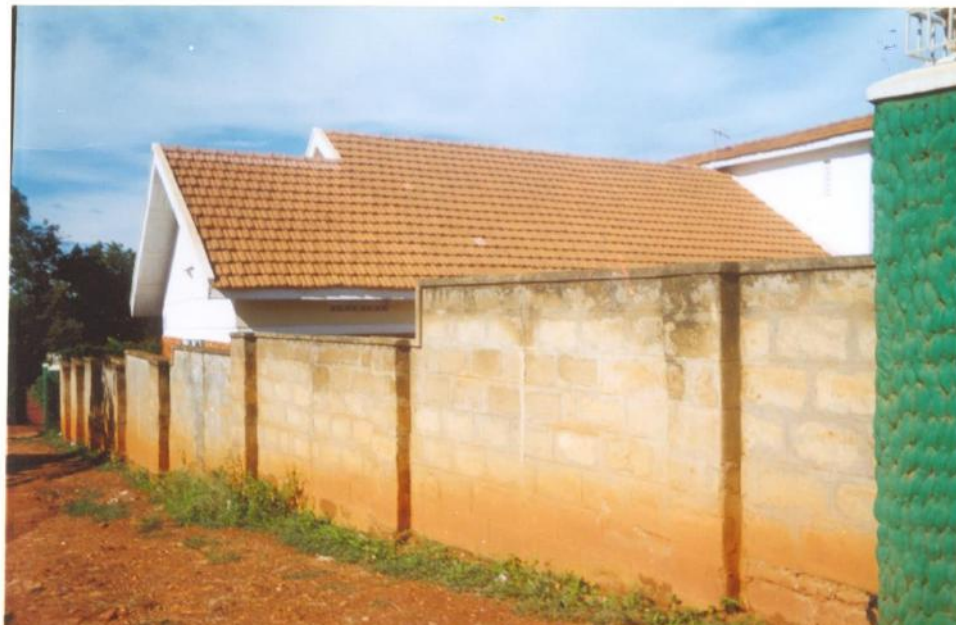
*Fig.1: KX3*

Care was taken to ensure that the water does not make contact with any object before running into the bottle. This entailed holding the bottle just below the eave, and trapping the water between the eave and the ground.

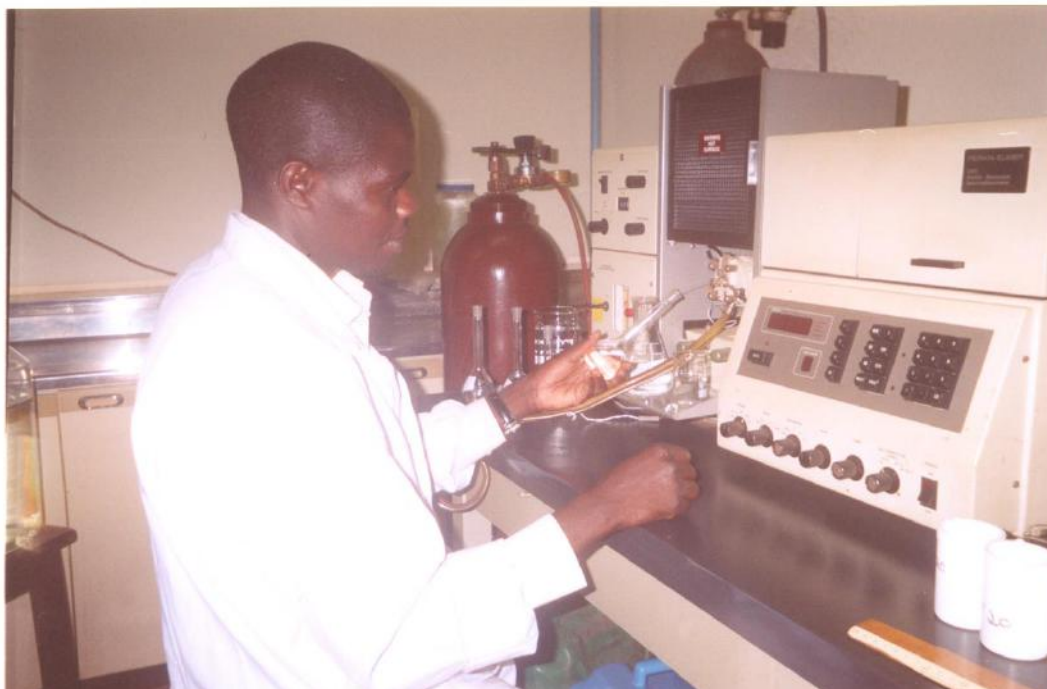
Fig.4: Heavy Metal Tests Being Run Using Perkin-Elmer 2380 model
