Stability Analysis of Brahmaputra Riverbank at Neulgaon

Abstract— River bank erosion is a recurrent problem in Jorhat district of Assam. Most of the rivers in Jorhat are shifting in nature and thus river bank erosion is common. Erosion has lead to the general widening of the river and instability of the river banks. River migration and land degradation displaces large number of people annually. This study intends to investigate the nature of river erosion and provision of adequate structural measures. Hydrological data and topographical sheet gathered from government departments have been used as a basis for this project. Software analysis and chronological survey techniques are used for the measurement of channel migration and thus eroded distances. Based on software viz. ARCGIS, channel migration of the river Brahmaputra in Neulgaon, Jorhat is found out. Secondary data were also collected from the local residents to explain the erosion status. The geotechnical properties of the eroded site are important parameters for construction of anti-erosion structures. The design of a structure mainly depends on the topography, hydrological data, and the materials of construction, the mode

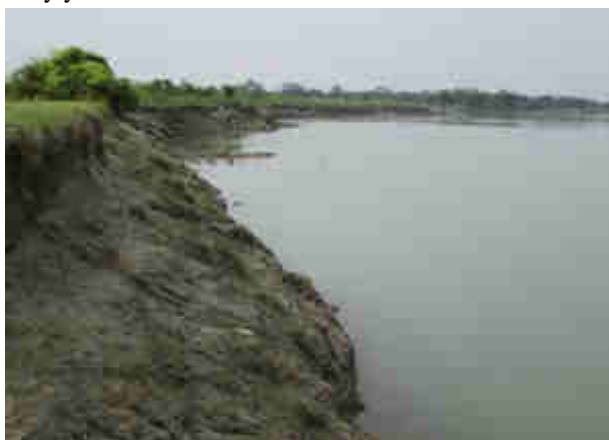
Fig.2: View of riverbank erosion at Neulgaon

Jorhat by-pass 37# highway. In this area villagers suffer extensive damages to agricultural fields and properties every year due to erosion. Villagers reported that the Brahmaputra River wash away 40-50 meters of the bank every year in the area.

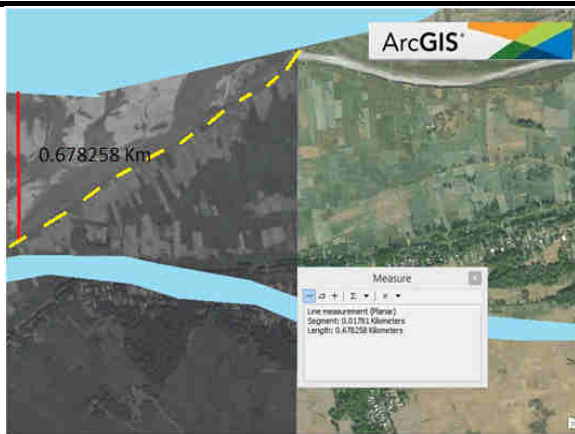
Fig.4: Superimposed braided channel layer showing an eroded distance of 0.678258 km

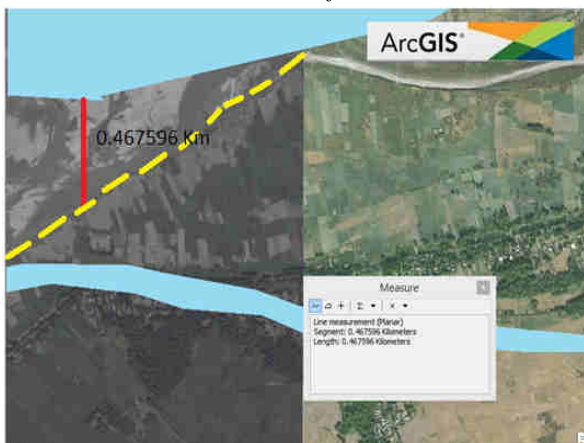
Fig.5: Superimposed braided channel layer at the site showing an eroded distance of 0.467596 km
