Cement Mortar Restorations and Disorders in the Archaeological Site of Chellah

Meriem Benharbit

Institut National des Sciences de l'Archéologie et du Patrimoine

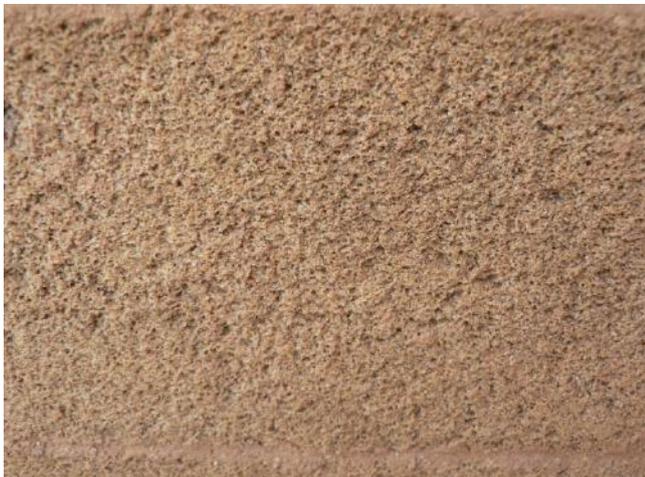
The cut stone used in the construction of the Roman structures, of plio-quaternary age, is outlined in the form of a system of elongated dune cords juxtaposed parallel to the line of the Atlantic coast from El Jadida to Larache. It corresponds to the local appellation of calcarenite of Salé. The rock, of beige color, shows stratification levels (So). The grain is predominantly millimetric. The petrographic study of the calcarenite shows a detrital fraction composed of rock debris and quartz grains and a bioclastic fraction (Lamellibranchiata, brachiopods and echinoderms shell fragments). These elements, which may present specific variations in terms of content and particle size, are linked by a mainly calcareous phase. The mechanical strength of the salt stone is about 50 MPa (Asebriy L., 2010). It is in fact sufficient to allow its use as a building stone but remains relatively weak, making its extraction, size and sculpture quite easy compared to other massive rocks of the region. The rock has an important porosity ranging from 25 to 35% (Rahmouni A., et al., 2013) releasing cavities of varying shape and size. This porosity conditions the sustainability of the rock in the long term: it regulates fluid transfers, gives the material a surface roughness for fixing pollutants, and also opens the way to biological colonization.

Fig. 3: Macroscopic aspect of the calcarenite of Salé

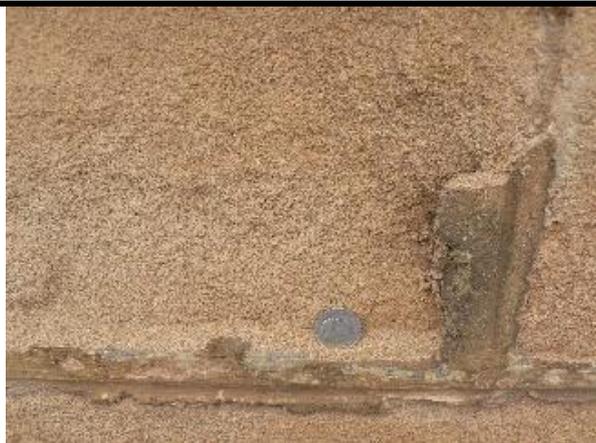
illustrated in glossary ICOMOS (2008) going, from the least harmful, of simple efflorescences saltworks to more or less dense saline encrustings “fig. 4 and 5”. However, other figures witnessing of more advanced disorders are also present: sandy disintegration “Fig.6”, alveolation “Fig.7” and gulying “Fig.8”.

Fig. 6: Granular decomposition of a block of calcarenite, consequence of the use of a hard cement mortar. The rock has grown into a single alveolus.

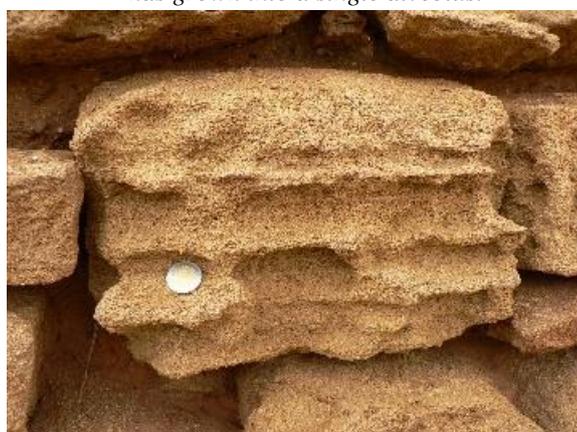
Fig. 7: formation, on the stone surface, of deep interconnected cavities

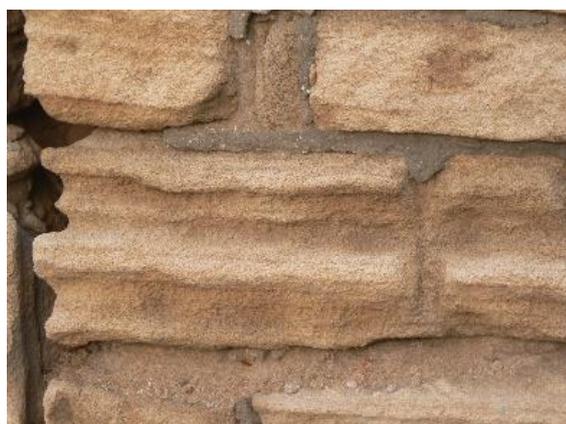
Fig.8: In contact with cement mortar, the rock has deep grooves that hollow out the material highlighting the hardest levels

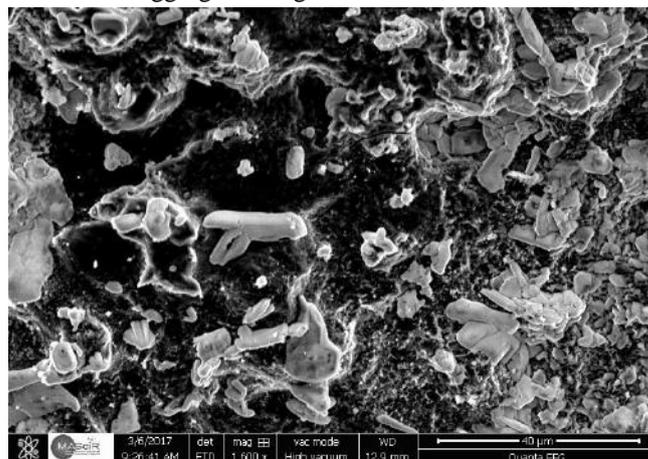
Sampling was carried out on the saline coverings developed at the stone-mortar interface and observed using the Moroccan Foundation for Advanced Science, Innovation and Research (MAScIR) environmental field emission electron microscope (FEG). Observations show

that the surface of the rock is lined with deposits of potassium sulphate. "Fig. 9" and cracks propagating between the aggregates" Fig. 10 "

Fig.9: observation with the MEB (X 1600) of potassium sulphate deposits recovering the surface of the calcareous rock

Analysis of the salt deposits formed shows the presence of potassium sulphate K_2SO_4 . This salt is commonly used as a fertilizer, potassium being an element that promotes the accumulation of reserves in both raciness and fruit.
