Wall Quality, Cost, and Environmental Impact Assessment of Wall Control Blasting – A Case Study

E. N. Asare¹, P. Mensah², S. Andoh³

¹Geological Engineering Department, University of Mines and Technology, Ghana

^{2,3}Geotechnical Section, Perseus Mining Limited, Ghana

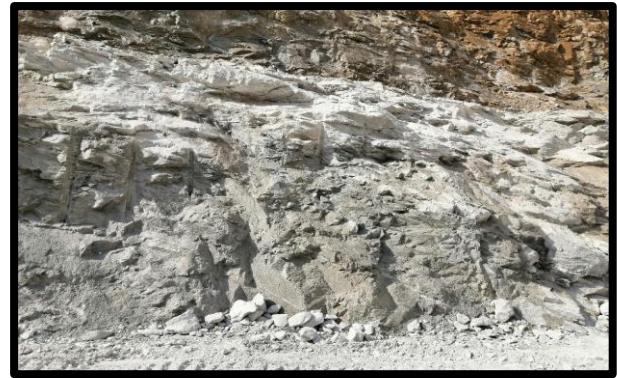
Fig.4.1: Wall Face after Wall Control Blasting

Results of wall control blasting are mostly regarded as unsatisfactory if a smooth wall profile is not obtained at the end of the blasting operation. A smooth wall profile is often obtained when the rock is massive (isotropic and homogenous) [5]. Obtaining a smooth wall profile is most often difficult when the rock has a lot of discontinuities (jointed) and as a result not always recommended as an effective tool for assessing the wall quality after wall control blasting. However, it has proved successful despite the limitations as the first stage in assessing the quality of pit walls after wall control blasting. Physical inspection of the smoothness of the final pit wall showed that the results of wall control blasting on-site were unsatisfactory as shown in Fig. 4.1 and Fig. 4.2. Final pit walls inspected were not inspected lacked the smooth wall profile and were normally rough. Few portions of the smooth as intended to be. Most sections of the final pit walls that were final pit walls inspected showed some degree of satisfactory results. The Half Cast Factor (HCF) is what is mostly used in assessing pre-split barrels seen on pit the wall face. The HCF expresses the length of the pre-split barrels seen on the pit wall face as a percentage of the total length at which the pre-split holes were drilled. HCF is usually successful in assessing the quality of pit walls after wall control blasting when the rock mass is massive as compared to rocks with discontinuities (joints) as it is difficult to see pre-split barrels on the pit wall face in most cases after carrying out wall control blasting in jointed rocks [5]. Pre-split barrels that were inspected in most cases had length less than half the length at which the pre-split holes were drilled as shown in Fig.4.1 and Fig.4.2. Pre-split barrels were assigned HCF of less than 50 % implying a less effective wall control blast. In some sections of the pit wall face inspected, pre-split barrels were hardly seen. The inspection of the pre-split barrels generally showed that wall control blasting on the site yielded unsatisfactory results.

Results obtained on the wall quality assessment showed that wall control blasting on-site yielding unsatisfactory results. Physical inspection of the wall face after wall control blasting showed that pit walls were not as smooth as intended to be. Pre-split barrels inspected on the pit wall gave Half Cast Factor (HCF) below 50% implying that results were unsatisfactory. Superimposition of the asbuilt berm on the designed berm on the 980 RL, 1000 RL and the 1020 RL gave a loss percentage of berm area of 58.86%, 39.96% respectively as compared to the allowable loss percentage area of 20%. This means that pit wall geometry intended to be achieved after wall control blasting were not achieved and signifies unsatisfying wall control blasting results. this poses probable threats to personnel and machinery in the pit Assessment that was done on the 980-1020 RL showed that apart from the cost discussed above, there was an additional cost of \$ 32,234.14 incurred from hauling waste rocks generated from crest damages. The analysis of blast monitoring results of the randomly selected pre-split shots against the 2mm/s (ground vibration) and 117 dB (air blast) limits set by Minerals and Mining (Explosive) Regulation (LI 2177) showed pre-splitting is environmentally successful as the selected shots plotted below the limit.

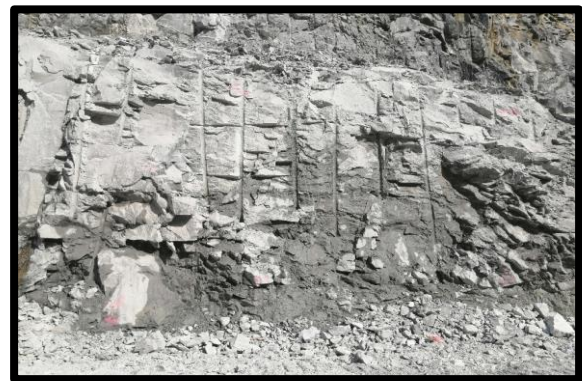
Fig.4.2: Wall Face after Wall Control Blasting

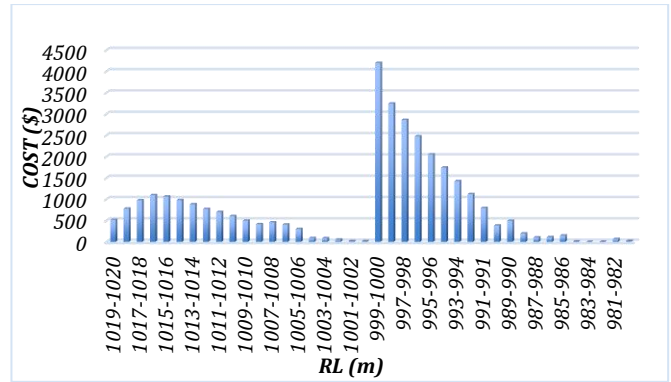
Fig.1.3: A Graph of the Cost of Hauling Waste Rocks Generated from Crest Damage at a Meter Interval

From explosives economy, explosives are energy, and the efficient use of this energy is a major factor in keeping rock blasting cost under control. The only to evaluate accurately the cost of explosives is to examine its effects on blasting (that is the purpose for which it was used for). It is seen from the wall quality assessment done that the purpose for which wall control explosives is used was not achieved. This implies that there is a cost incurred for not achieving the intended purpose of wall control blasting. Aside from this, there is a cost associated with scaling of pit walls (labour cost, fuel and equipment cost) to the designed pit geometry. Pit walls are in the waste zones of the deposit and are not meant to be hauled and this means that the company indirectly increases its cost of hauling by hauling rock materials generated from crest damage. In addition, a deviation of the actual pit geometry from the designed pit geometry leaves a rock material between the two, which needs to be excavated and hauled and this adds to the cost [1]. The extra cost incurred from hauling waste rocks generated from crest damage is shown in Fig. 4.3. The company increased its cost of hauling by \$ 32,234.14 as a result of crest damages generated from wall control blasting aside the cost of scaling pit walls, the cost of secondary blasting, cost associated with increased stripping ratio and the cost for not achieving the intended purpose for using explosives.

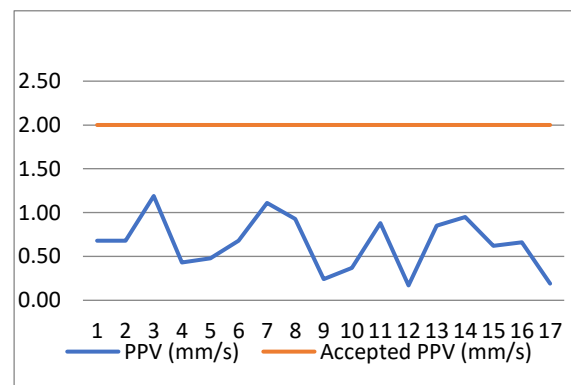
Fig.4.5: Ground Vibration Values Selected from Pre-Split Blast Data

Blast monitoring results of randomly selected pre-split shots were compared against 2 mm/s (ground vibration) and 117 dB (air blast) limits set by Minerals and Mining (Explosive) Regulation (LI 2177). The graph for the comparison shows that in both cases, the blast monitoring results for ground vibration and air blast for the randomly selected shots plotted below the limits set as shown in Fig.4.4 and Fig. 4.5. This means that, environmentally, wall control blasting is successful and therefore blasting
