Diagnosis and proposal of an alternative system for the supply and treatment of water in the Mato Stream, municipality of Simonésia-MG.

Mariza Silva Bitarães Dias, Rosane Gomes de Oliveira, Walber Gonçalves de Souza, Daniel Rodrigues Silva, Wederson Marcos Alves and João Batista Alves dos Reis

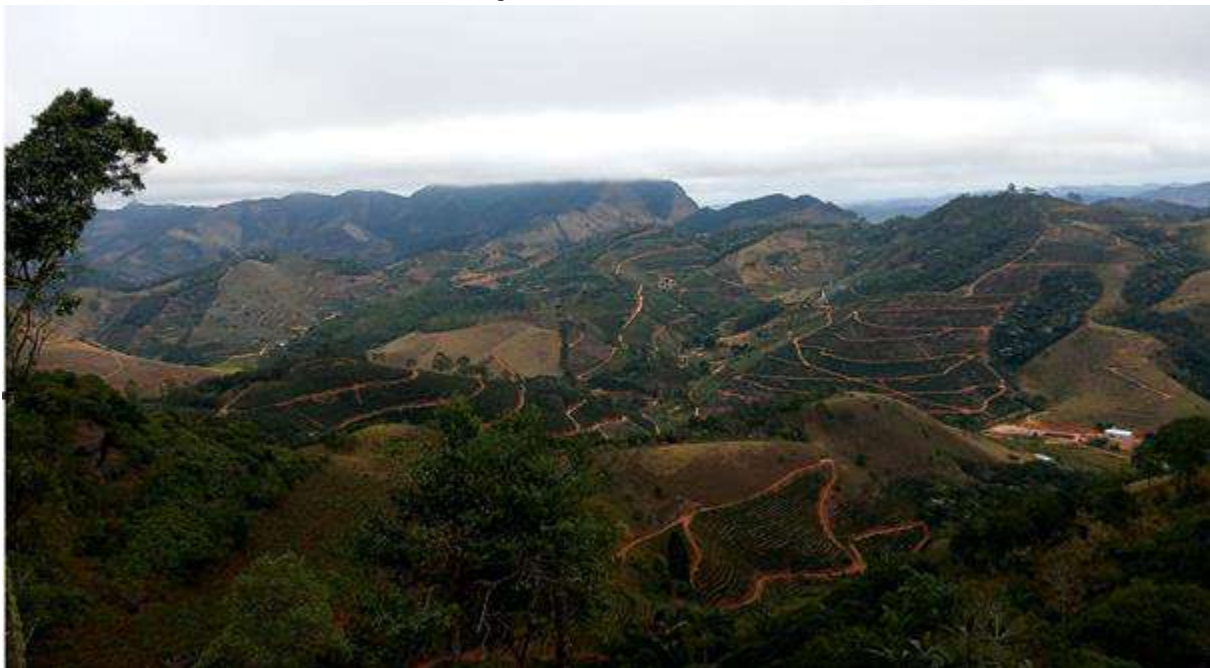
Fig.1: Geomorphological aspects in the municipality of Simonésia-MG.

The municipality of Simonésia is located in the São Braz community, 207 km from the capital of Belo Horizonte, in the Mata Mineira zone (Fig.1) and the coordinate relations at the central point, de is between 20°07'21.74"S and 42°00'10.05"W. Access to the region is

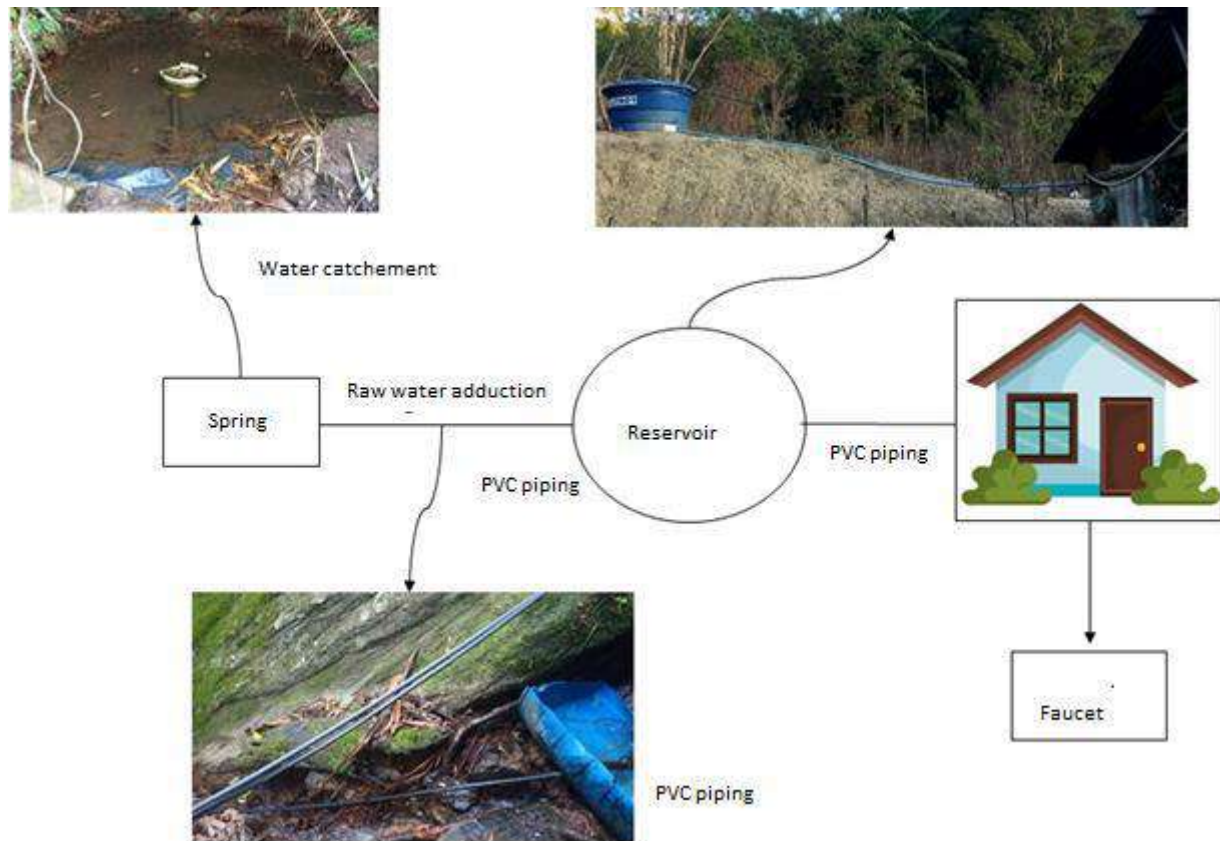
Fig.7: Scheme of the water supply system used.

composed of individual alternative systems, under the sole responsibility of the user, having only abstraction, adduction of raw water, and reservation and distribution to the points of use, as shown in the diagram in Figure 7.

The water used to supply homes comes from springs and the water course (surface catchment), from direct intake, being transported by PVC pipes to the reservoir (water tank), and distributed to the points of use of the residence, such as faucets, showers, and toilets, without receiving any type of treatment. It is known that surface water sources are more susceptible to contamination, which poses a risk to the health of the population served, requiring greater expenditure on treatments (LIBÂNIO, 2008). Surface springs also present, in most cases, changes in the quality of raw water, due to seasonal variations between periods of rain and drought (BRASIL, 2007), which demands attention, and implies, in some cases, interruption of supply.

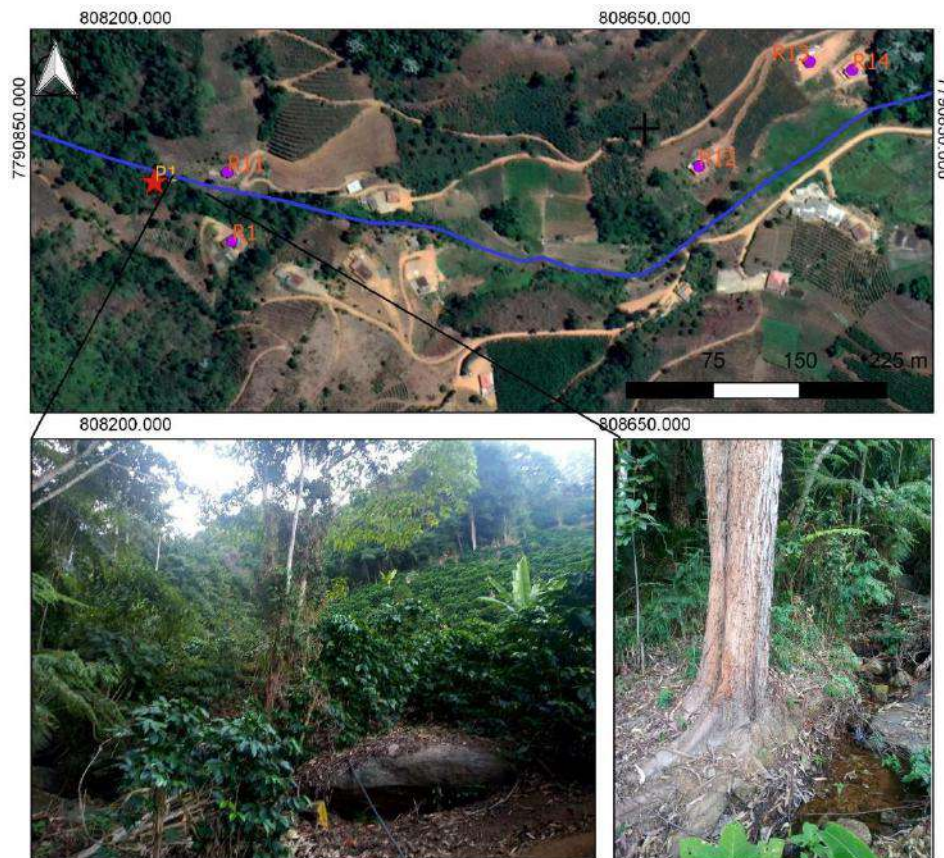
Fig.10: Location and perspective around P1.

The first source of water intake is located at approximately 1075m of altitude. It is a perennial Stream, supplied by a hillside spring, which concentrates the largest

number of individual users of this microbasin, supplying 5 homes, as can be seen in Figure 10. Each user is responsible for the implementation and individual maintenance of the system itself, having reports of disputes over the use of the source.

The collection takes place from the watercourse, using 1" or ¾" PVC pipes, being inserted in the most favorable places for the adduction of water, with the help of rocks found in the place. These ducts are inserted with the tip protected with a porous material, usually improvised with onion bags, fabrics or pieces of sieve, which allow the liquid to flow and at the same time, retain particles such as sand, branches, leaves and insects.

The water has a transparent and odorless visual appearance. However, there is the presence of biodegradable organic matter such as branches, flowers and leaves, which, when decomposed, naturally release nutrients such as nitrogen and phosphorus, responsible for water fertilization. However, Esteves (1998) states that, under natural conditions, these nutrients are limiting, as they are in low concentration compared to those required for the proliferation and maintenance of algae.

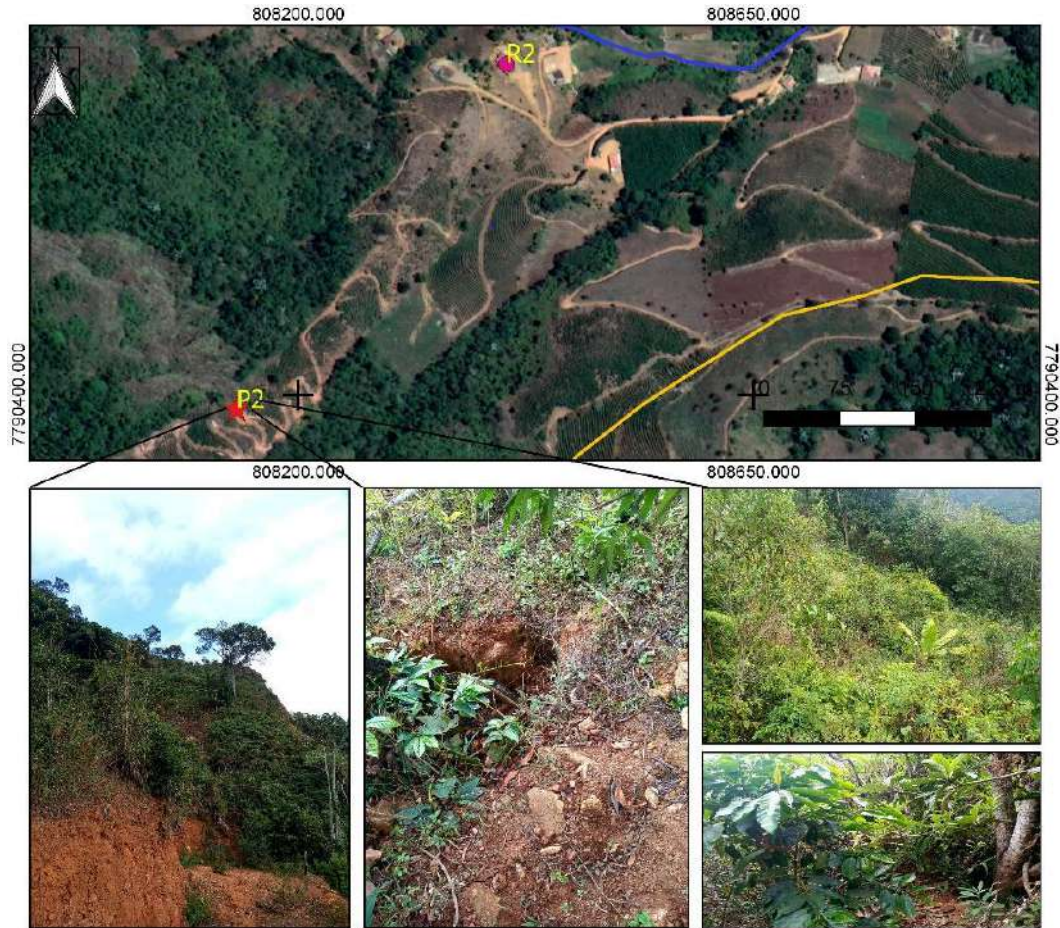
Fig.11: Location and perspective around P2.

The second capture point is located at approximately 1219m altitude, having a central coordinate point 7790385.38 m S and 808138.96 m E, shown in figure 11.

This point consists of a perennial slope spring in which there is no flow. Water infiltrates near the outcrop. The collection is carried out with the introduction of a 1” PVC pipe where there is a fountain, which transports water to a small asbestos box, from where the adduction begins.

It was noted that there is a lot of plant-derived debris at the site, which makes it impossible to see the water, and which can cause clogging of the pipes, in addition to interrupting abstraction. Also, it was observed that there is decomposition of this organic matter, which can influence the water quality.

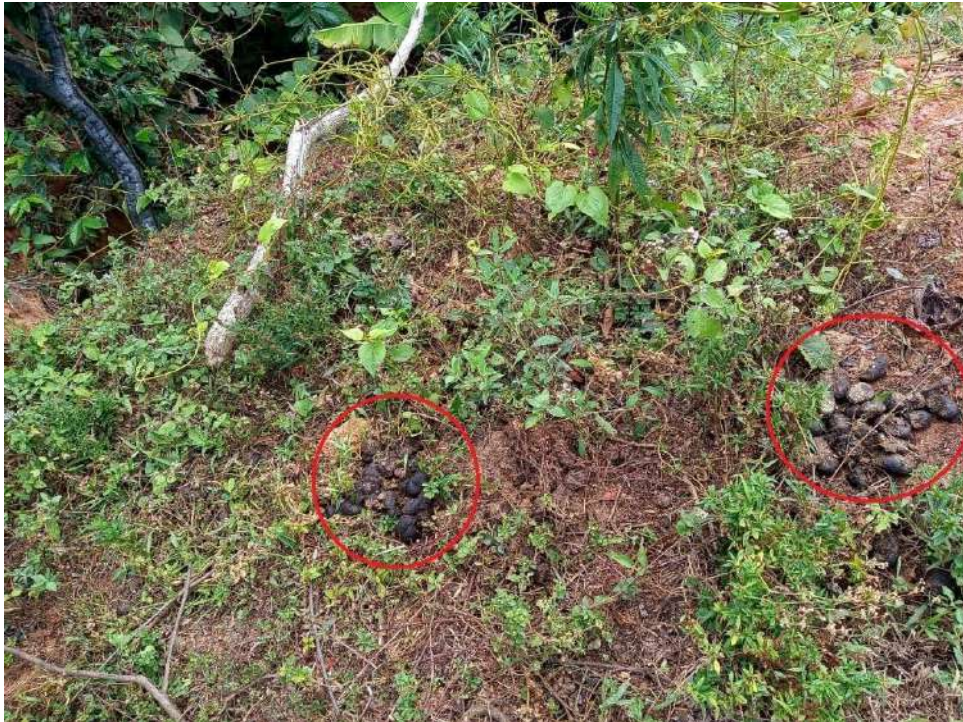
Fig.12: Presence of animal feces close to the collection point.

The location of the location is a favorable scenario for water contamination. In the vicinity of the collection point, animal feces were found, traces of the presence of horses, as shown in figure 12. This situation can be aggravated by the physical conditions of the site, an area that presents erosion and sediment drag problems (figure 24). In addition, the container where the water intake takes place does not have a lid, and is located under a fruit tree, which can attract birds due to the supply of food, which can defecate on the spot.

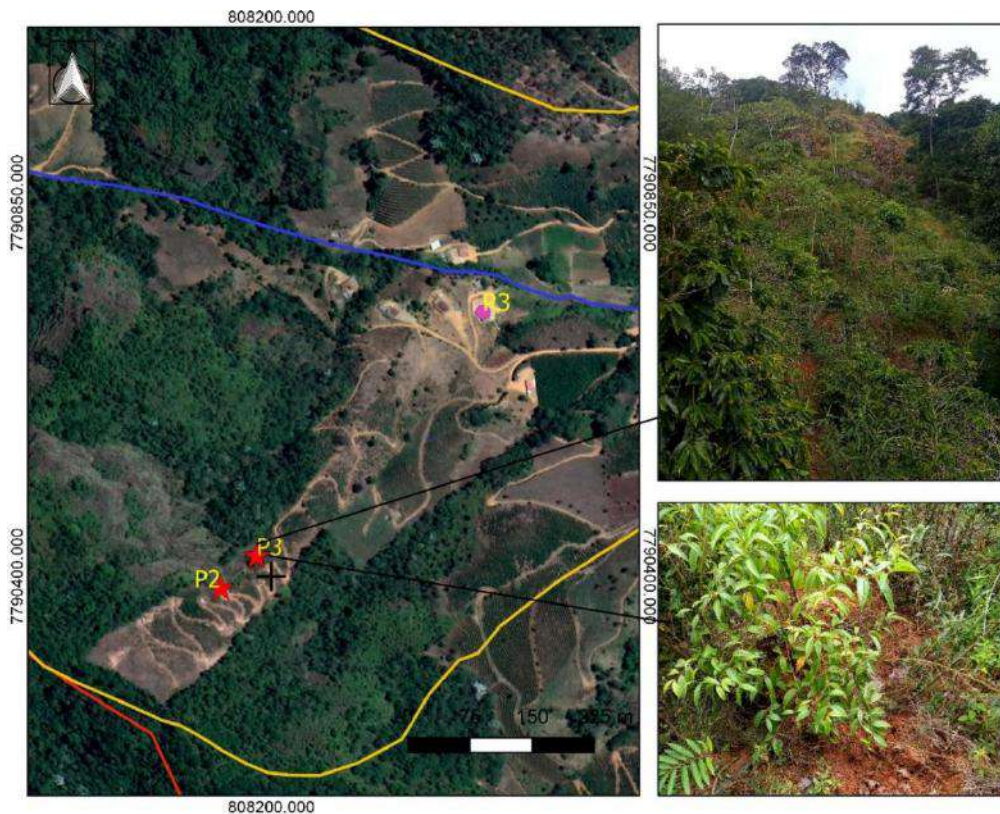
Fig.13: Location and perspective of the surroundings of P3.

The third capture point is located at about 1181m altitude, having a central coordinate point 7790424.02 m S and 808182.13 m E, is close to P2, as can be seen in Fig.13.

Through field research, it was noted that the area where points P2 and P3 are located, represents a great risk for maintaining the quantity and quality of water in these springs. In addition to the presence of animals, it was also observed that the region has steep slopes that are susceptible to mass movements.

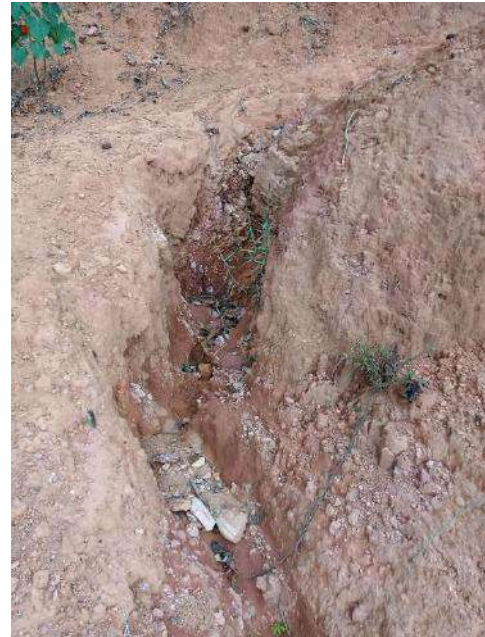
Fig.14: Erosive process caused by floods.

The top forest, important for water infiltration and maintenance of the water table, as well as for the protection of the soil against erosive agents, was removed to make way for coffee cultivation. The situation was aggravated by the construction of roads, which serve as paths for the runoff and make the soil more suitable for the detachment of particles and drag of material, as can be seen in Fig. 14.

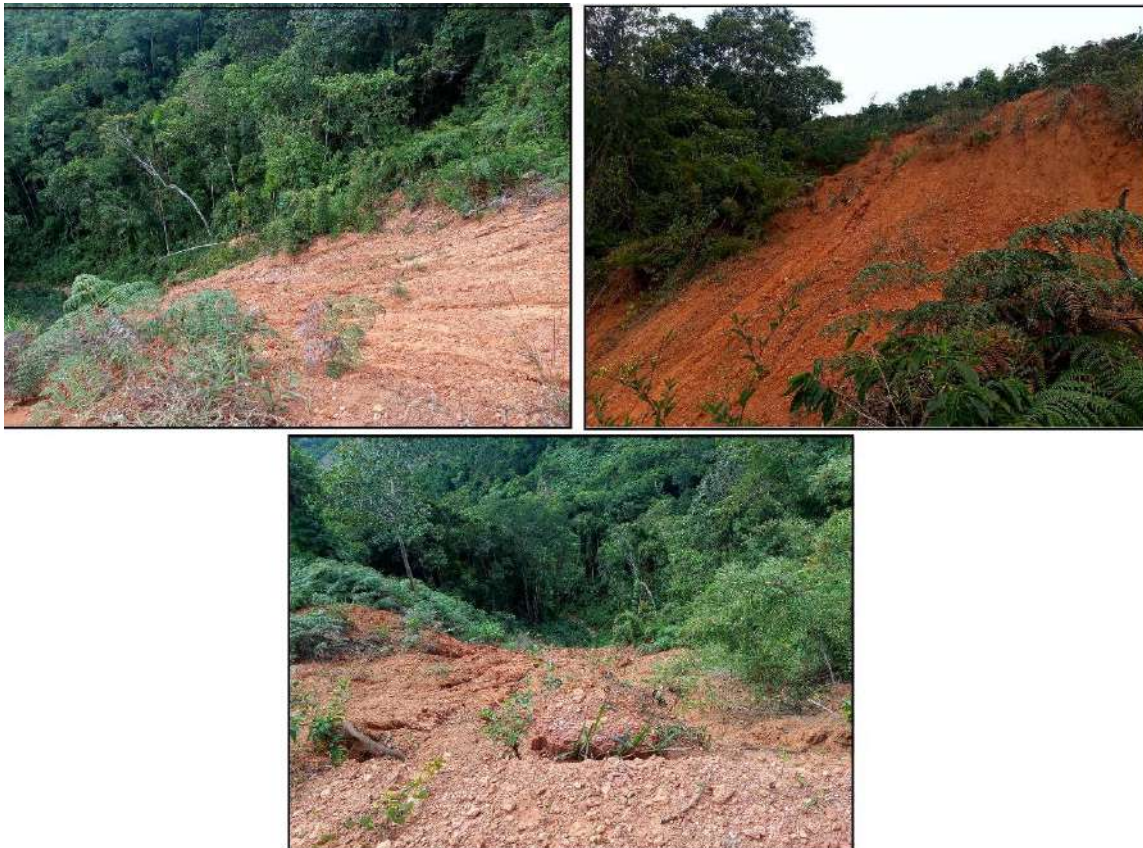
Fig.15: Mass movement occurred in the area in question.

In the rainy season of 2020, there was a large release of soil in the area due to the situation exposed above, shown in Fig.15.

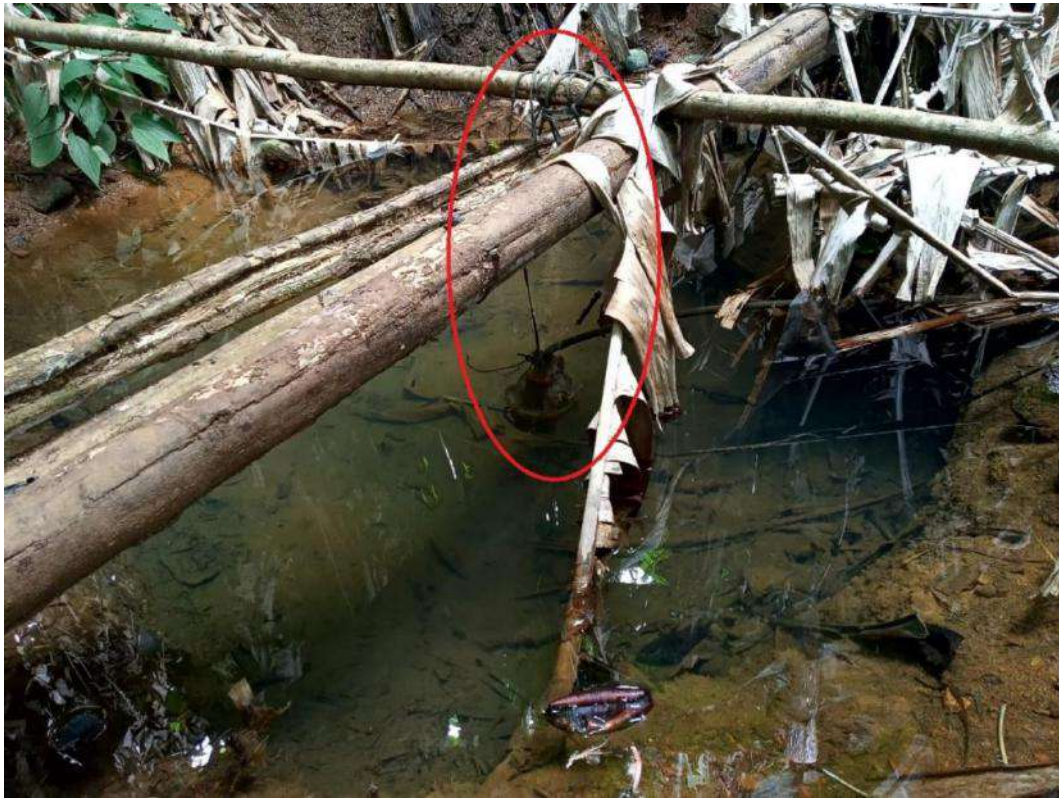
Fig.16: Suction and water holding in P4.

It consists of a perennial lowland spring, which requires equipment to carry out the suction and hold of water, illustrated in Fig. 16.

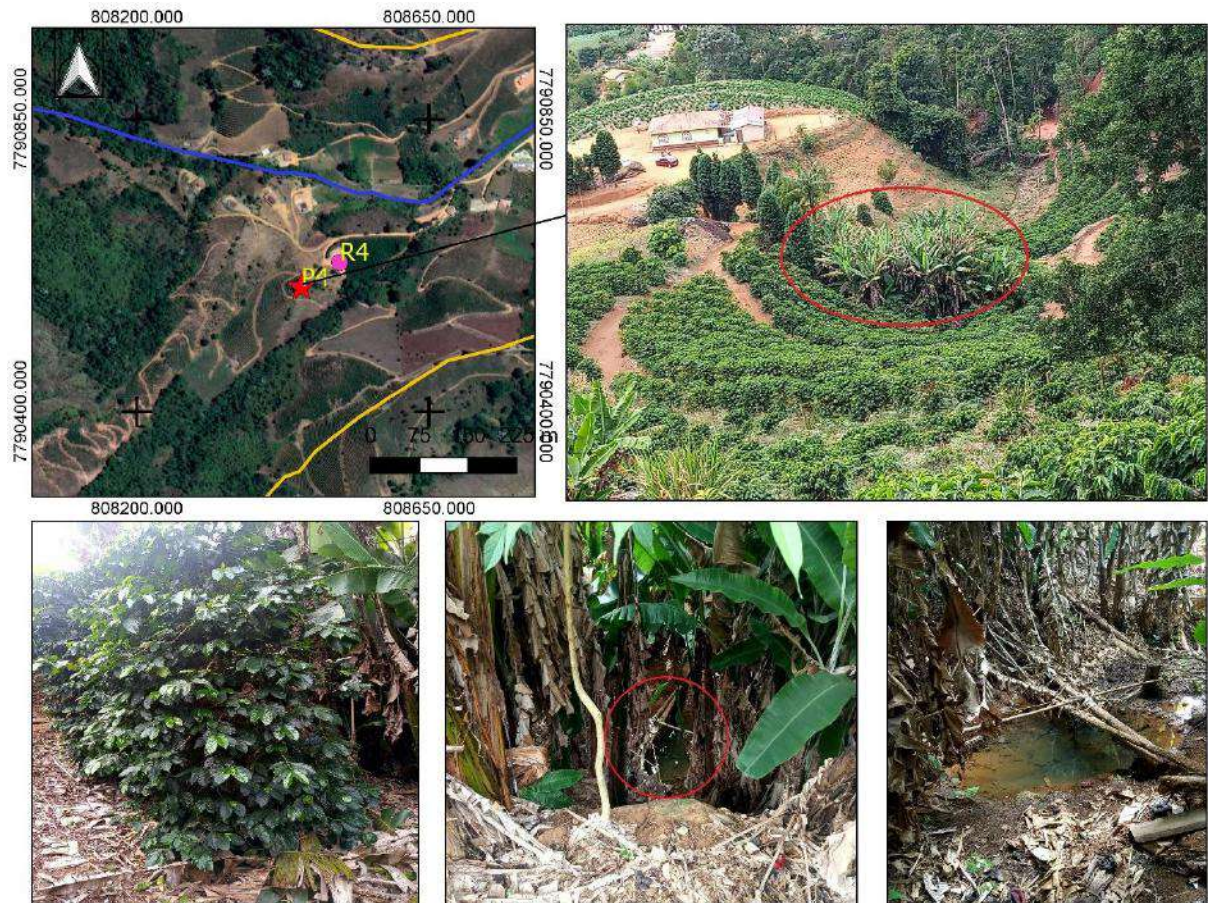
Fig.17: Location and perspective of the surroundings of P4.

It is highlighted in Fig.17, that in this source, the vegetation consists of banana trees cultivated around it. This fact is due to the popular belief that this species brings benefits in terms of increasing the amount of water.

In addition, it is observed that the land where the source is located has a concave shape, which implies the surface runoff towards the source. Another aggravating factor is the cultivation of coffee around this area and throughout the catchment basin.

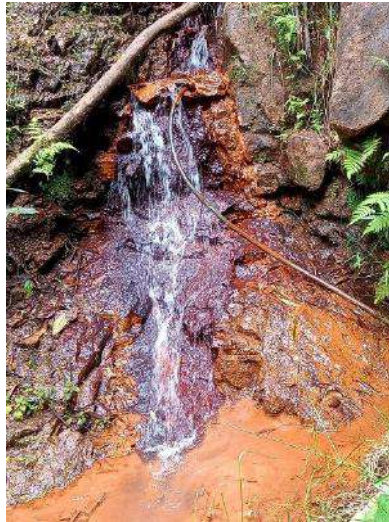
Fig.18: Water abstraction at point 5.

The collection takes place at a natural waterfall point, with favorable conditions for drainage and water intake, as can be seen in Fig.18.

It was observed that the water has a light yellowish color, with the presence of mud and rust, which changes the flavor and odor. In addition, its domestic use without proper treatment sets up some inconveniences, such as stains on clothes, incrustations on surfaces, and clogging of filters.

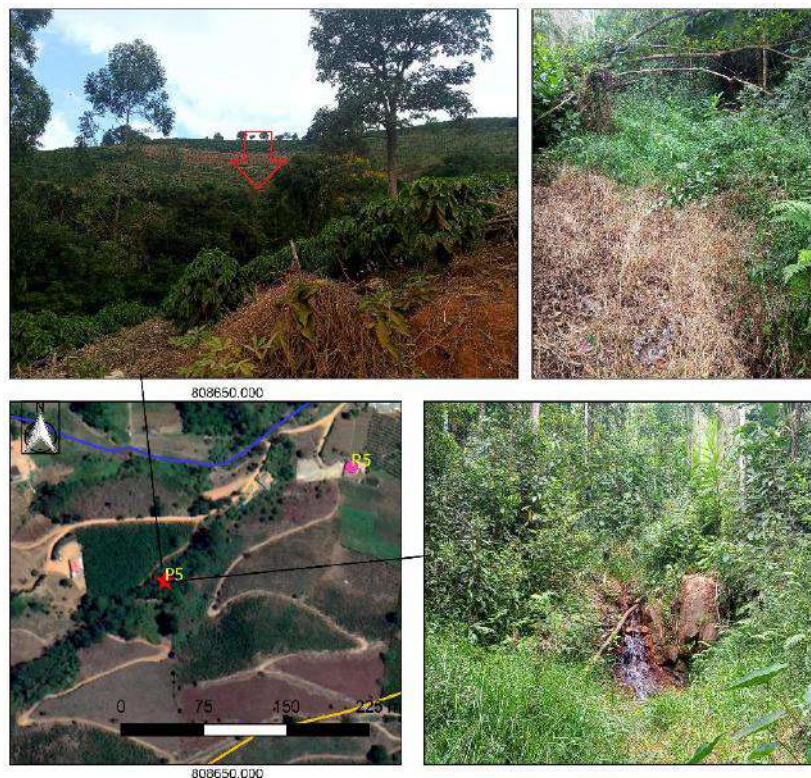
Fig.19: Location and perspective of the surroundings of P5.

Fig.19 presents a perspective through the processing of satellite images and photographic record, in relation to the geographic location of the catchment source 5, and the anthropic activities that can interfere in the quality and quantity of water.

The red arrow in Fig. 19 indicates where the capture point 5 is located in relation to the geographic space. Note that it is also an area of concave terrain, with steep slopes, where the flow converges to the source. There is also coffee growing.

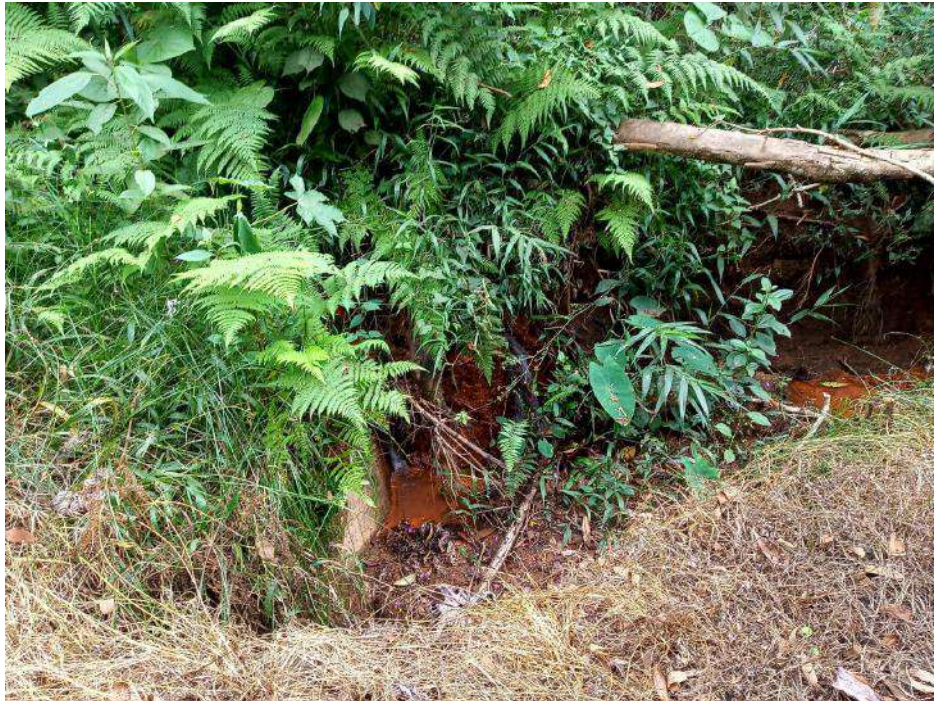
Fig.20: Use of herbicides on plant cover.

The use of herbicides in this area was identified, as suggested by the presence of dead vegetation, illustrated in Fig. 20.

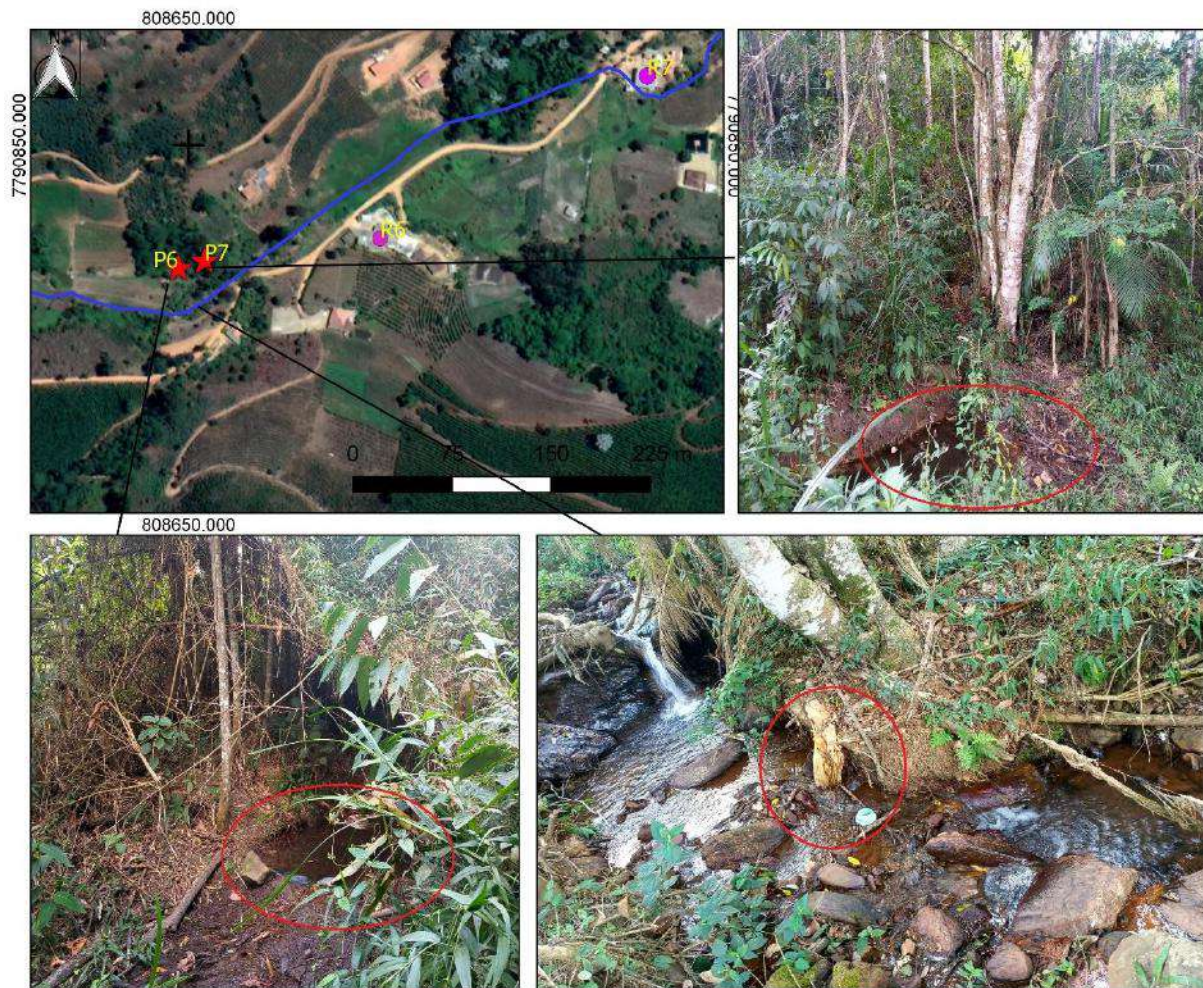
Fig.21: Location and perspective of the surroundings of P6 and P7.

photographic record of these two points, with emphasis on the capture. The main river of this microbasin can also be seen.

The sources present a slow flow, with smooth movements, favorable to the sedimentation of heavier particles.

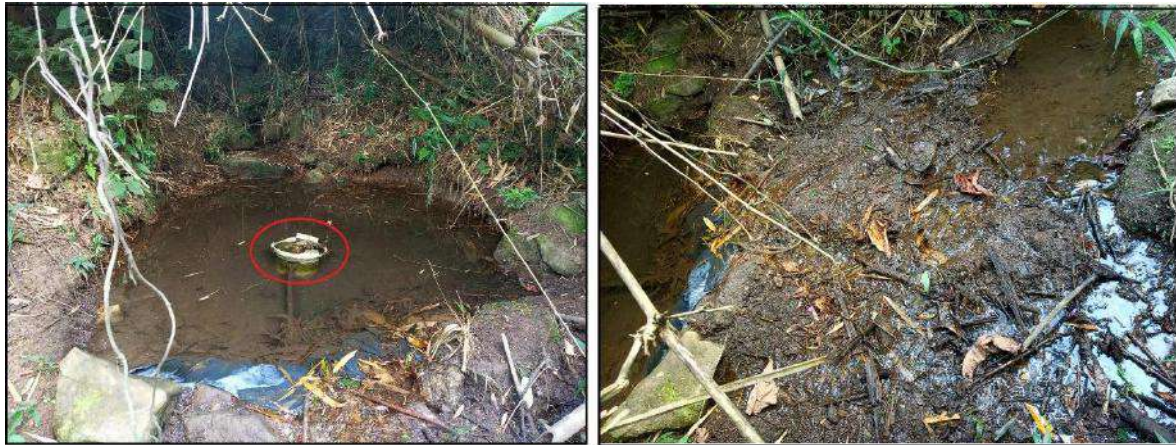
Fig.22: Water abstraction at P6.

Fig. 22 illustrates the water catchment from P6. It should be noted that an intervention was carried out to allow for water intake and flow regulation, which consisted of a dam with soil, stones and canvas, ensuring the amount of water needed to meet the demand of this user.

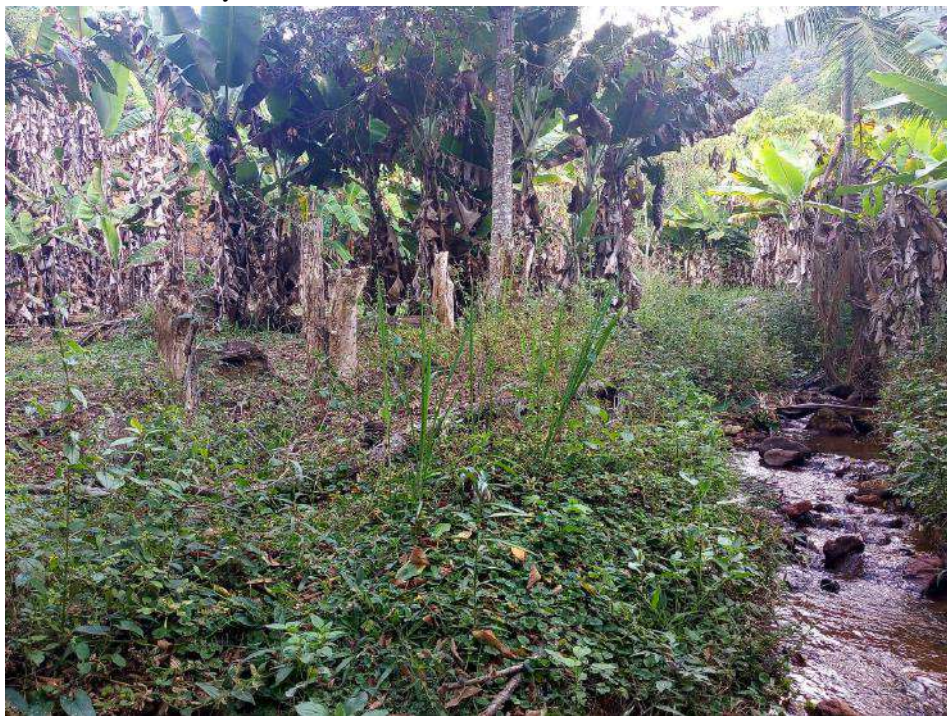
Fig.23: Agricultural activities in the vicinity of P6 and P7.

contribution of the springs. There are banana and cassava cultivation, as shown in Fig.23. The presence of solid waste in the main watercourse was also observed.

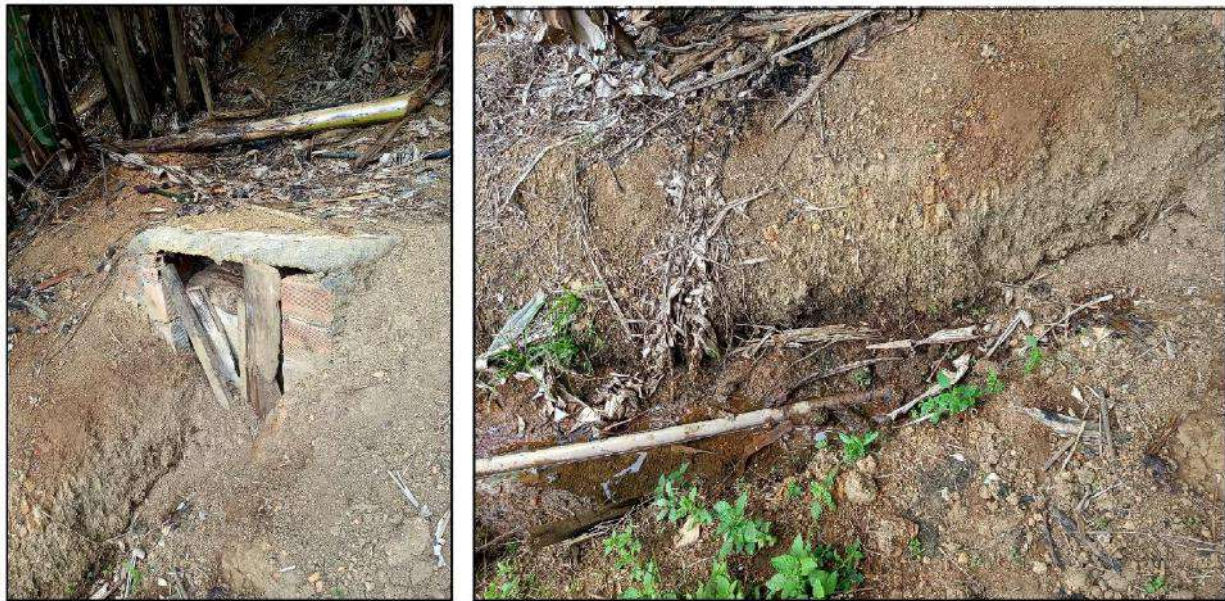
Fig.24: Water abstraction from P8.

To protect the source, a masonry box with a slab roof was built, sealed with pieces of wood, as illustrated in the image in Fig. 24. The capture takes place inside it, with the insertion of a 1½" PVC tube , which then branches to individually supply the 3 residences.

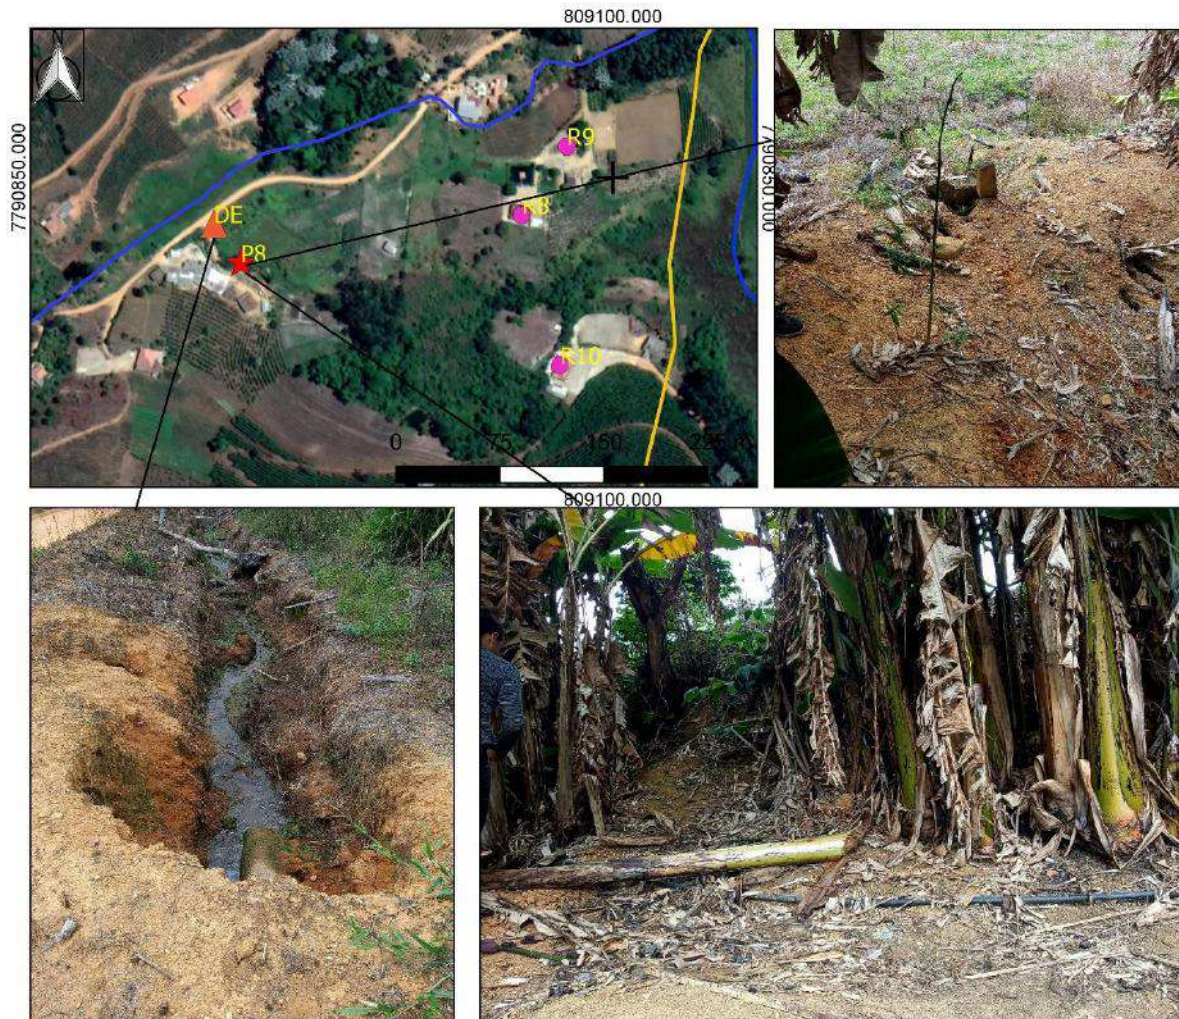
Fig.25: Location and perspective of the surroundings of P8.

He also noted that downStream from the source, it consists of a floodplain, in which the land was drained to facilitate the implementation of agricultural activities.

Another source of impact observed and highlighted in the set of images in Fig. 25, as 'DE', consists of the discharge of domestic sewage and effluents from swine production, also existing at the site.
