# Survey of pathological manifestations in flexile pavement in the city of Manaus/AM

<sup>1</sup>Civil Engineering Student, Estácio of Amazonas College, Manaus, Brazil

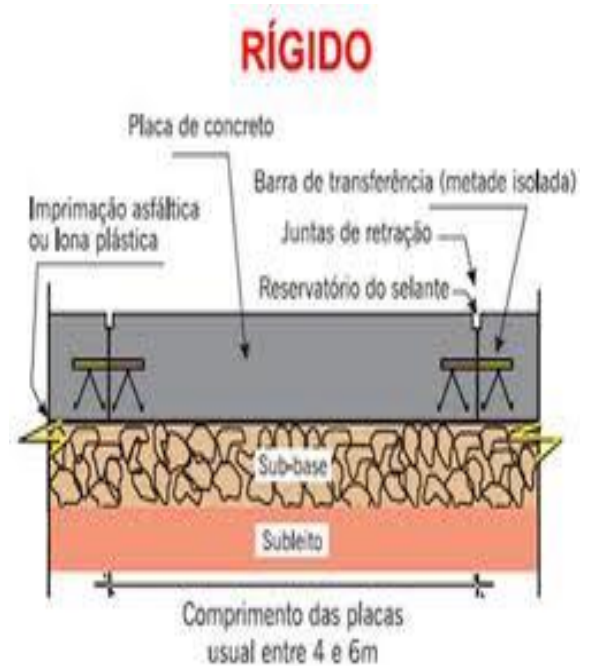
Fig 2 Rigid Pavement, IBRACON (2008).

Rigid pavements are layers that work essentially in traction, unlike flexible pavements. Its design is based on the resistant properties of Portland cement concrete slabs, which are supported by a transition layer, the sub-base (BERNUCCI, 2012).

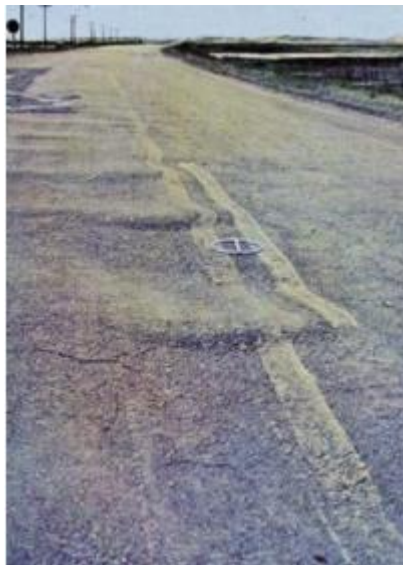
Fig 6 Corrugation example, DNIT (2003)

According to the DNIT 005/2003 – TER (DNIT, 2003) norm, it is defined as transverse undulations on the pavement surface.

The figure below shows an example of corrugations, also known as Ribs, and it is common to find them on climbs, ramps, curves and intersections (SILVA, 2008, p. 31).

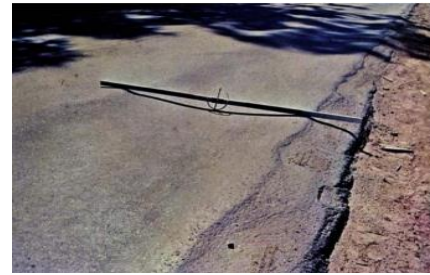
Fig 7 Afundamento da trilha de roda, DNIT (2003)

It is characterized as a permanent deformation through a depression on the surface, which may be accompanied by lifting.

Therefore, the DNIT (2003) states that foundering is a perennial defect determined by depression in the pavement coating, combined or not with lifting, showing itself as a plastic foundering or consolidation.

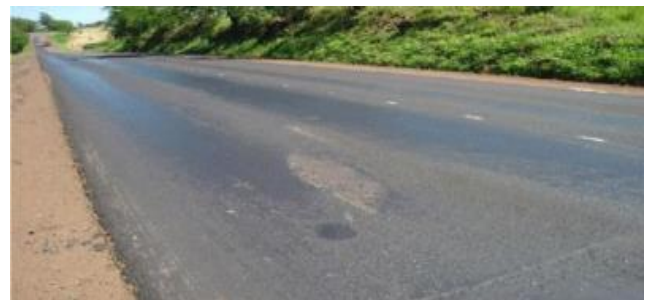
Fig 8 Asphalt exudation, DNIT (2003)

According to Balbo (2007), he explains that this type of pathology may be related to the segregation of the asphalt mixture at some moments during its execution, excessive compaction of the mixture, excess binder, use of low viscosity binder in places with high climate average temperatures or the lack of adhesiveness of the asphalt binder. It may also be related to the slipping of the asphalt mixture.

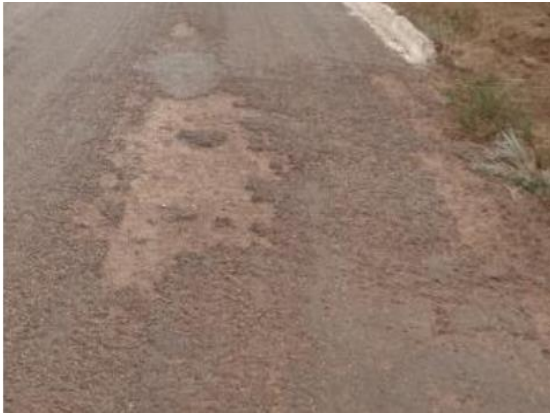
Fig 9 Wear exmple, SONEGO (2018)

According to Dnit (2003), wear is conceptualized as a result of the progressive pull out of the paved structure's aggregate, identified by the roughness of the bearing cover surface and caused by tangential loads caused by traffic.

It is noteworthy that surface wear can be classified as the association of traffic with bad weather. At the limit we may have a polished surface, which can compromise skidding safety. In the progressive pullout of aggregates, surface wear is at an advanced stage. Wear is characterized by surface roughness. (SILVA, 2008).

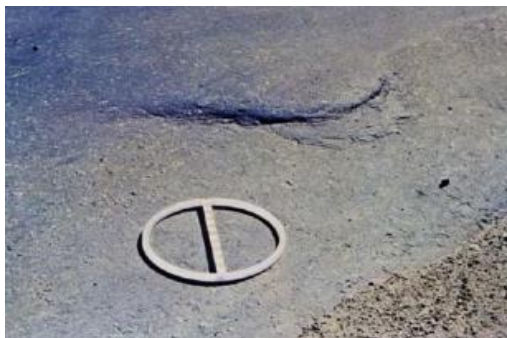
Fig 10 Slip, DNIT (2003)

For Balbo (2007), it is described as a transverse displacement of the asphalt mixture, usually occurring in lanes requested by commercial vehicles and attributes its origin to inadequate priming of the coating on the lower layer, inadequate compression of the asphalt mixture before the release of the lane for traffic, the inadequate viscosity of the asphalt cement for the conditions of use and the excess of binder in the mixture.

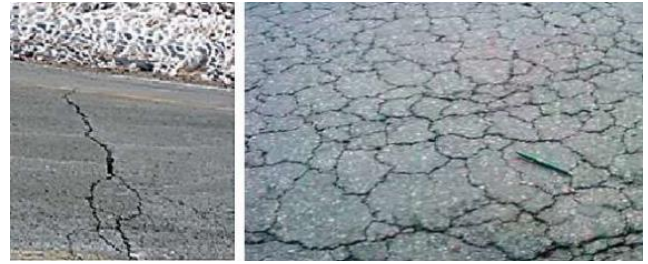
Fig 11 Alligator skin crack, Bernucci et al.(2012)

In flexible pavements, cracks are a more common form of pathology, due to the flexural traction of these layers repeatedly with the passage of load from vehicles (BESKOU, et al, 2016, p. 476).

There are several types of cracks, however, the most common are alligator or crocodile skin cracks, isolated retraction cracks, block cracks, longitudinal cracks, transverse cracks and edge cracks.

According to DNIT (2003), crack is any break in the structure's coating that leads to greater or lesser degree grooves, presenting itself in various forms, it can present as a fissure or crack according to what is exposed ahead.

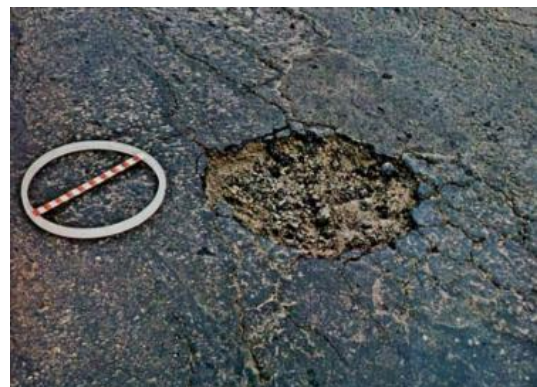
Fig 12 Panela ou buraco, DNIT (2003)

Also called a hole, thus, the DNIT (2003) states that pan is precisely the hole formed in the coating due to various factors (including the lack of cohesion between overlapping layers, generating the peeling of these), which can reach the underlying layers of the pavement, leading to the disaggregation of these layers.

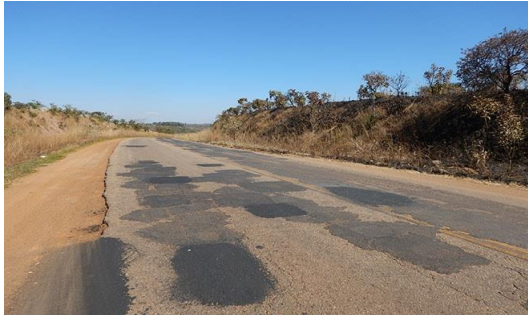
*Fig 13 Superficial patch*

According to DNIT (2006), the making of patches should consist of the following steps: regularization of degradation (geometric delimitation of the pan); waterproofing (priming) of the affected granular layers; spreading, shaping and compacting the filling

material and surface sealing (when the filling material has high void rates).

The superficial patch is also known as a filler, and its use is quite common, with the objective of repairing degradations in the road.

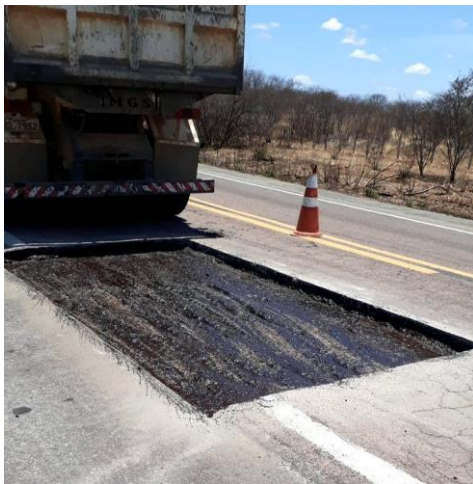
*Fig 14 Deep patch*

Deep patching is already a more corrective technique, in which fractions of underlying granular layers can be removed.

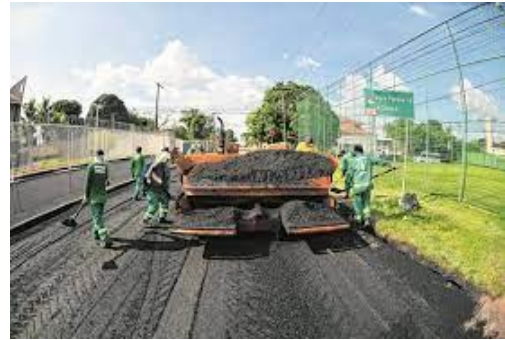
*Fig 15 Resurfacing*

For the treatment of foundering, two techniques are suggested: recapping and crimping, as seen in the following figures:

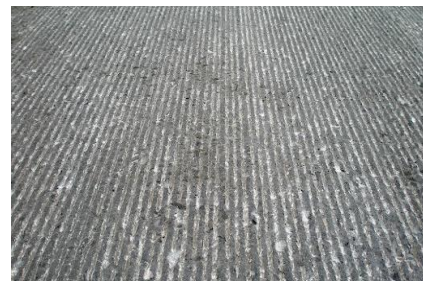
*Fig 16 Milling*

In the event of undulation/corrugation, the recommended techniques to recover pavements with this defect are also the same used in the recovery of foundering: resurfacing and milling.
