Risk Assessment for Professionals Performing Excavation Services in Civil Construction: Case Study in Manaus - Amazonas

Abstract— The purpose of this study is to analyze safety conditions during excavation services, seeking to identify risks to employees in situations of ignorance or use of safety measures. Therefore, this study was conducted through a qualitative study, exploratory and descriptive, seeking to diagnose the main impacts of the adequacy of NR-8, NR-12 and NR-18 in a construction site in Manaus-AM. The results showed lack of signaling on the excavation perimeter, no use of personal protective equipment and residue around the excavation perimeter. The nonconformities found imply exposure of the employee to situations of imminent risk, compromising their safety and health. Training proposals to raise awareness of the importance of safety standards for the execution of activities can contribute to a safer scenario regarding working conditions.

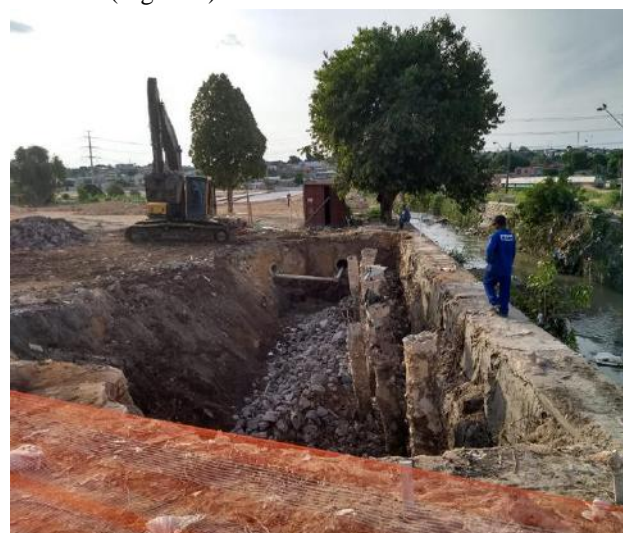
The excavation was observed, and proved that it is not in accordance with the legality of the NR-18, in the process of digging ditches, where it happens in soil or rock, with the lack of proper signs, warning not to cause accidents (Figure 2).

Fig. 2: Excavation for the construction of the retaining wall.

The entire perimeter of the excavation work should have warning signs that define the traffic of people, vehicles, machinery and equipment. Safety signs should be planned to prevent accidents. Traffic near excavations should be diverted and, if not possible, vehicle speeds should be reduced. At least two access roads must be built, one for pedestrians and one for heavy machinery, vehicles and equipment. Excavations should be signaled and isolated to prevent falls from people and / or equipment.

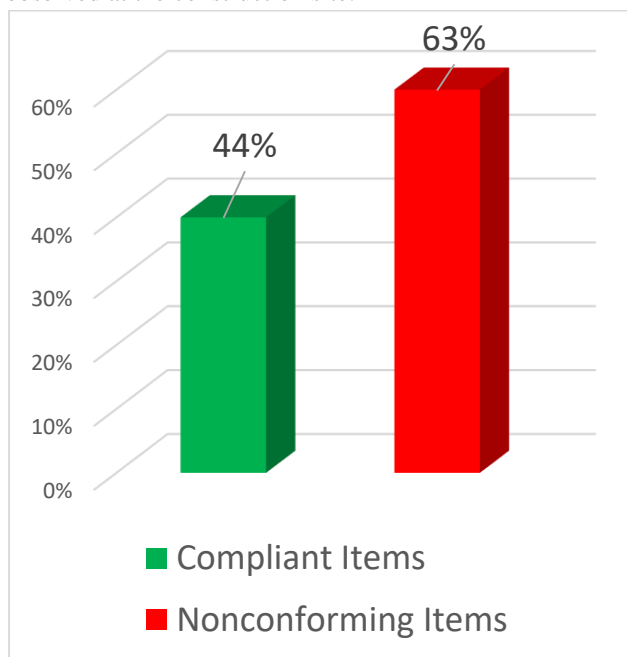
Two errors were found in the work: 1- lack of signaling in the excavation perimeter, disagreeing with the NR-18; 2- employees without protective equipment characterizing

unlawfulness in the safety norms NR-6. Figure 3 shows the conformities and nonconformities of excavation items as observed at the construction site.

Fig. 3: Compliance and nonconformity chart of excavation items.

In this type of work the PPE must be used to suit the existing risks, namely, helmet, safety shoes, goggles, protective gloves and reflective vest. Being able to do these jobs without human intervention at the bottom of the excavation and being outside would avoid many problems and a large number of fatal accidents.
