Analysis of use of lumber of angelim-iron species and cupiúba in Construction in Boa Vista/RR.

Abstract— The wood is used as construction material from antiquity. It's a raw material in abundance in nature. This article has as objective the use of wood angelim-iron species and cupiúba in the processes of construction of the city of Boa Vista/RR, in relation to the durability and sustainability, aiming at cleaner production, with low environmental impact and the reduction of waste generated in construction. The methodology will have a descriptive approach, bibliographical, documentary and field. At the end, the research conducted in the field, presents a proposal for improving the use of the material in buildings, which approaches the problems of this material.

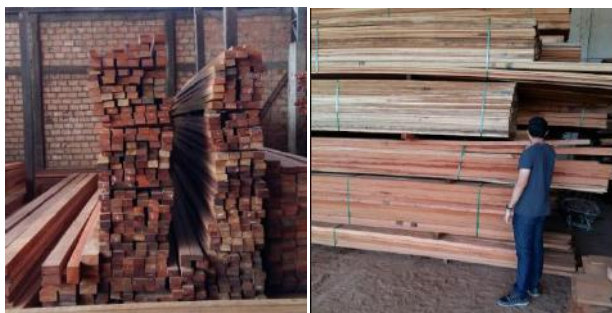
Fig.1 - Analysis of the wood and iron angelim cupiúba.

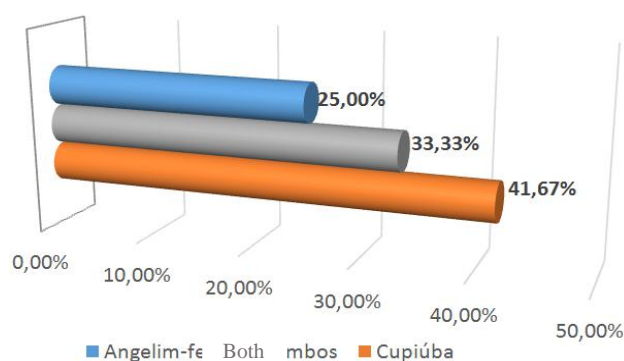
Chart 1 - Quantity of the species in the work.

It was visited 28 constructions sites, which use the angelim-iron wood or cupiúba in order to see how it was being used pieces of wood sawn in the sites. In this way, in chart 1 are asked to charge the work of 24 sites, which wood species were being more used, where 10 sites had cupiúba species (41.67%); 8 sites in both had the two species (33.33%); and 6 pieces had angelim iron species (25%).

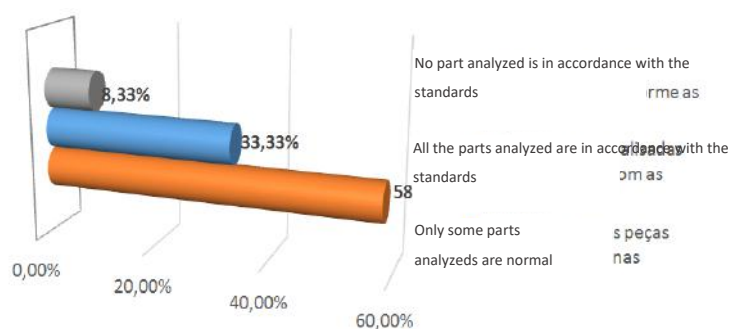
Chart 2 - Dimensions of pieces of wood sawn in the works of the municipality.

Thus in chart 2 gave the following results: 58.33% with only a few pieces are the rules, in which the error was in the majority in one piece with slat naming, with width > 7cm; 33.33% of the 24 works verified, reached all dimensions of standards; and only 8.33% was no piece according to the rules.

These results are consistent with Atanasov (2011), although there are specifying dimensions in norms ABNT and part names, they are ignored by the sectors of production and trade of timber sawn and processed. Often, it was observed that entrepreneurs and workers do not see in their classifications concepts, differences between plank, beam and joist. The same was observed for the relationship between batten and slat.

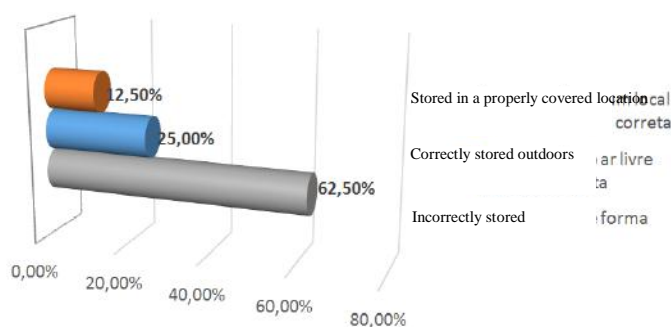
Chart 3 - Quantity of the types of stores.

In order to check how the pieces of wood were being stored, according to chart 3, there is 62.50% and were stored incorrectly, 25% are properly stored outdoors; 12.50% stored in a covered place correctly.

It was observed on-site visit that most pieces of wood sawn were all stacked horizontally flat against the ground, with no low battery holder, the woods can't get in touch with the ground, as changes in the moisture content of wood as rain, may suffer fungal attack and insects, warping, deformation and swelling of the wood. This is consistent with Oliveira et al. (2008) which was found during visits that 33.3% of companies do not properly store their wood stocks. In such cases, it was observed that the coverage is

partial, or inefficient, or just the parts are stacked in yards with no cover against sun and rain.

Being a natural product, wood parts suffer from insect and fungus attacks. They also absorb moisture and can easily deform, warp or swell. according to standard the pieces of wood should be stored stacked, spaced at least 15 cm from the ground and covered in places protected from moisture and rain.

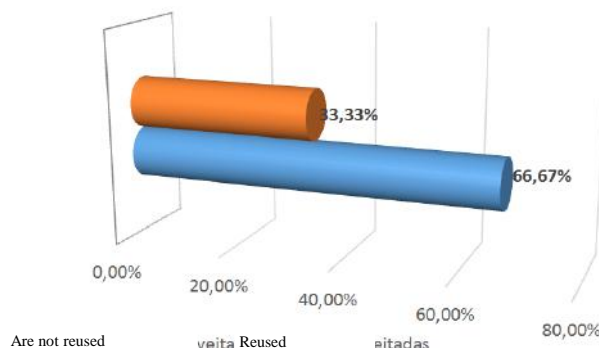
Chart 4 - Reuse of parts.

In chart 4, it was asked to parents in the work, which the final destination are given the parts used for forms, shoring, scaffolding and others, where the 24

constructions site visited, 66.67% of those in charge said reused wood that would not use more temporarily in the site; however 13.33% said they are not reused.

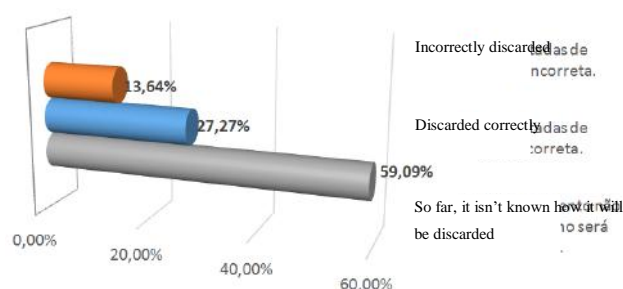
Chart 5 - Quantitative on disposal of parts.

In chart 5, found in the sites, like the pieces of wood used temporarily will be discarded, and the results of this research were 59.09% do not know how it will be discarded; 27.27% rule correctly; and 13.64% rule incorrectly.

It's observed that most of the construction sites that do not know how it would be done disposal correctly, either through the city, any company that recycles wood or that the pieces were donated to other sites in progress were being thrown into a corner the sites anyway, consequently, were affecting the properties of wood, as were flat on the

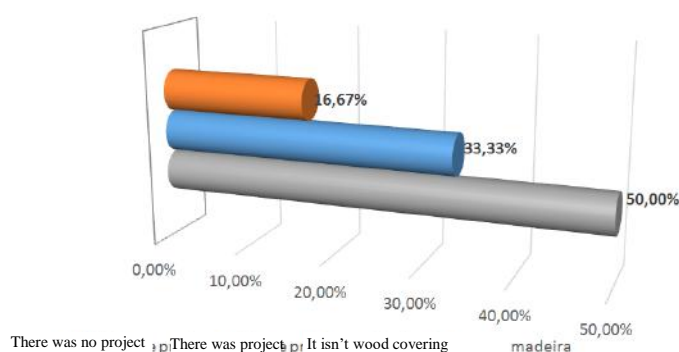
Chart 6 - Quantitative raised on the cover design project.

Already in chart 6, found out how many of the 24 sites visited, have wooden cover, and there was a design project to perform according to NBR 7190: 1997. Thus, it was obtained that 50% coverage is wood, there project 33.33%; and 16.67% no project.

In this chart, it's possible to observe that the four sites visited, equivalent to 16.67% of total recorded sites, didn't have a cover design project for the residence, this isn't good for the residents because the lack of design, it can cause serious problems in the structures, as a filler for high-withstand structure makes it necessary to adapt the capacity of parades have a good channeling of rain water, so that infiltrations and moisture are avoided that might jeopardize the structure.

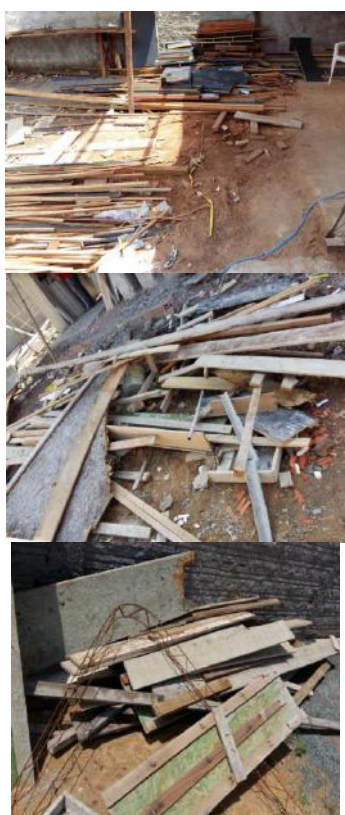
Based on the survey study, it was noted that most of the sites were wood waste left in a corner of the site, as shown in Figure 2 below.

Fig.2 - Some examples of waste wood found in the works.

As a result, introduced to reduce waste generated by constructions, it's recommended that these parts for reuse during construction, is due to ladders, scaffolding, and the like, if needed. You can also call the town hall of the city to take these spoils, or call any company carrying out recycling of material to make furniture, decorative objects, logistic supports, among other things, for the Resolution No. 307 / 2002 CONAMA, wood is classified as Class B - recyclable waste.
