# Incompatibility stone-mortar Influence of pH on the sensitivity of rocks to saline alterations

Meriem Benharbit

Institut National des sciences de l'Archéologie et du Patrimoine, Rabat, Maroc

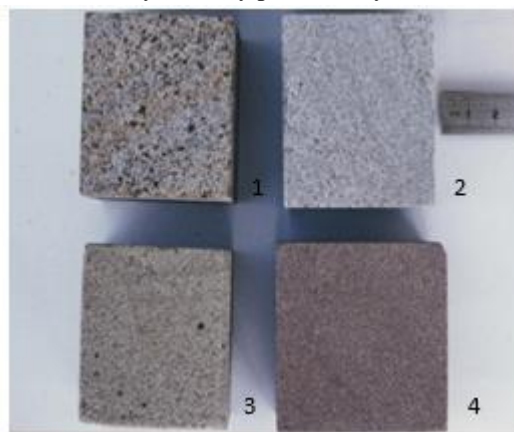
Fig. 1: Macroscopic aspect of sandstone materials, reflecting the differences in mineralogical composition and matrix that gives the rocks their specific color, 1- molière sandstone, 2-coal sandstone, 3- beige vosgian sandstone, 4- red vosgian sandstone.

The characterization of the studied materials (Fig. 1) was determined by various analytical techniques including optical microscopy (Figs. 2, 3, 4, and 5) for the petrographic aspect. The characterization of the porous space was done by mercury porosimetry.

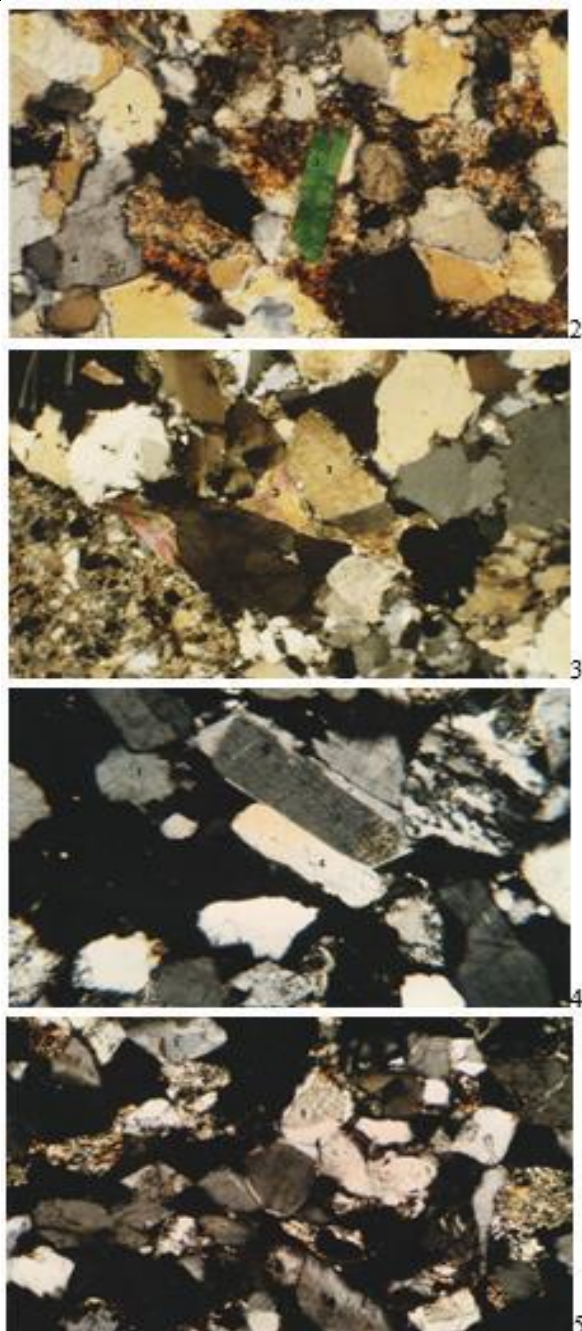
Fig. 2-3-4-5: Optical microscopy of sandstones. The molière sandstone (1) presents aggregates of microcrystalline quartz, detrital quartz, and muscovite flakes bathed in a clay-ferruginous matrix ; Coal sandstone (2) shows fragments of detrital and polycrystalline quartz, muscovite flakes and a clay matrix ; Beige vosgian sandstone (3) shows fragments of detrital quartz, quartz fed by secondary silica, fragments of metamorphic rock and muscovite ; The red vosgian sandstone (4) has elements of secondary feeding detrital quartz, aggregates of micrograiny quartz and a hematite rich matrix.

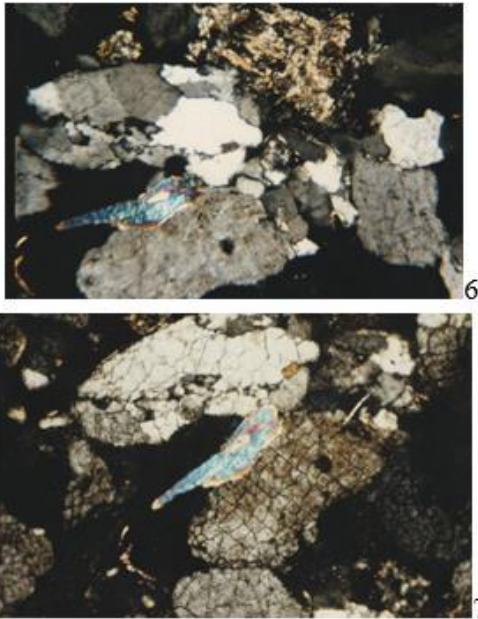
Fig.6-7: Observation of thin blade of the coal sandstone before (6) and after (7) treatment with pH 12.6

The observation of thin plates of rocks of the treated batch at pH 12.6 shows the development of an important microcracking of the quartz grains constituting the sandstones. The microcracking revealed is generalized to all the materials studied (Figs. 6-7-8-9-10-11-12-13). Such disturbances have already been noted [2] in sandstones, granites and mortars, and attributed to the synergy of several processes: thermal effects (variations in temperature), hydric (successions of humidification-drying cycles, chemicals (dissolutions) and mechanical (saline crystallizations).

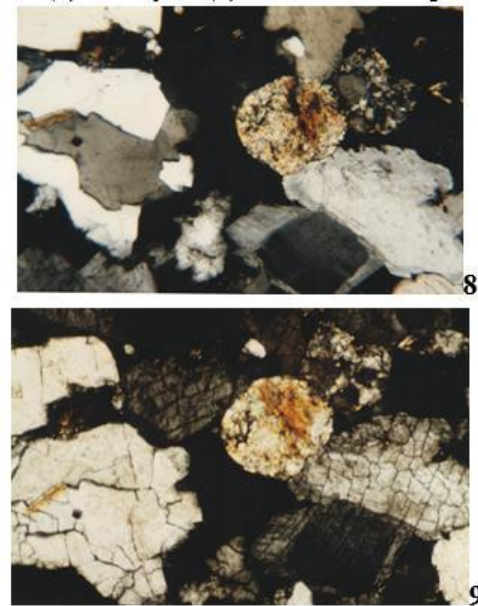
Fig. 8-9: Observation of thin blade of the red vosgian sandstone before (8) and after (9) treatment with pH 12.6

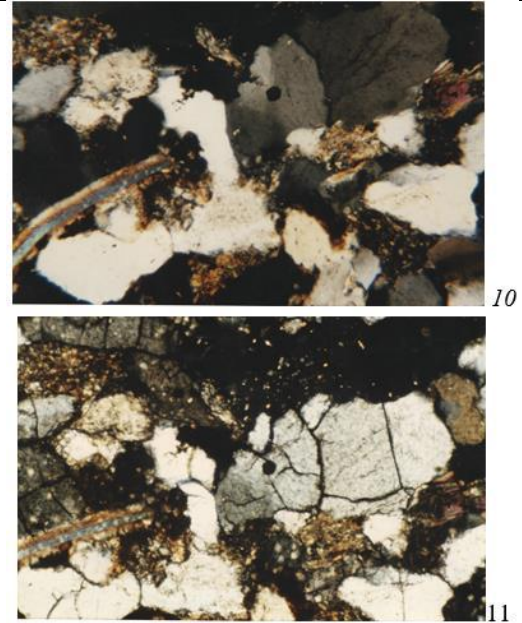
Fig. 10-11: Observation of thin blade of the molière sandstone before (10) and after (11) treatment with pH 12.6

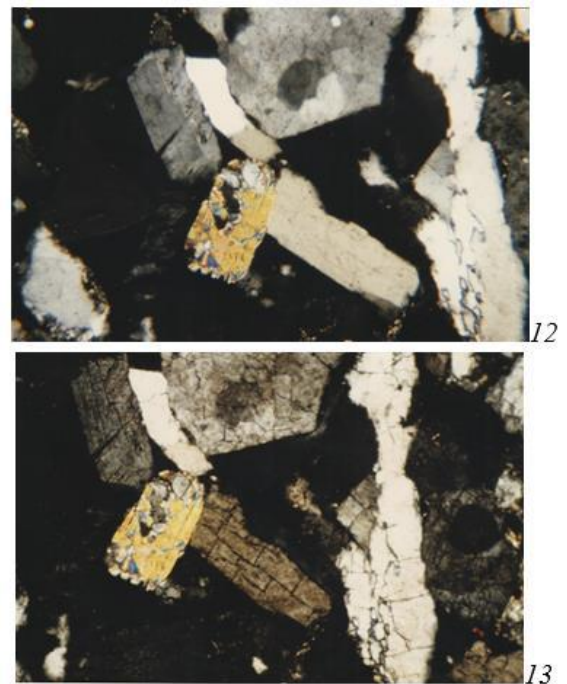
Fig. 12-13: Observation of thin blade of the beige vosgian sandstone before (12) and after (13) treatment with pH 12.6

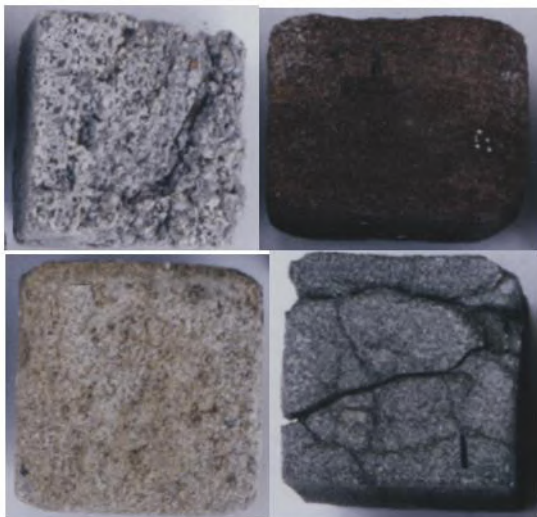
Fig.14: Illustration of facies of alteration of sandstone under the effect of saline crystallizations.

Following the accelerated aging test by the salts, the two batches of samples studied show, over the course of the cycles, a high granular disintegration leading to the complete degradation of the test tubes (Fig. 14). The results obtained confirm the abundant data in the literature concerning the problem of the saline alteration of the stones used in the historical monuments [3], [4], [5], [6].

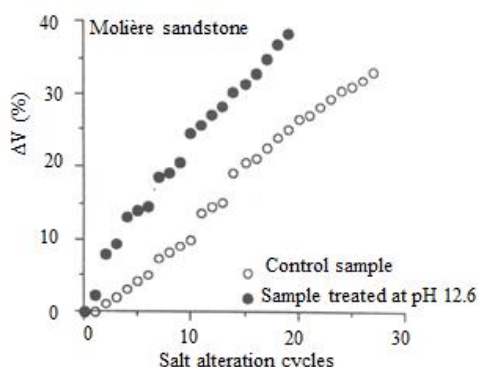
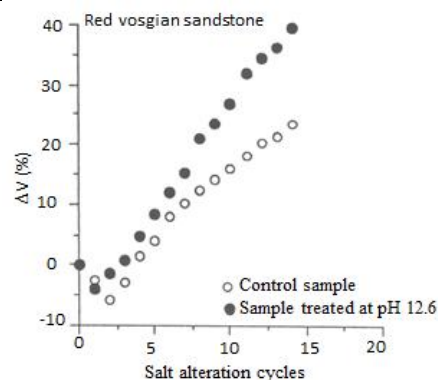
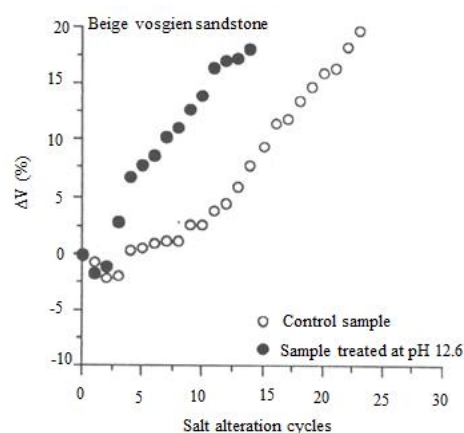
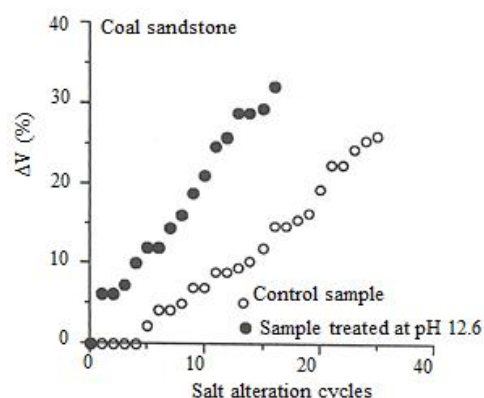
Fig.15: Variation according to salt alteration cycles of rate of loss of ultrasonic speed of the control and treated samples at pH 12.6 for 28 days at 60°C.

Fig.16: Variation according to salt alteration cycles of rate of loss of ultrasonic speed of the control and treated samples at pH 12.6 for 28 days at 60°C.

Fig. 17: Variation according to salt alteration cycles of rate of loss of ultrasonic speed of the control and treated samples at pH 12.6 for 28 days at 60°C.

Fig.18: Variation according to salt alteration cycles of rate of loss of ultrasonic speed of the control and treated samples at pH 12.6 for 28 days at 60°C.

The results are plotted in the figures (15-16-17-18) where  $\Delta V(\%)$  represents the variation of the ultrasonic velocity as a function of the saline alteration cycles.

$\Delta V(\%) = 100 (V_c - V_x) / V_c$  with:

$V_c$  = ultrasonic propagation velocity measured through the samples of the control batch;

$V_x$  = ultrasonic propagation velocity measured through the materials after x cycles.

It should be noted that the batch treated with the basic pH shows a reduction in the propagation speed of the sound that is greater than the control samples, for all classes of rocks combined. These results can be attributed to the microcrack network revealed in quartz crystals following the alkaline attack. The play of the dilation and the

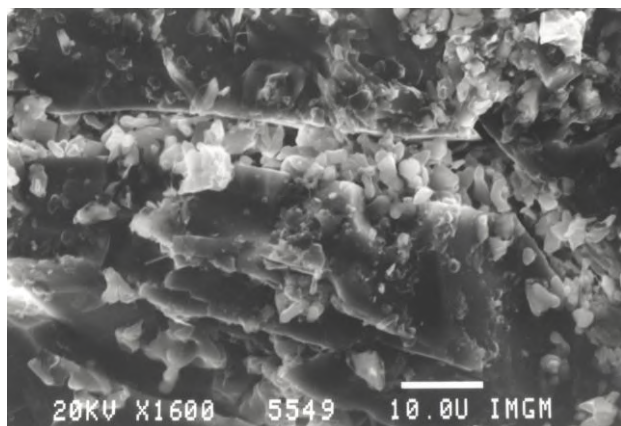
Fig. 19: SEM observation of crystallizations of mirabilite ( $\text{Na}_2\text{SO}_4 \cdot 10 \text{H}_2\text{O}$ ) in the cracks of quartz crystals previously induced

growth of salts in this microporosity (fig.19) further weakens the rocks by accentuating the observed disorders.

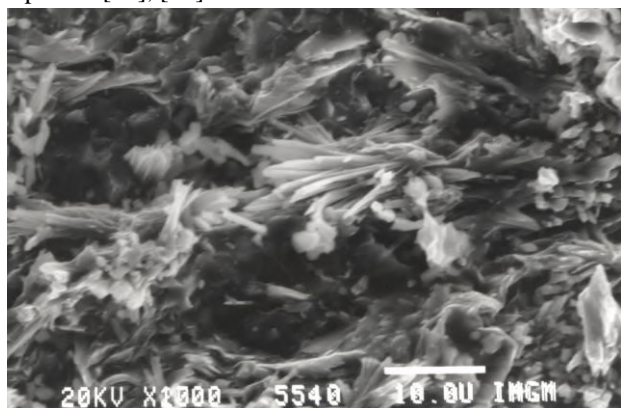
Fig.20: Observation in the SEM of crystallizations of ettringite ( $\text{Ca}_6\text{Al}_2(\text{SO}_4)_3(\text{OH})_{12} \cdot 26\text{H}_2\text{O}$ ) in the samples treated simultaneously in pH 12.6 then in the cycles of ageing by salt alteration.

It also appears that the mineralogical nature of saline crystallizations varies according to the nature of the batch of samples. If, in the batch of control samples, the crystallization of the mirabilite is observed, the batch treated at pH 12.6 also shows the appearance of ettringite (FIG. 20), calcium sulfate and hydrated aluminum, of formula:  $\text{Ca}_6\text{Al}_2(\text{SO}_4)_3(\text{OH})_{12} \cdot 26\text{H}_2\text{O}$ . The calcium introduced during the alkaline treatment reacts in the presence of the sodium sulphate of the saline immersion solution to give ettringite, known salts for its swelling properties [10], [11].
