Occupational Safety Analysis at a Construction Site in the City of Manaus/AM

Abstract—The object of this case study is the analysis, according to regulatory norms, of the construction site located in the city of Manaus/AM. The study begins with the approach of concepts and norms related to occupational health and safety inside the construction site environment. An inspection was held, through a questionnaire, of the measures taken by the company about occupational safety at the construction site. Lastly, it was possible to verify the conditions of the site concerning the safety established by the responsible company. Therefore, what could be seen was the lack of organization and cleanliness of the site. It was identified the lack of concern with regard to safety equipment by the employees themselves. But still, it was seen a great concern with the employees' safety by holding of meetings and lectures on accident prevention.

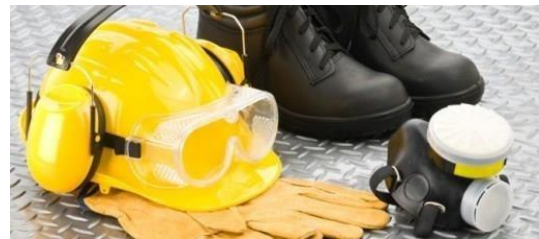
Fig. 3: Personal Protective Equipment. Source: Saúde e Vida Group, 2020.

The use of PPE is the last of the measures that an employer should consider in its strategy of eliminating or minimizing the harm that a particular risk agent may cause to the health and/or physical integrity of its employees.

As a priority, all alternatives should be exhausted in combating the risk agent using collective protections. If they are technically unfeasible or insufficient, administrative or work organization measures should be implemented and only in the last case should personal protective equipment (PPE) be used.

It should be emphasized that when implementing disproportionately costly solutions, the cost factor is not considered as a valid justification by the supervisory agents when it is detected that collective protection appropriate to the risk are not implemented and counting only on the use of PPE.

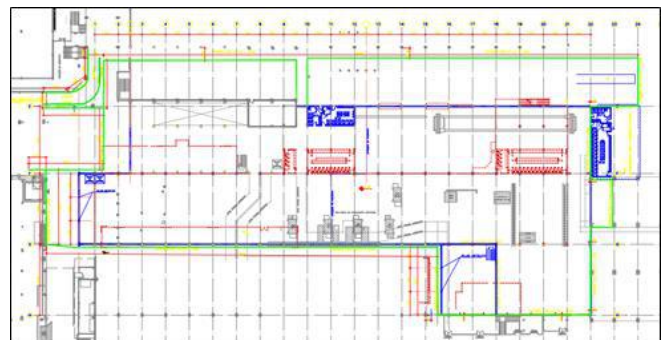
Fig. 4: Layout of the Work

The site has approximately 2,300 m² and an area formed by 2 assembly lines as can be seen in Figure 1. During the visit, the site was in the stages of foundation execution, masonry execution, floor concreting and metal structure assembly.

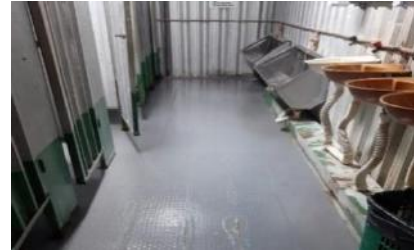
Fig. 5: Sanitary construction site installation

Yes, there were two sanitary facilities in containers. Both were in good condition and the environments were well lit. Cleaning was realized daily and twice a day. There was also a control of the day and time that the facilities were clean, contributing to the health of employees.

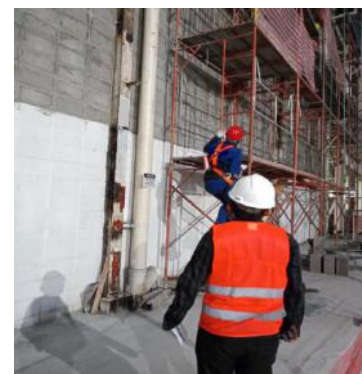
Fig. 6: Practical NR-35 Training

With regard to the prevention against fall from height, training was carried out that guided the employee to use the safety equipment correctly, since learning how to put the safety belt on a paratrooper type until climbing on a scaffold properly as shown in Figure 6. And lifelines and signs were also found that warned of the dangers that could be encountered as ahead in Figure 7.

Before performing the work at height, the employee underwent screening with the measurement of pressure to evaluate his conditions of doing the service and ensuring the health and well-being of the worker.

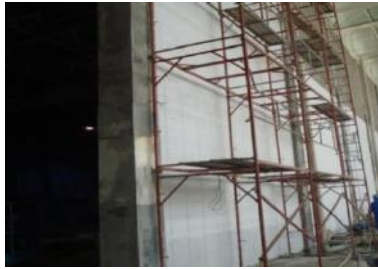
Fig. 7: Scaffolding of the work.

The company had its own scaffolding and also rented by a outsourced company that also did service on the site. Some scaffolding were without footers and without sufficient platforms for the worker's locomotion, although there were lifelines fixed throughout the site, yet there was a risk of high-level accidents.

Although many favorable things have been noticed regarding security, some problems have still been noticed. Like the electrical cables that circulated through the lower part and can be damaged and thus generating accidents such as electric shocks. Another factor was the random assembly of scaffolding that did not promote safety in relation to work at height, due to the lack of footers and platforms.

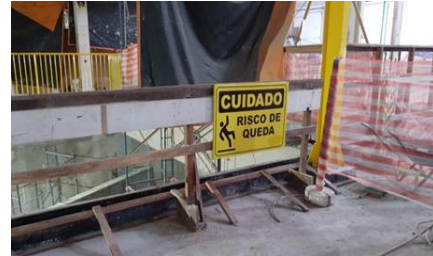
Fig. 9: Sign board for risk of fall

In the site there were accident prevention signs that allowed the safety of the construction site to be emphasized. Places with ditches were isolated with cerquites at a safe distance.
