LUBRICANT FAILURE ANALYSIS OF ROLL NECK BEARINGS OF WIRE ROD MILL: A CASE STUDY

Abstract - Wire Rod Mill is a high speed roll mill of modern technological design, including equipment for controlled cooling of product from rolling heat. Steel wire rods are an all-round talent since they are the key product of steel industry with multiple uses. They are used as the material for fasteners, springs, bearings, wire ropes, chains, cables, wire meshes, wire fencings, tyre cord, reinforcement in railway sleepers, and many other uses. Further, it is necessary that the wire rod mills are able to achieve very high precision with rolling stands designed to withstand high loads and changing temperature requirements. In this project we find the causes for frequent failure of ball neck bearings and preventing the failures in bearings. Insufficient lubricant supply and inappropriate lubricant type (Viscosity and Temperature) causes the roll neck bearings to fail during working of wire rod mill. Due to improper lubrication, contamination, installation and misapplication of the bearings, and can be considered as premature since they will not achieve the calculated life. Countermeasures to premature

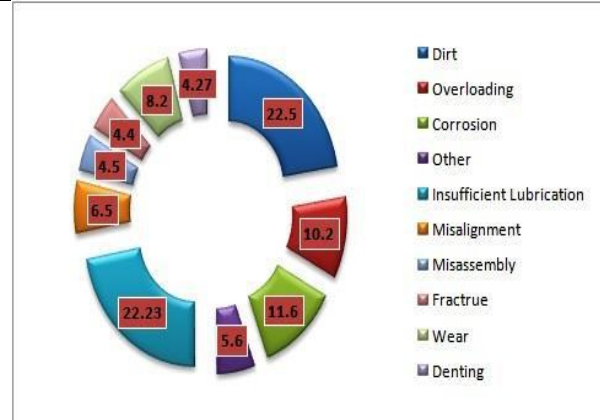
Fig.1: Major Causes of failure in Wire Rod Mills (in %)

The chart above lists the major causes of premature bearing failure, along with percentage figures which indicate prime contributor to a bearing’s destruction. In many cases a premature bearing failure is due to a combination of several of these causes.

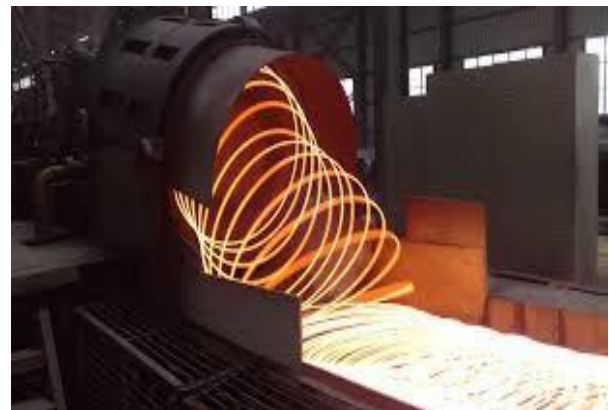
Fig.2: Wire Rod Mill in Vizag Steel Plant

Wire, rod, and bar mills operate similar to the rolling mills for plate and other product. Operating conditions in these mills tend to subject the bearings to high temperatures, water spray, high loads and marginal sealing arrangements, resulting in short bearing lives [1,2].

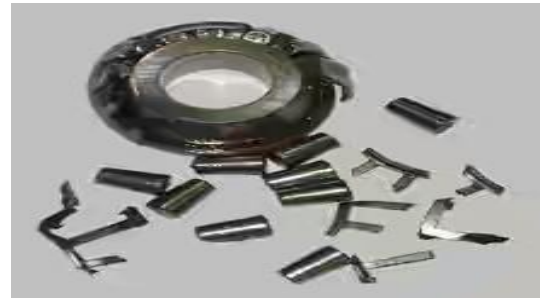
Fig.4: Damaged bearing in Wire Rod Mill

- Grease including large quantity of water mixed in.
- Foreign matter attachments and corrosion occurs.
- Seizure and adhesion of raceways, roller and cage.

- Looseness and breaking of pin.

Improper or inadequate lubrication can result in a breakdown of the oil film between the rolling elements and raceways. The resulting metal to metal contact generates excessive heat which reduces the hardness of the metal. Localized welding of the rollers or balls to the raceways will rapidly seize the bearing. Fracture of cage side edges damages due to poor lubrication. Insufficient lubrication, resulting in an increase in friction and material stressing at the raceway surface.

Carefully select the proper amount and type of lubricant that will maintain a film between the rolling elements and raceways.

- ✓ Remember to pre-lubricate whenever necessary before installation.
- ✓ If the temperature cannot be lowered, review the possibility of change to high temperature grease.
- ✓ Avoid improper sealing.
- ✓ Provision of load carrying lubricant film (additives, if necessary), increase in lubricant quantity.
- ✓ Filter lubricant.
- ✓ Mount Carefully.
