External Corrosion of the bottom plate of Petroleum and Derivative Storage tanks on Compacted Soils

Mauro Muniz de Castro[1], Fernando B. Mainier[2], Miguel Luiz Ribeiro Ferreira[3]

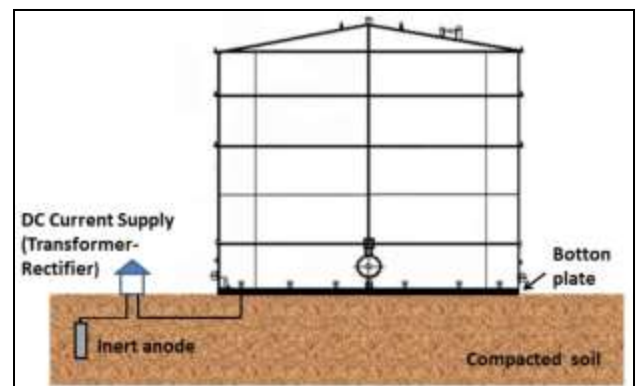
Figure 1 shows a scheme of a storage tank supported on compacted soil, with the bottom plates being protected by cathodic protection system by an impressed current (inert anode).

Fig. 1 - Scheme of a storage tank supported on compacted soil with the bottom plates protected by cathodic protection system

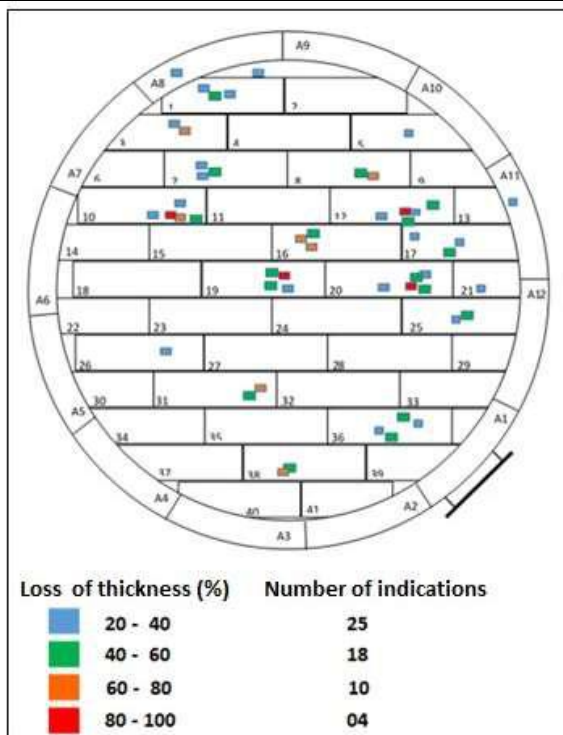
Fig. 2 - Loss of thickness (%) in carbon steel plates of the bottom of a diesel storage tank by the non-destructive inspection (method Magnetic Flux Leakage).

Figure 2 shows the results of the loss of thickness of the bottom plate of a 40-m diameter diesel storage tank supported on compacted soil by non-destructive inspection, the so-called MFL (Magnetic Flux Leakage). This technique consists of the detection, evaluation and measurement of the magnetic flux due to the presence of discontinuities in the carbon steel plate, such as loss of thickness and corrosion holes [8, 9].

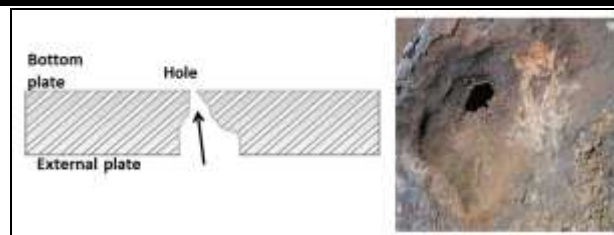
Figure 4 shows the external localised corrosion and the loss of the thickness of the cut carbon steel plate, demonstrating that cathodic protection was inefficient.

Fig. 4: External localised corrosion and loss of the thickness of the cut carbon steel plate.

This paper aims to demonstrate the inefficiency of impressed current cathodic protection when there are voids or spaces between the bottom plates and the compacted soil. It was also evaluated the application of the aluminium thermal spray on the outer faces of the bottom plates to inhibit or interrupt the localized corrosion.

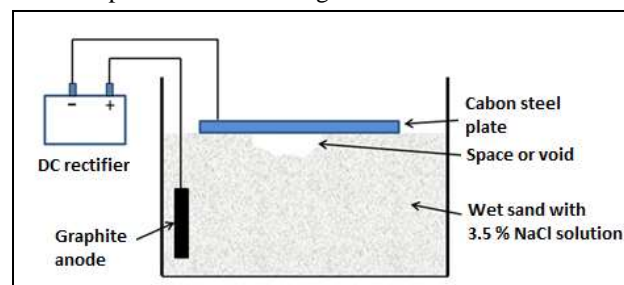
This experiment consisted of the application of an impressed current on a carbon steel plate (20 x 30 cm, thickness 6.35 mm) uncoated and supported on sand moistened with 3.5% sodium chloride solution. The use of the wet sand, representing the compacted soil, had the purpose of increasing the conductivity, aiming at the development of accelerated tests. For the application of the electric current to the carbon steel plate, a DC rectifier was used and a graphite anode was inserted in the sand (Fig. 5). As seen in Figure 5, the sand was removed from underneath the steel plate to simulate a space or void without electrical conductivity to demonstrate the lack of cathodic protection in this region

Fig.5: Evaluation of impressed current cathodic protection.

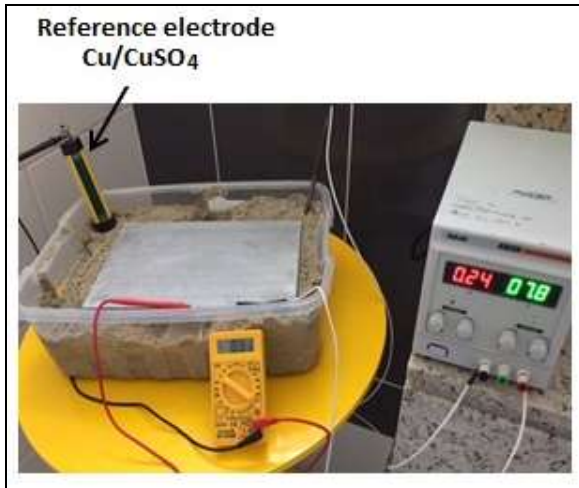
potential plate/electrolyte of 0.91 V was obtained, which was more negative than -0.85 V, measured with the reference electrode (Cu/CuSO$_4$) as shown in Figure 6, illustrating the experiment in progress. The duration of this experiment was 30 days. After the experimental period, the carbon steel plate was evaluated.

Fig. 6: Evaluation-impressed current cathodic protection

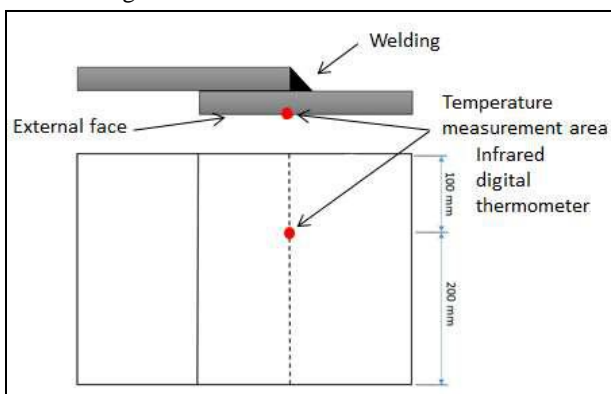
Fig. 7: Temperature measurement. Side view and bottom view of plates with overlapping joints.

The temperatures obtained in the welding of the carbon steel plates were 295°C in the first pass and 320°C in the second pass. This test aims to represent the welding of the bottom plates in the construction of an oil storage tank. According to the Petrobras Standard N-2568: 2011 [13], thermal spray aluminium coatings can be used at temperatures of up to 600°C, meaning that welding would not damage the anticorrosive performance of this coating. Figure 10, below, illustrates the immersion of the aluminium-coated carbon steel plate in 3.5% NaCl solution for 3 months, showing the good performance of the galvanic protection exerted by the aluminium in relation to the 3 cm strip which was not coated and had no localised corrosion.

The highest welding temperature of 320°C was observed during the execution of the second pass. This allows the use of plates coated with aluminium thermal spray that are not altered by welding temperatures and at the same time are protected against corrosion.

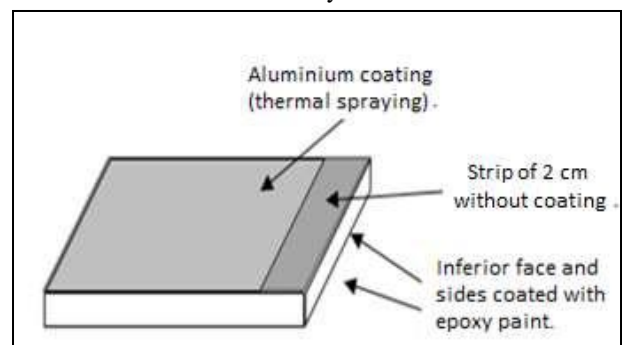
A 2 cm strip was removed from the surface coated with the aluminium thermal spray to evaluate the galvanic protection exerted by the aluminium with the carbon steel plate. The other side and the sides were coated with a thick epoxy resin layer as shown in Figure 8, considering that this sample will be immersed in 3.5% sodium chloride solution. The function of the epoxy paint is to insulate the exposed surface of the carbon steel, which was not evaluated in this study.

Fig.8: Aluminium-coated sample prepared for immersion in 3.5% NaCl solution.

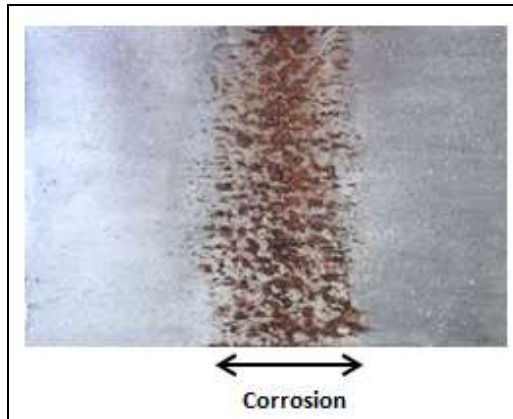
As shown in Figure 9, the sample investigated after 30 days showed that the area that was not supported by the sand suffered intense generalised corrosion, while the other part was totally protected via cathodic protection by the impressed current. This suggests that the causes of

ineffective tank bottom plates are linked to the continuity of the contact of the plate with the compacted soil. According to Gentil [11] and Mainier et al. [12], the electrical connection and the electrolyte continuity are the basic and fundamental requirements of cathodic protection. Any voids or spaces may lead to a loss of corrosion protection.

Fig. 9: Aspect of the area of the plate that was not supported in the experiment described in Figure 5.

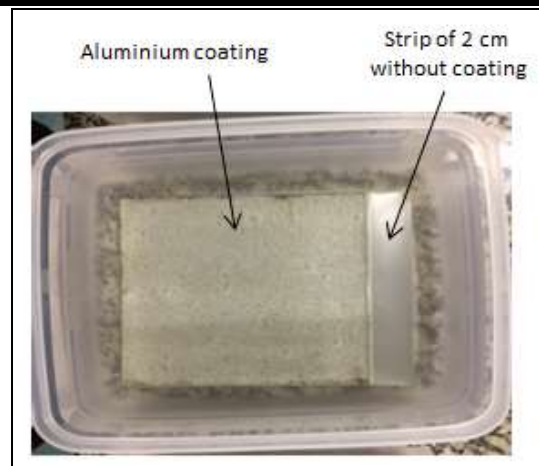
*Fig. 10: Carbon steel plate coated with aluminium in 3.5% NaCl solution.*

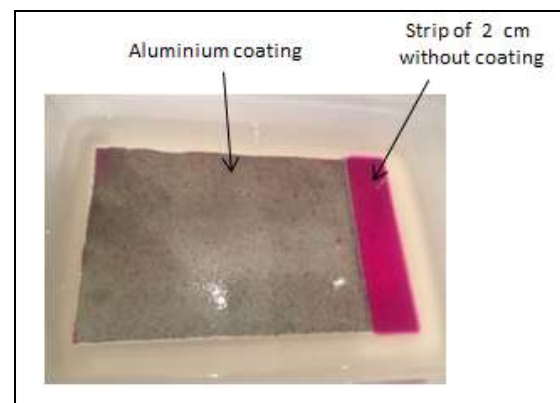
Figure 11 shows another plate of aluminium-coated steel, also immersed in 3.5 % NaCl solution, where phenolphthalein solution droplets were added to show the efficient cathodic protection of the aluminium as evidenced by an intense pink coloration, based on the following electrochemical reactions:

Fig.11: Carbon steel plate coated with aluminium in 3.5% NaCl solution with phenolphthalein solution droplets.
