The Fatigue Failure Analysis of Steel Structure and Review of Collapse Accidents

In this paper, exemplified by a certain factory building of Shanxi bolt-ball rack collapse as the research background, we will study the area of collapse network frame through the methods of field observation, deformation measurement, fracture analysis and sampling test, and analyze the failure process of the network frame, find out the accident reason finally. Main job:

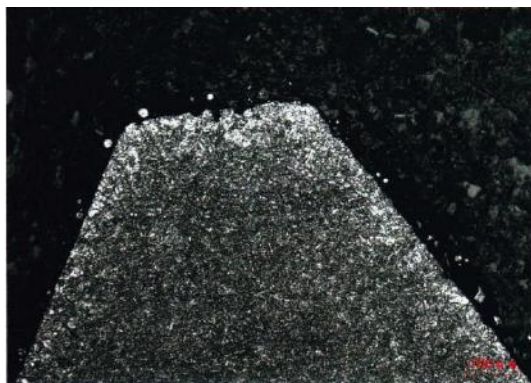
Fig. 4-1 Thread 1

The high-strength bolts of the grid are produced by Shijiazhuang city Standard Parts II Plant, and the material is 40Cr. On the basis of testing the chemical composition and mechanical performance testing of high-strength bolts, in order to further determine whether the high-strength bolts are qualified, the other performance of the high-strength bolts of the grid is further tested. The test results are show : All indicators are qualified.[20]
