# Geotechnical Investigation of Fracture Patterns in a Rock Mass during Excavation by Blasting

**Abstract**— *Overcharging in rocks (wall faces) during blasting and excavation usually causes damage to rock mass in most mining and quarry industries. This creates blast-induced fractures which can relate with pre-existing fracture pattern thereby increasing sliding and rockfall from the crest and body of an excavated wall. The spacing and orientation of pre-existing fractures are predominant at a small-scale mining (galamsey) site at 'Atta ne Atta', a town near Beposo, in the Western Region of Ghana. Geotechnical field studies were carried out to investigate the possibility of any instability within the area to eradicate the occurrence of an unexpected future wall failure (rockfall). The geotechnical mapping conducted was focused on fracture distribution and spacing. Mean spacing ( $S_m$ ) of existing fractures was calculated and corrections were made to obtain calculated spacing ( $S_c$ ). The scanlines of wall face 001 and wall face 002 intersect with their corresponding strike and dip at  $78^\circ$  and  $80^\circ$  respectively creating a slightly favourable fracture pattern and

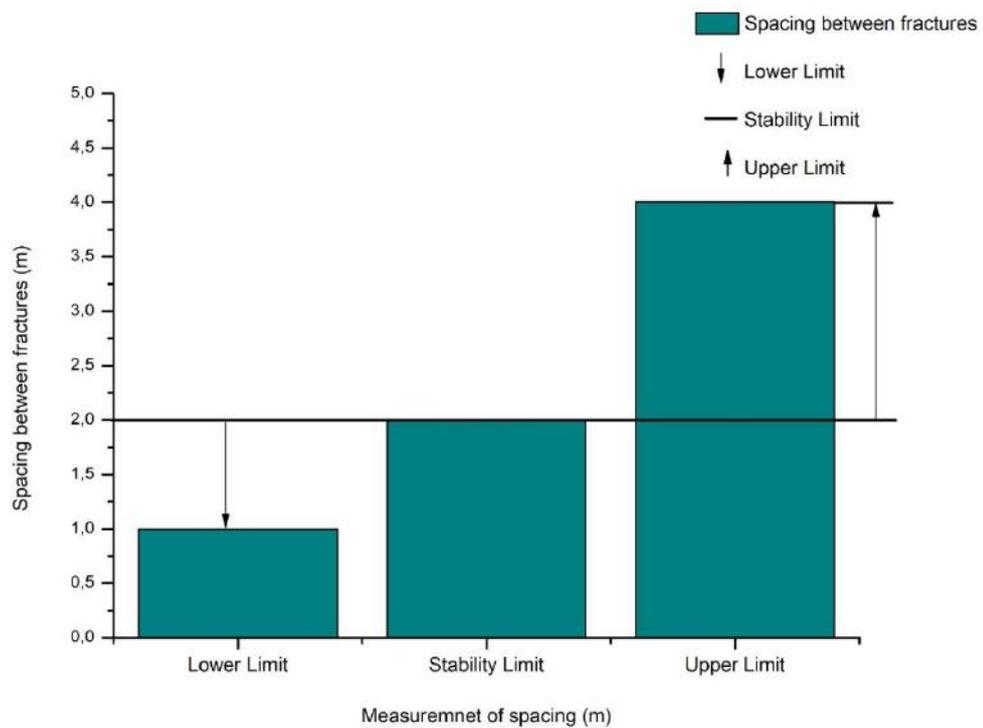
Fig. 3: A Graph of Standard Stability of Fracture Spacing

According to the Rock Mass Rating System [11], discontinuity within rock mass is characterized by a standard stability limit less than 2 m for a non-continuous and unweathered wall rock. Therefore, for a wall face to achieve maximum stability, spacing of fracture set above 2 m will be considered to be favourable in this study. Hence, a defined boundary between the upper (favourable) and lower (unfavourable) limits for standard stability of rock masses has establish in this study as shown in Fig. 3.

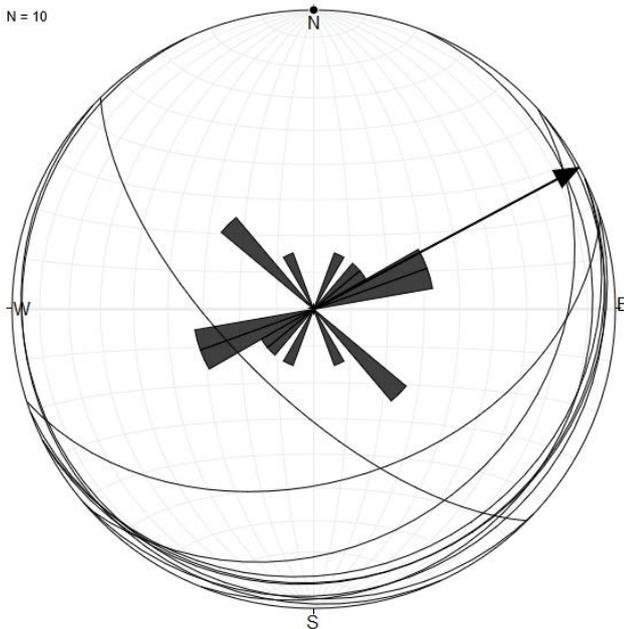
Fig. 9: Stereographic projection and Rose plot for Fracture Spacing at Wall Face 002

Again, the calculated spacing  $S_c$  was used in concluding the results because errors were corrected. As illustrated in Fig. 8, all the fracture sets were below 2 m of mean spacing between fractures indicating high instability condition within the Wall face 002. Stereographic projection of the dip and strike of fracture spacing within Wall Face 002 also shows a general strike of ENE-WSW. Observations made from the Rose plot also shows a maximum of 20 % strike between  $061^\circ$  and  $070^\circ$  (Fig. 9).
