# Reuse of waste from the manufacture of the granilite floor

**Abstract**—The purpose of this article is to seek a use for the waste obtained through the reuse of the waste from the breakdown of granilite. In order to become a more economical and beneficial option for use in the mortar mix. The tests were carried out at the Civil Construction Laboratory of the Instituto Tocantinense Presidente Antonio Carlos, ITPAC-Porto in Porto Nacional, Tocantins. Granilite rejects were added in percentages of 5, 10 and 15 in traces of mortar idealized for plastering the wall, then tested and analyzed, where the objective was to develop a resistance equal or superior to that of a conventional mortar, working at a lower cost and evolving into a new mortar additive for plastering purposes.

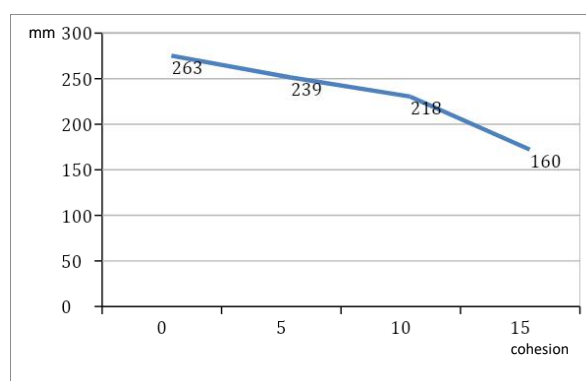
The results obtained on the consistency table, Flow Table Test were; for 0.0% of tailings addition obtained 263mm of cohesion, for 5% of tailings addition obtained 239mm of cohesion, for 10% of tailings addition it obtained 218mm and for 15% addition of tailings obtained 160mm of cohesion.

Fig 1: cohesion index graph

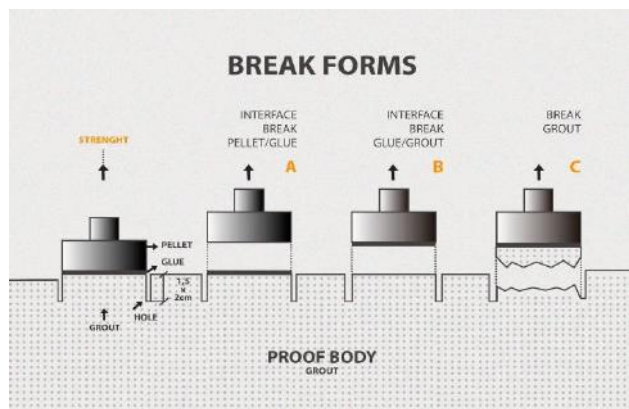
Fig. 2: forms of rupture

- Break in the insert / glue interface: indicates failure in execution (BARRETO and BRANDÃO, 2014).
- Break in the glue / mortar interface: considered as adhesive breaks indicates that this is the weakest layer of the coating. In this case, when results are low means that initial resistance is inadequate (powderiness) (BARRETO and BRANDÃO, 2014).
- Mortar break: Breaks are called cohesive when they occur in the internal regions of some constituent material (BARRETO and BRANDÃO, 2014).

As for the pathology, possibly "the phenomenon is caused by the dosage inadequate or inferior quality of the materials present in the mixture. Contribute for water loss failures in determining the type and content of binders, errors in the percentage of fines and the poor granulometric distribution of the sand" (AECWEB.2020). As well as indications indicate that this pathology has a correlation with cohesion index due to the retraction. In the adherence exit, three main types of disruptions being them.

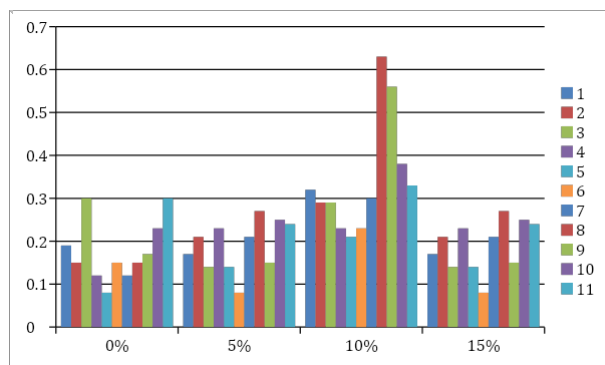
To performing the test on the specimen we obtained the following data.

Fig 3: pullout graph

In the 11 (eleven) pull-offs performed on the specimen of 00% addition. I got 6 (six) adhesive breaks and 5 (five) cohesive breaks. In the specimen of 5% of addition we obtained 7 (seven) adhesive breaks and 4 (four) cohesive breaks. At the specimen of 10% addition we obtained 8 (eight) adhesive breaks and 3 (three) cohesive breaks. In the 15% addition specimen we obtained 10 (seven) breaks adhesive and 1 (one) cohesive breaks. There was not a break in the interface pastille / glue. Of the 44 holes, 29.6% resulted in cohesive rupture and 70.4% resulted in

adhesive break. There is an increasing adhesive rupture, which points out that add the granilite tailings if there was a considerable increase in the characteristic powderiness. Data which was already expected due to the degree of fineness of the tailings.

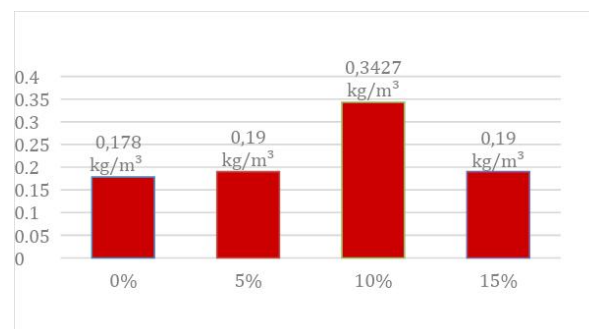
Analyzing by the average of the efforts applied to each specimen we obtained the following parameters.

Fig. 4: averages chart

As for the pullout result, in which 70.4% rupture of "adhesive" characteristic, demonstrates a worrying degree of powderiness, in which the chosen mortar mix was inadequate for the purpose. By analysis average of the efforts applied, it is observed that the bodies of evidence that received the granilite tailings in their composition behave positively, showing to support the efforts, the traction, as much as the sample without the rejection in composition, thus proving that it is possible to reuse this type of waste for civil construction works. It is also stated the importance of further studies and tests, like the ones presented in this article, for a better security of your application.
