# Evaluation of Water Quality for Water Bathing Conditions on Querer Beach in the Municipality of Santa Rosa, Tocantins

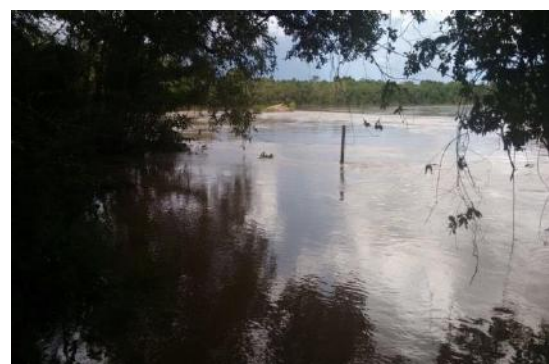
Fig. 2: Sample collection location in Querer Beach.

The raining season represents one of the main causes of contamination of the river body through the transportation of materials over the soil. With this scenario, a collecting point was selected with the assistance of a GPS device according to the legal standards established by Resolution 274, as demonstrated in figure 2.

The geographical coordinate of the chosen collecting points described in Table 1. It was performed collections in this specific place, in virtue to the beach access in the rainy season.

In each week a sample of water was collected at the selected spot in a suitably sterilized 100 ml glass vessel, approximately 1 meter deep. Sampling was carried out during 6 consecutive weeks, from March to April 2018: (03/08, 03/15, 03/22, 03/29, 04/05, 04/12), in the morning period as shown in the table 2.
